APPENDIX L: RAPID GEOMORPHIC ASSESSMENTS (RGA) CONDUCTED FOR THE PROPOSED LOWER BOIS D'ARC CREEK RESERVOIR SITE IN 2008 AND 2016

**L-1: RAPID GEOMORPHIC ASSESSMENT OF BOIS D'ARC CREEK AND ITS
TRIBUTARIES FOR THE LOWER BOIS D'ARC CREEK RESERVOIR
PROJECT (2008)**

**L-2: SUPPLEMENTAL RAPID GEOMORPHIC ASSESSMENT DATA
COLLECTION AT THE PROPOSED LOWER BOIS D'ARC CREEK
RESERVOIR SITE (2016)**

**Rapid Geomorphic Assessment of
Bois d'Arc Creek and its Tributaries for the
Lower Bois d'Arc Creek Reservoir Project**

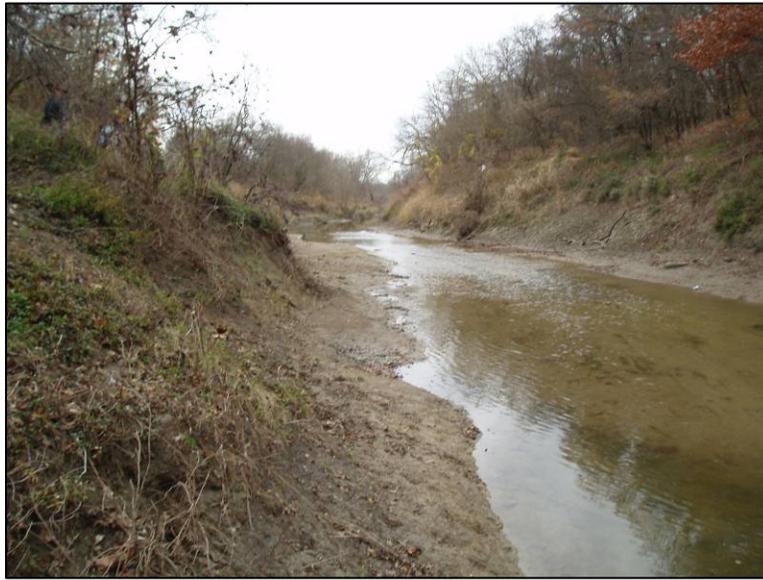
Figure 5.5 - Reach 1 of Bois d'Arc Creek.

rapid geomorphic classification for this reach is presented as Figure 5.20 at the end of this section.

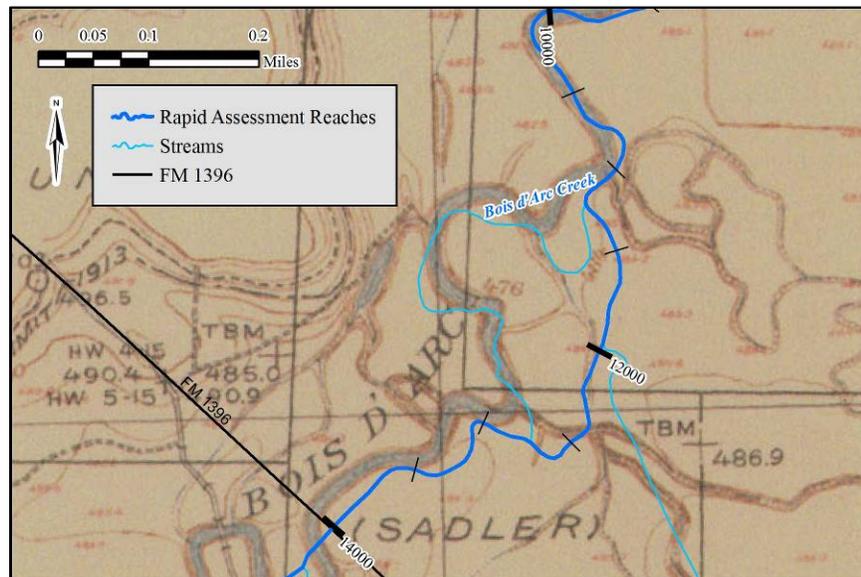
Figure 5.6 - Chute Cutoff in Reach 2 of Bois d'Arc Creek

Reach 2 of Bois d'Arc Creek (Figure 5.1) stretches from Station 70+00 to 190+00, covering approximately 13% of the total stream length. Most of this reach has not been straightened and matches quite closely to the 1915 meandering alignment. However, 1,500 feet of the reach was straightened between 1950 and 1976 to accommodate F.M. 1396. There are two locations along the reach where a chute cutoff has formed (near Sta. 127+00 and 178+00), making the chutes the main stem of the creek and abandoning the original alignment over time. Figure 5.6 provides an example of one of the chute cutoffs.

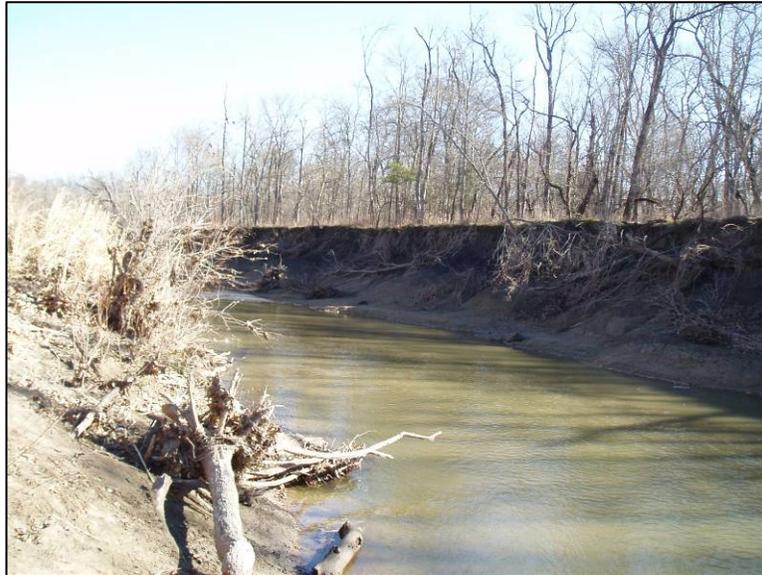
Figure 5.7 - Reach 2 of Bois d'Arc Creek during winter

As shown in Figure 5.2, Reach 2 has an average channel slope of 0.08%, but channelization of the downstream reach is causing a headcut into this reach. Figures 5.7 and 5.8 provide typical views of Reach 2 of Bois d'Arc Creek.

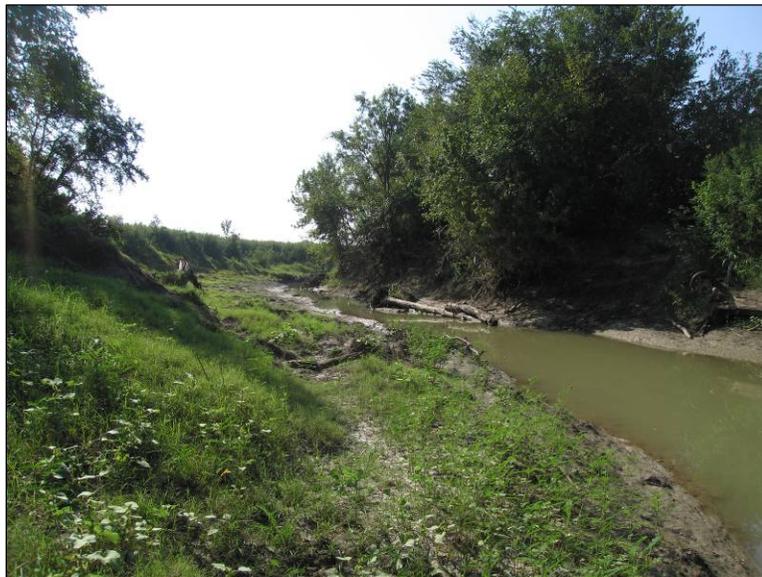
In terms of the rapid assessment classification of Reach 2 of Bois d'Arc Creek, the upper reaches of this creek seem to be in Type III of the channel evolution process. Downstream of F.M. 1396, the creek seems to be in transition between Types III and IV, with an inner berm forming inside the channel (Figure 5.8b). The stability of this reach is predominantly poor, with approximately 45% of the reach given a "fair" rating and the other 55% a "poor" rating. The rapid geomorphic classification for this reach is presented as Figure 5.20 at the end of this section.

Figure 5.8b - Reach 2 of Bois d'Arc Creek showing the formation of an inner berm.

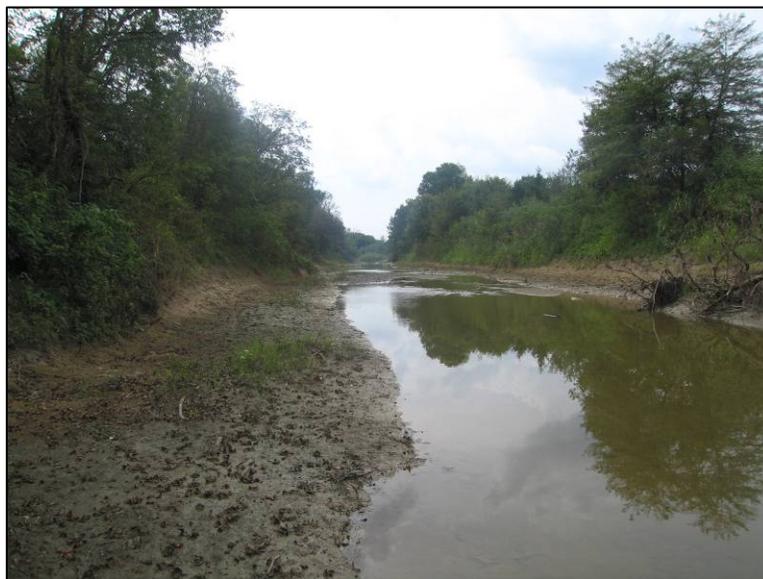
Figure 5.10 - Reach 3 of Bois d'Arc Creek during summer.

As shown in Figure 5.2, Reach 3 has an average channel slope of 0.08%. Figures 5.10 and 5.11 provide typical views of Reach 3 of Bois d'Arc Creek.

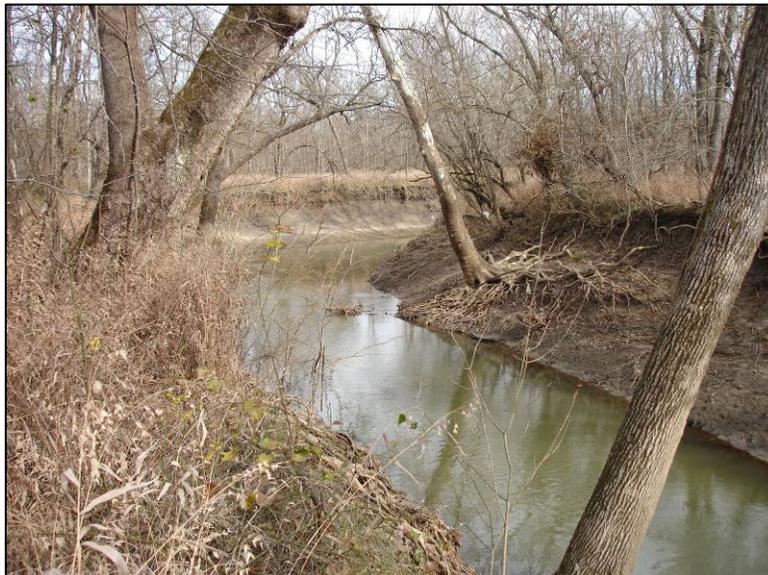
Figure 5.13 - Reach 4 of Bois d'Arc Creek during winter

There is one location along the reach where a chute cutoff has formed (Sta. 300+00), making the chute the main stem of the creek and abandoning the original alignment over time. Figures 5.13 and 5.14 provide typical views of Reach 4 of Bois d'Arc Creek.

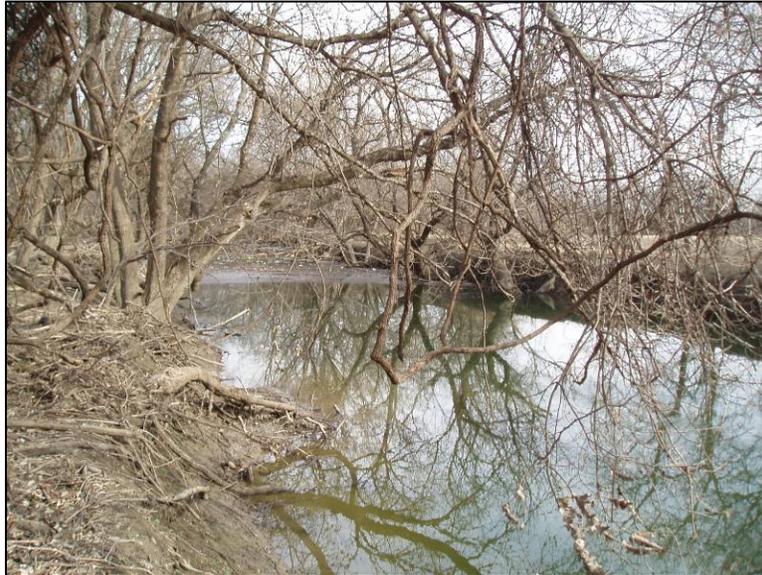
of the banks, with the remaining percentage left as barren slopes. In addition, the side slopes are vertical, causing undercut banks. Channel slopes for this segment of reach average 0.01%.

Figure 5.16 - A “poor” rated reach on Reach 5 of Bois d’Arc Creek.

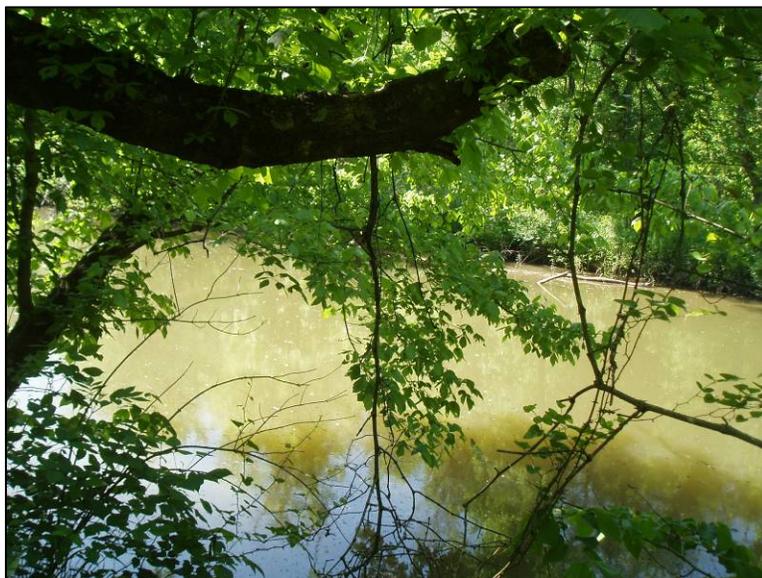
Figure 5.17 - A “fair” rated reach on Reach 5 of Bois d’Arc Creek.

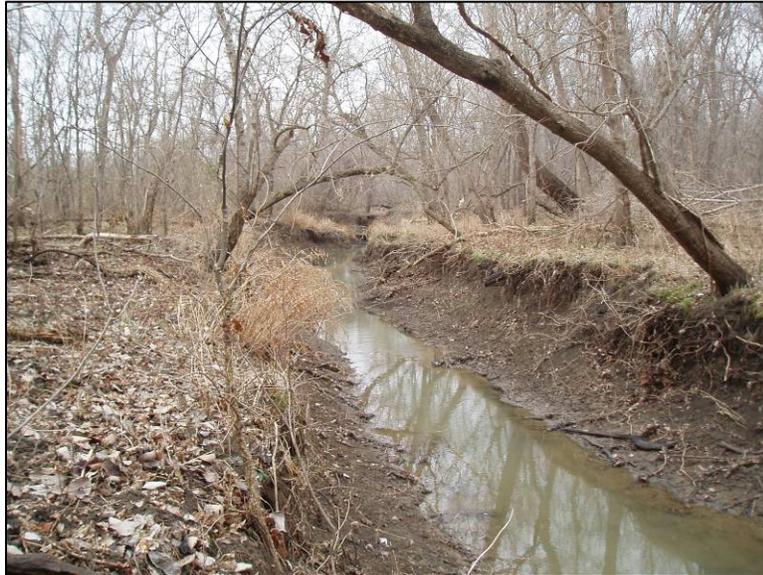
Outside of this low lying area, the channel dimensions vary from a top width of 50 feet to 70 feet and a channel depth of three feet to eight feet as you move downstream. Channel slopes for this segment of reach average 0.10%. Figure 5.18 shows an example of a stream segment in this area classified as “poor.” Figure 5.19 shows an example of a stream segment in this area classified as “fair.”

Figure 5.18 - A “poor” rated reach on Reach 5 of Bois d’Arc Creek.

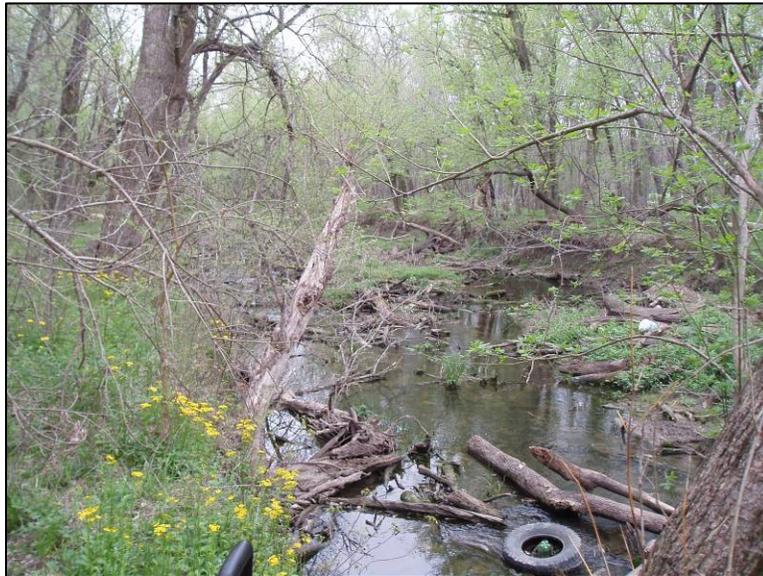
Figure 5.19 - A “fair” rated reach on Reach 5 of Bois d’Arc Creek.

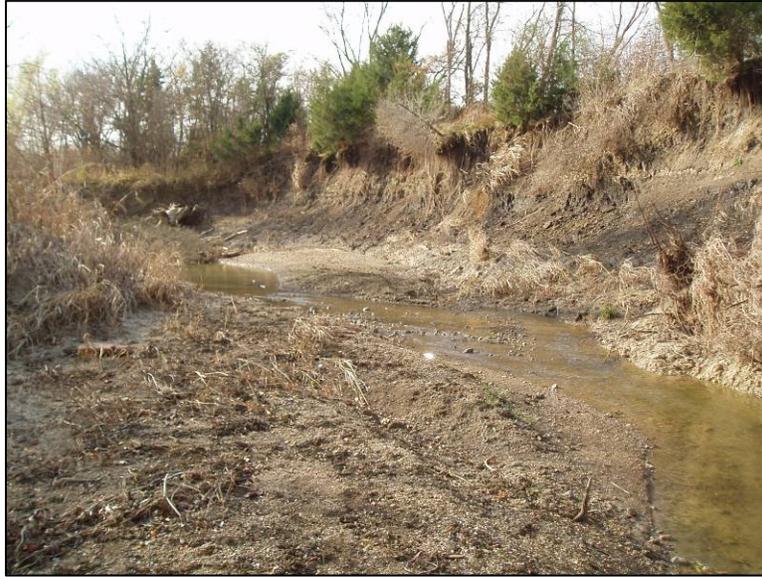
Figure 5.26: Poor rated section of Honey Grove Creek along lower reach.

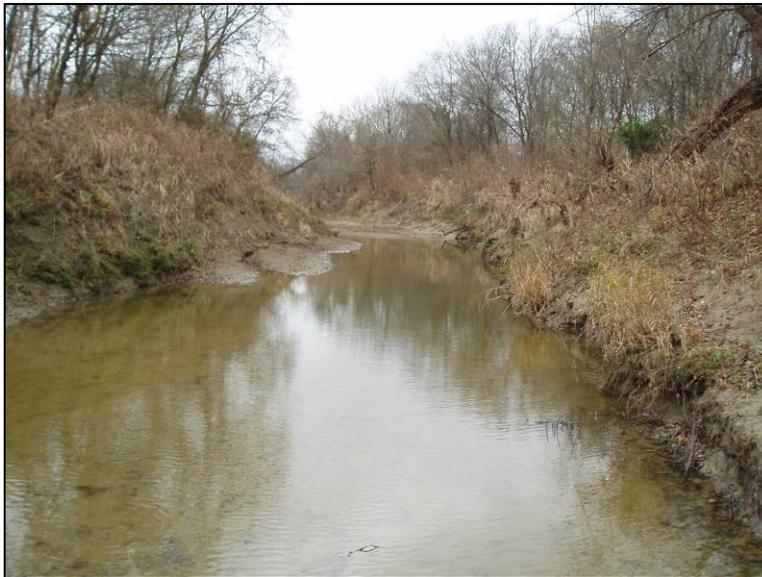
Figure 5.27: Fair rated section of Honey Grove Creek along lower reach.

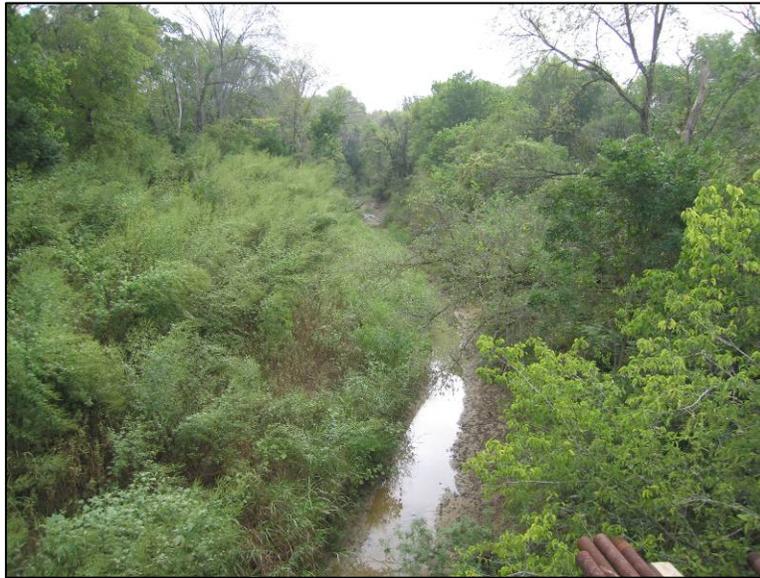
banks. There is little habitat potential for most of this reach, with very little shade over the creek and incised channel banks. Figure 5.28 shows a typical view of this fair rated stream segment.

Figure 5.28: Fair rated section of Honey Grove Creek along upper reach.

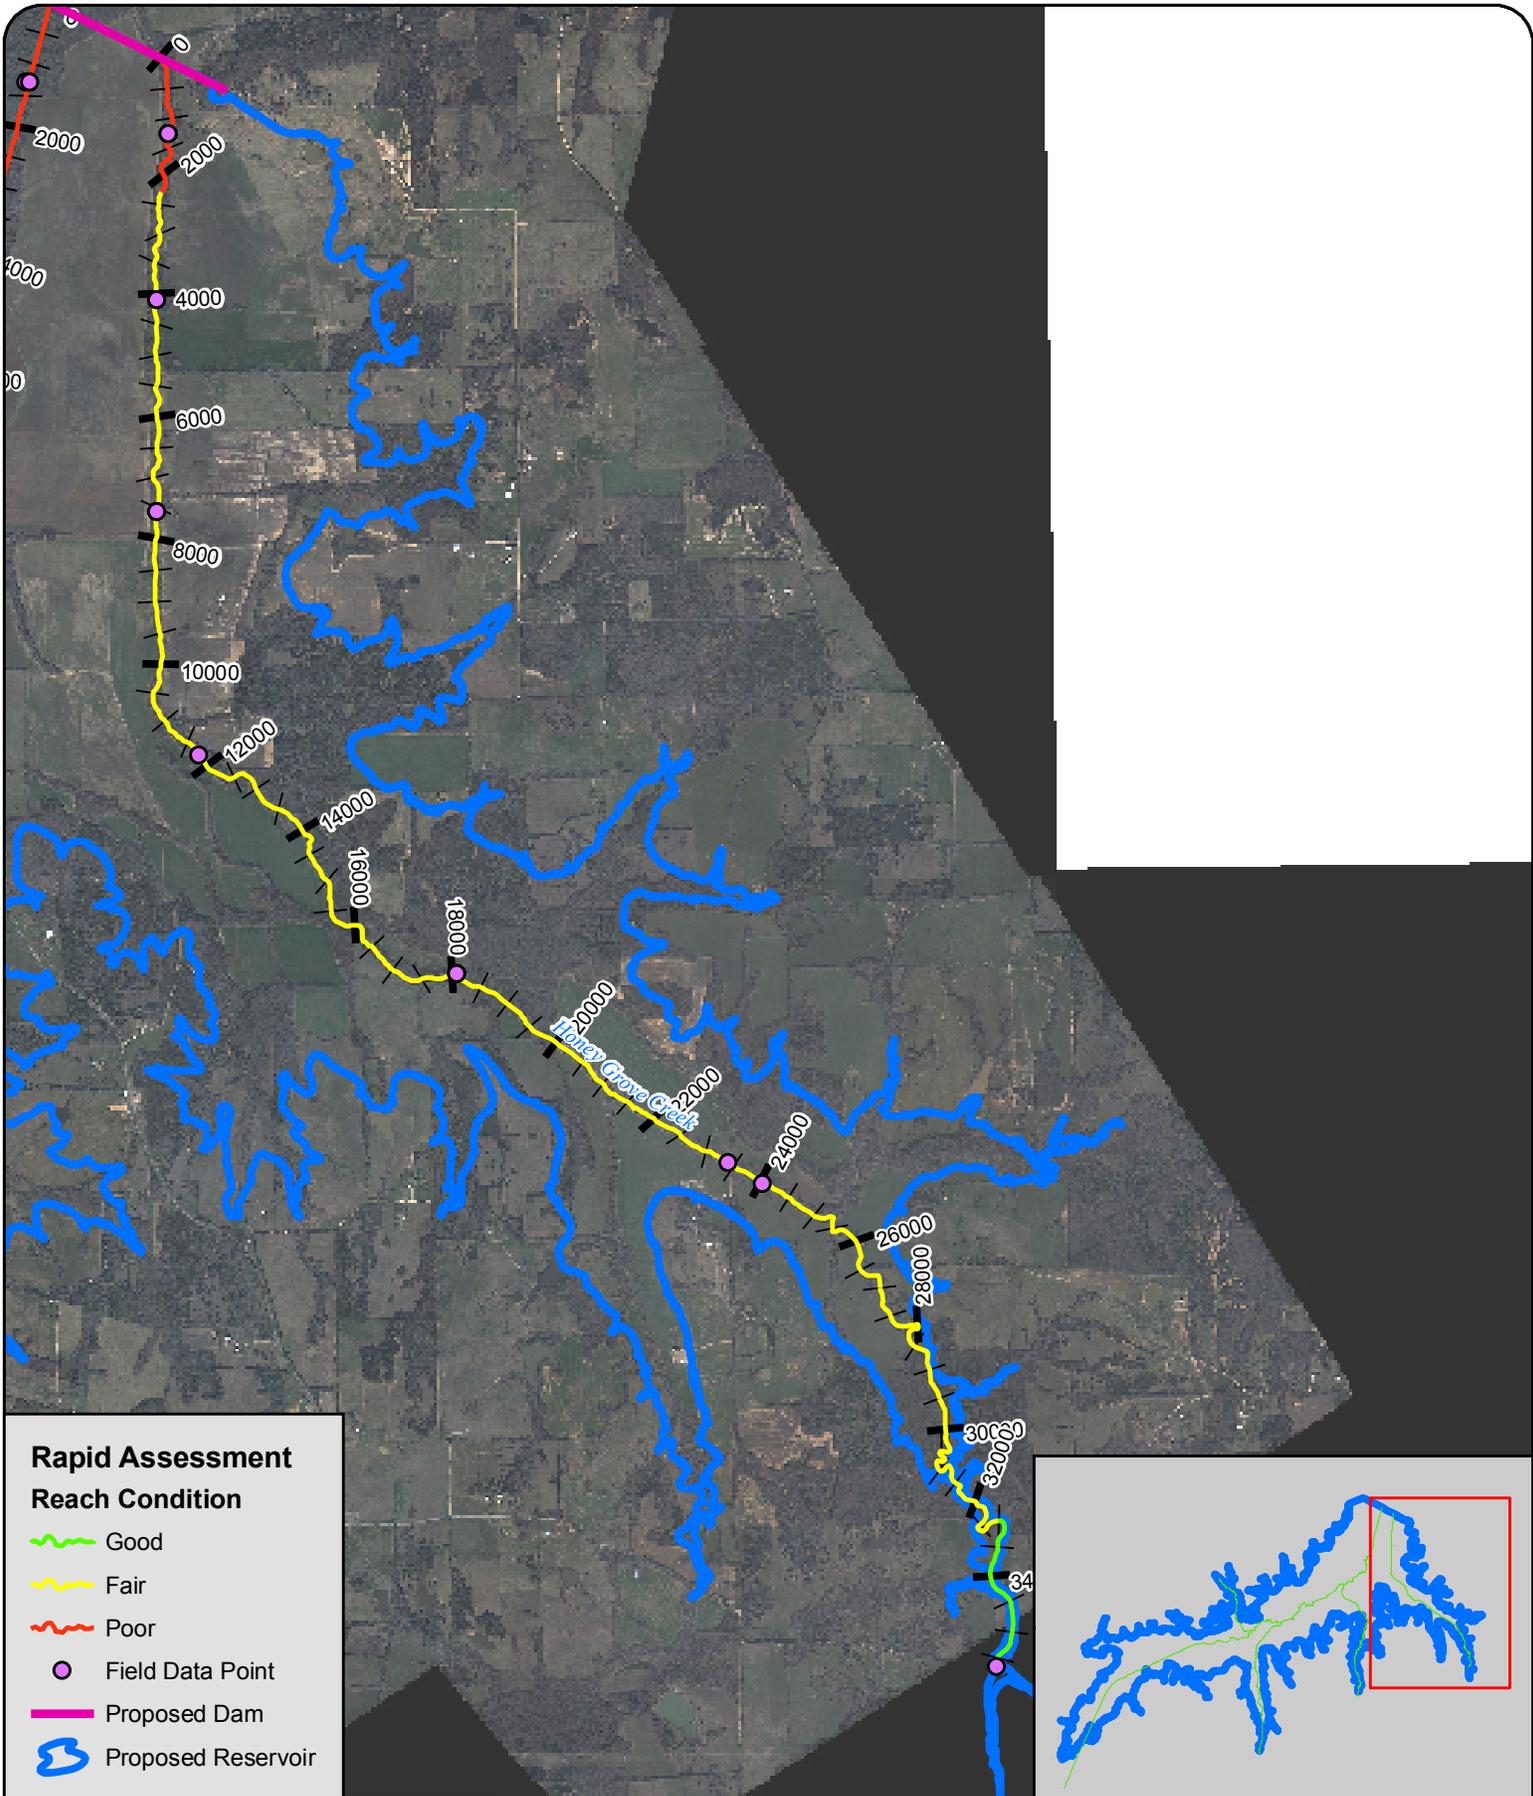
The classification of the entire reach is predominantly fair, with approximately 86% of the reach given a “fair” rating, 8% a “good” rating, and the remaining 6% a “poor” rating. The rapid geomorphic classification for this reach is presented as Figure 5.29.

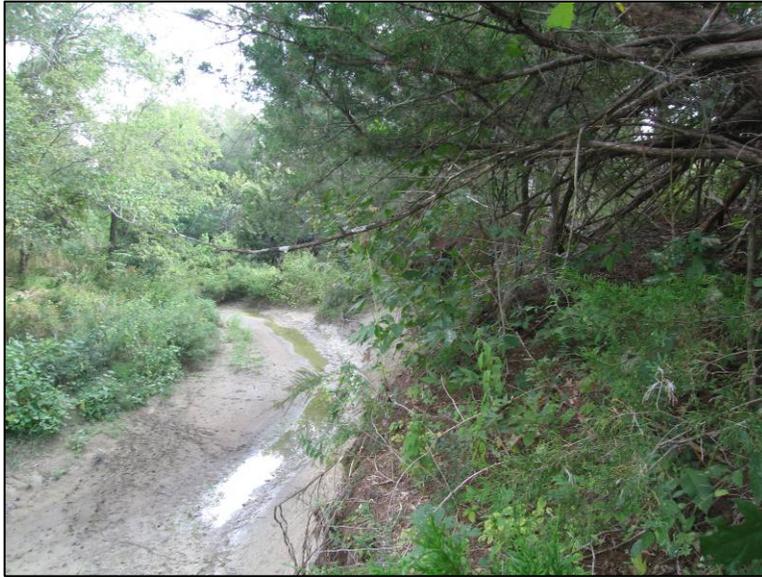
Figure 5.32 – Typical view of Ward Creek

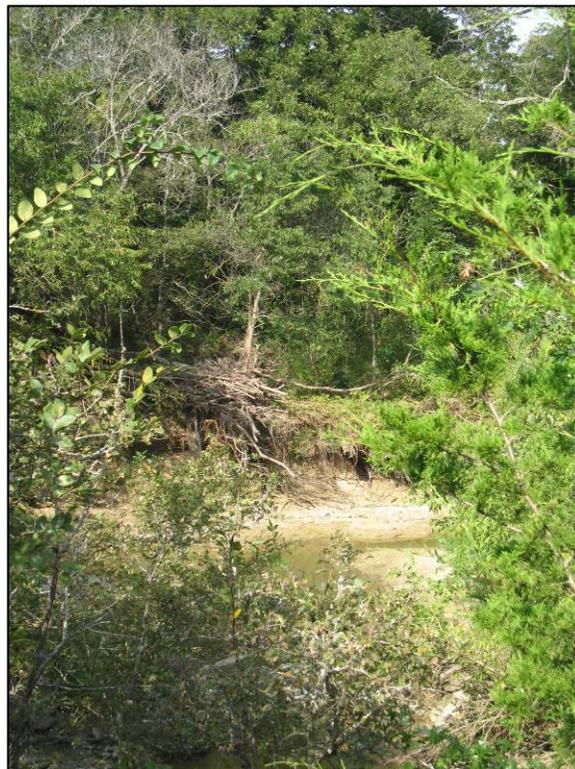
Figure 5.33 - View of Ward Creek with evidence of mass wasting.

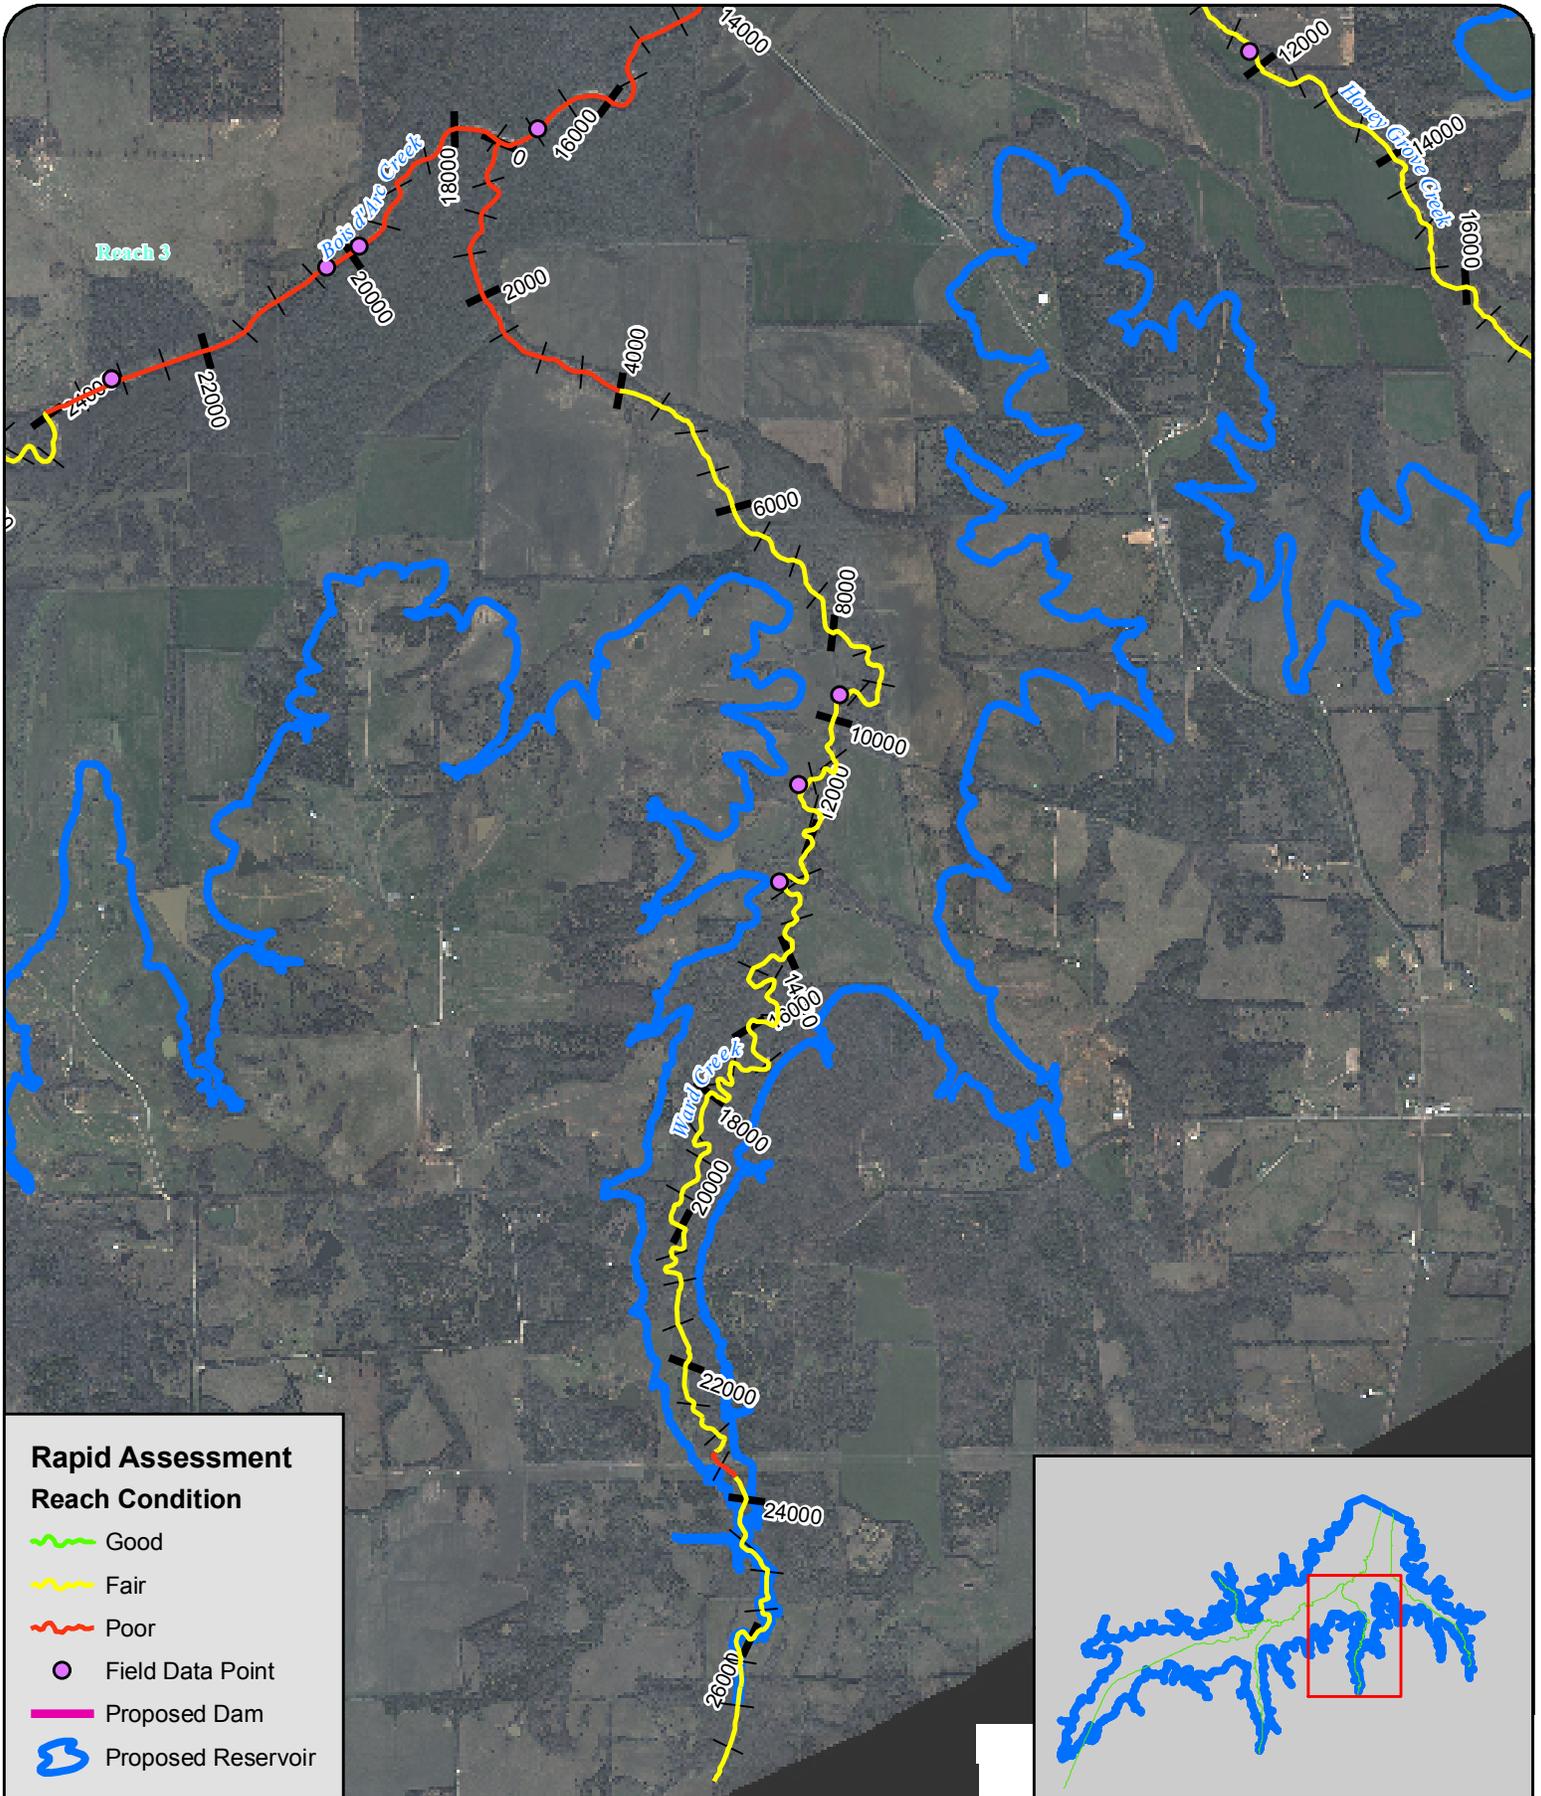
In terms of the rapid assessment classification of Ward Creek, the majority of the reaches of this creek appear to be in Type III or Type IV of the channel evolution process with inner berms forming within the channel. The downstream segment of this creek appears to be in Type III and continues to react to the changes in Bois d'Arc Creek. A major impact on this segment of the creek was the apparent meander cutoff at the confluence. The overhead electric easement and section downstream of the knickpoint are in Type III and Type II, respectively of the evolution process. The classification of this reach is predominantly fair, with approximately 84% of the reach given a "fair" rating and the remaining 16% a "poor" rating. The rapid geomorphic classification for this reach is presented as Figure 5.34.

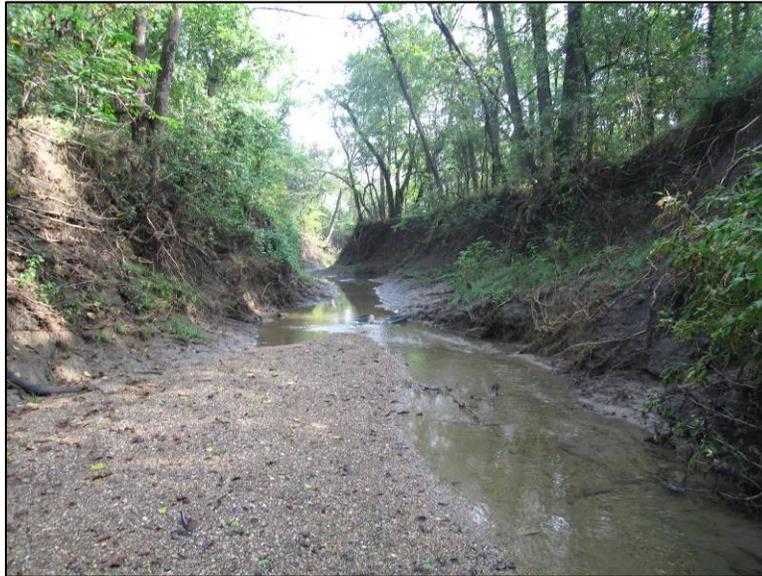
to high sediment load from the stream banks. Streambank erosion rates in some reaches appear to be very high due to mass wasting from the near vertical side slopes; however, there are some reaches that appear to be recovering with the formation of inner berms and emergent vegetation. Figure 5.37 shows an example of a stream segment classified as “poor.” Figure 5.38 shows an example of a stream segment in this area classified as “fair.”

Figure 5.37 - A “poor” rated stream on Bullard Creek.

The stream conditions shown in Figure 5.37 look very similar to those shown in Figure 5.38; however this “fair” rated stream is showing signs of recovery by the development of the inner berm and floodplain and vegetation along the banks. This reach seems to be in Type IV.

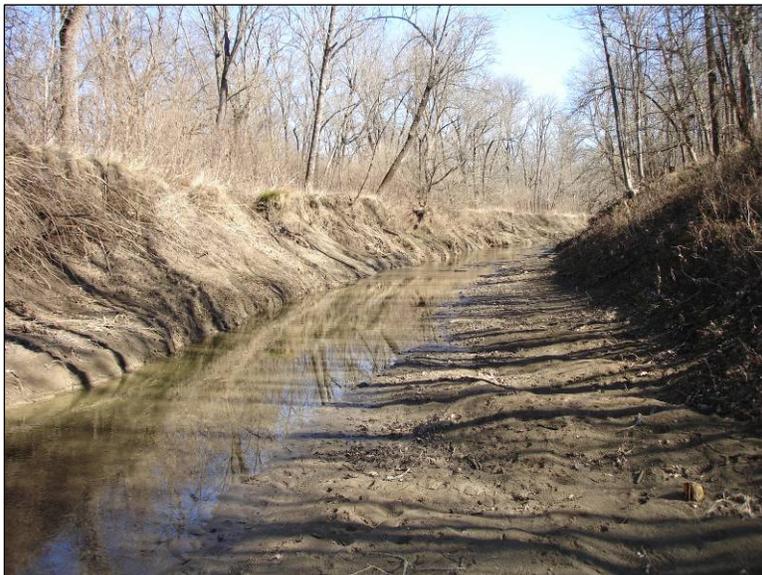
Figure 5.38 - A “fair” rated stream on Bullard Creek

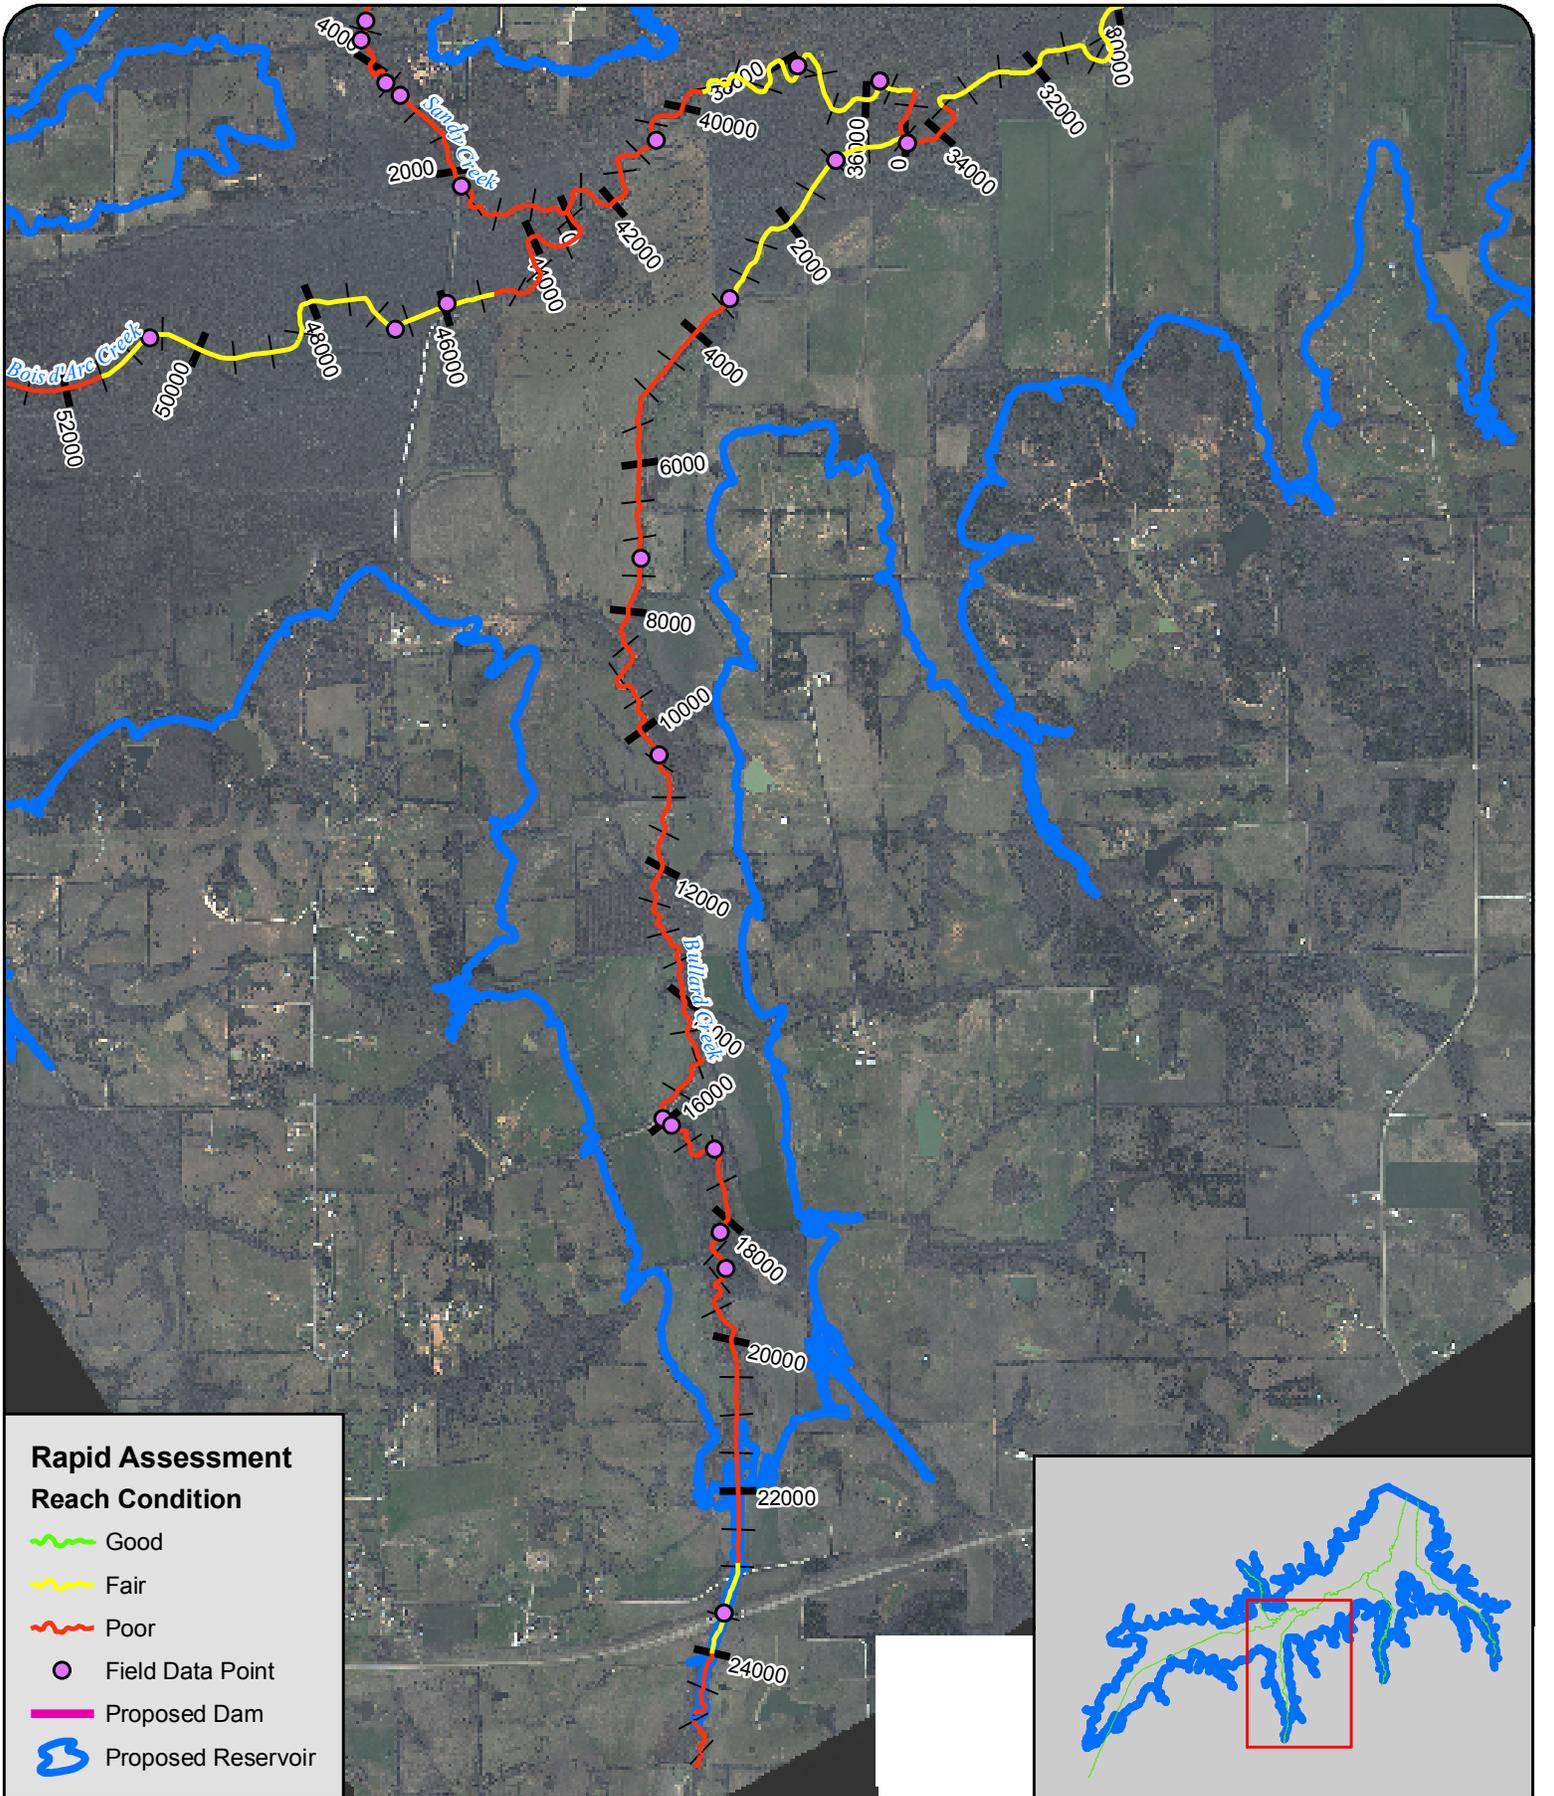
The rapid geomorphic classification for Bullard Creek is presented as Figure 5.39. Bullard Creek is predominantly in fair stability conditions, with approximately 18% of the reach given a “fair” rating and the other 82% given a “poor” rating.

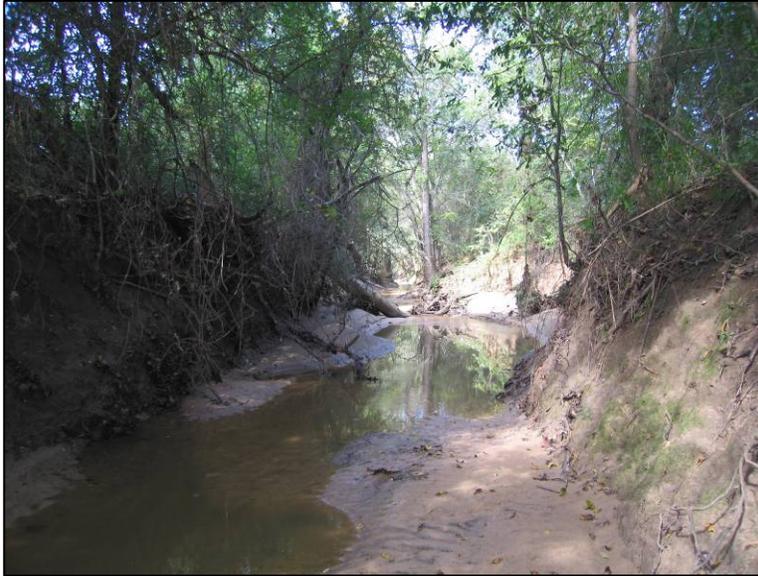
Figure 5.42: Typical View of Sandy Creek with vertical side slopes.

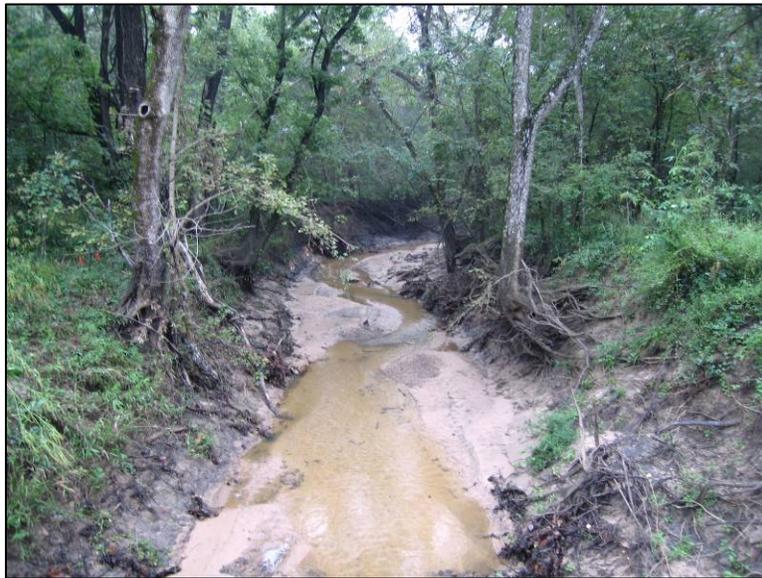
Figures 5.43: Typical view of Sandy Creek with flatter side slopes.
