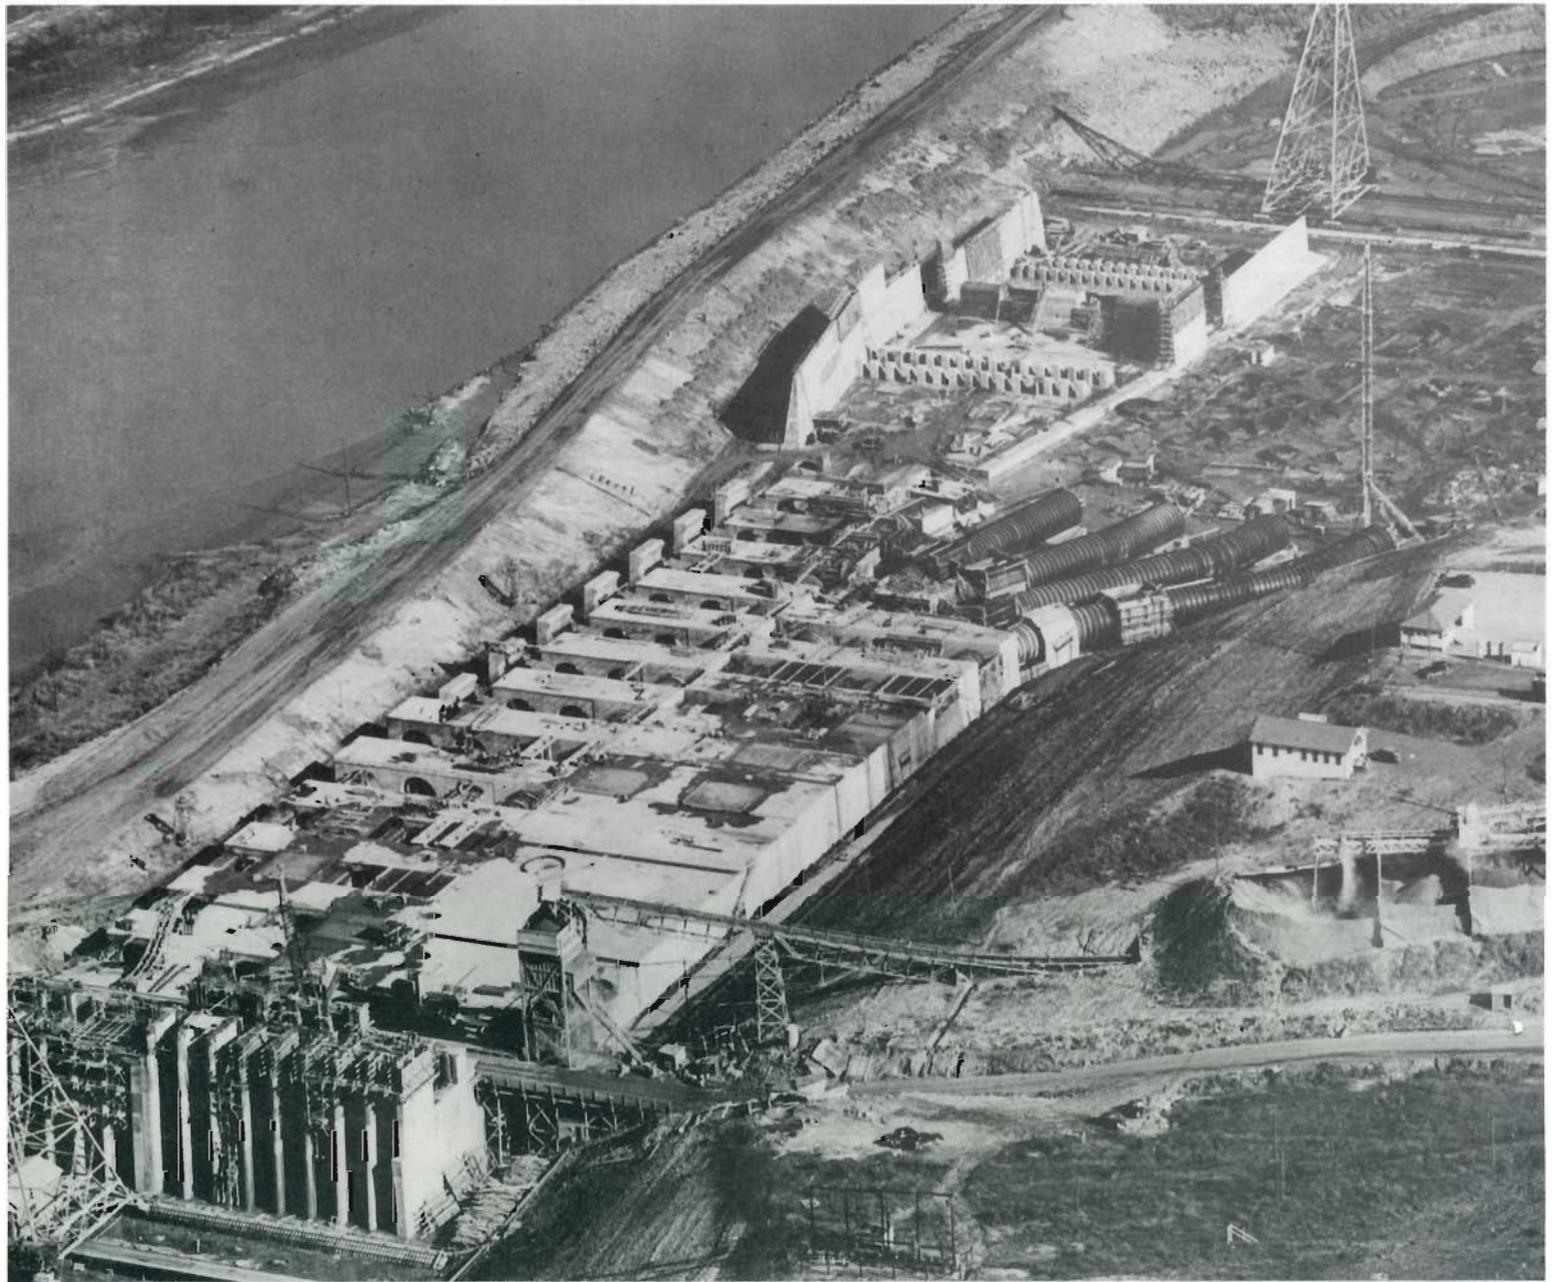
By the fall of 1940, construction of Denison Dam was progressing rapidly. The October 1940 photo. above, shows construction of the intake structure, conduit section, and stilling basin, looking toward the northeast. Sections of the penstock, still in shipping crates, dwarfed the worker in the photo at right.
