Enclosure 2

Ecological Issues Evaluation Results of the Jacob's Creek Landing Neosho River Log Jam

Scott L. Satterthwaite, KDHE BOW WMS- 9/16/04

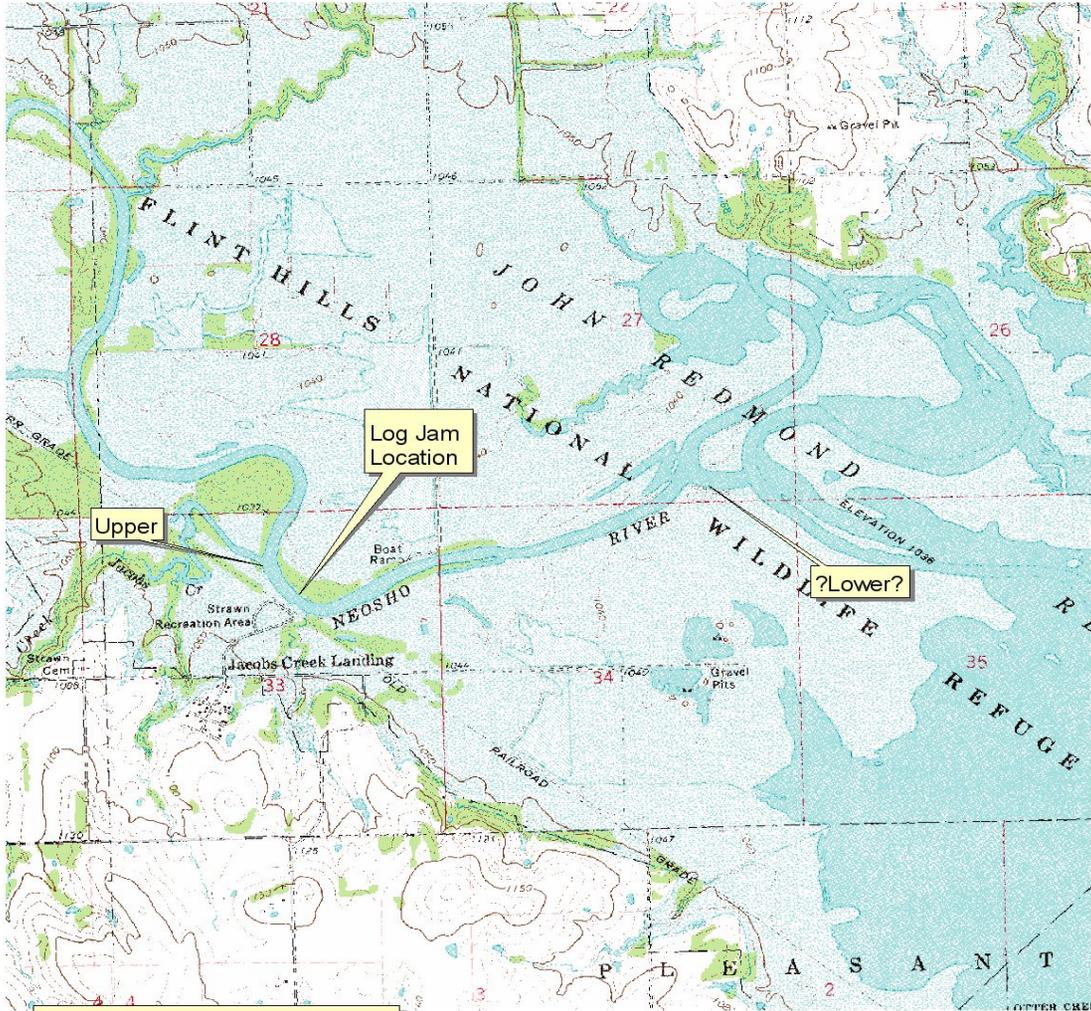
**Log jam
UFWS**

- Boat ramp was un-useable.
- 55 gallon drum, cooler and small gallon container.
- Water still flowing in/out of the area indicated by stranded forage fish, water moving through ditches, over roads, etc.
- Wildlife feeding in floodwater next to US Fish and Wildlife Refuge road to Strawn Flats.
- Fish surfacing and feeding on or between logs.
- Woody debris varied in size from branches to trunk logs.

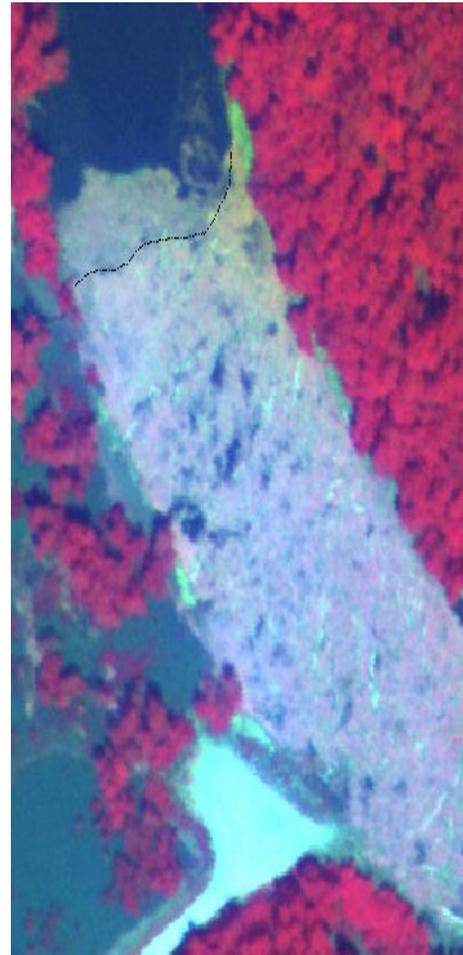
- The jam is expanding

Figure 2. Image from August 2004 with a patch of relatively newly deposited debris shown above the black line.

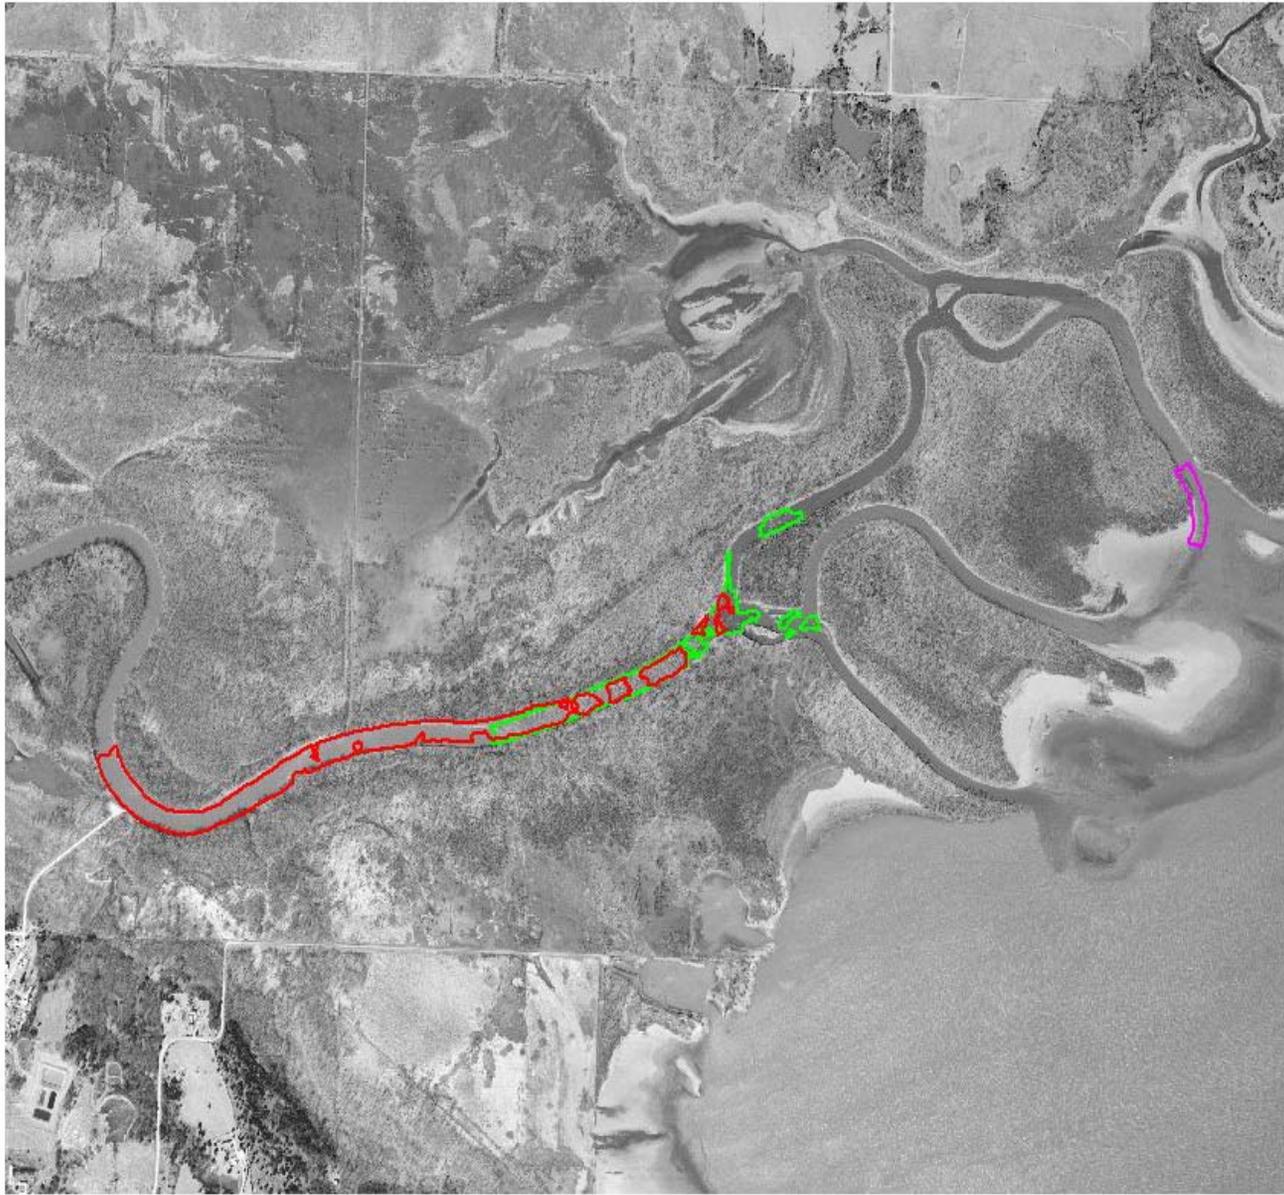
Log jam 1991

Log jam 2002

Log jam 2004

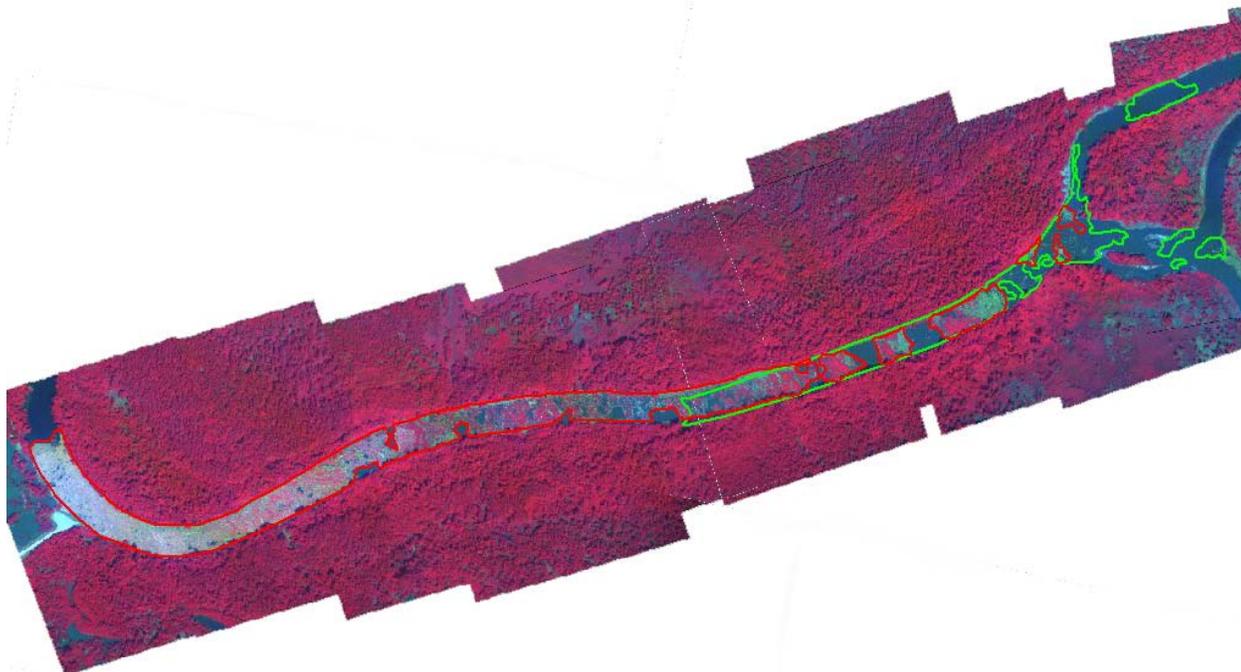
Background: Near Infrared false color composite from airborne multispectral camera. August 17, 2004

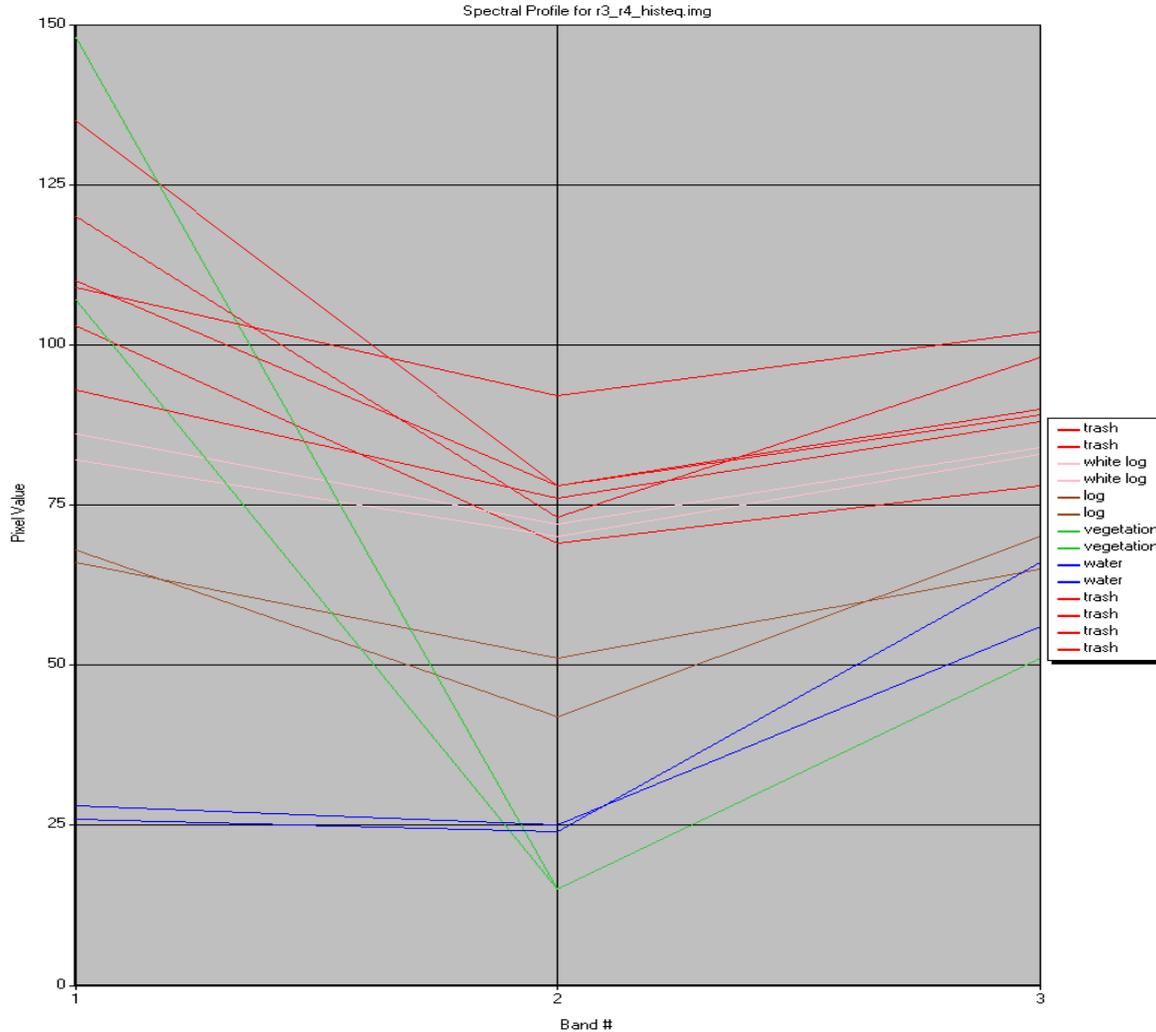
Figure 3. Graph showing the amount of reflectance (vertical axis) of each of the three spectral bands of the DuncanTech camera. Note how each type of feature has a unique reflectance pattern: Red = SW, pink= bright logs, brown = common log, blue = water, green = vegetation.

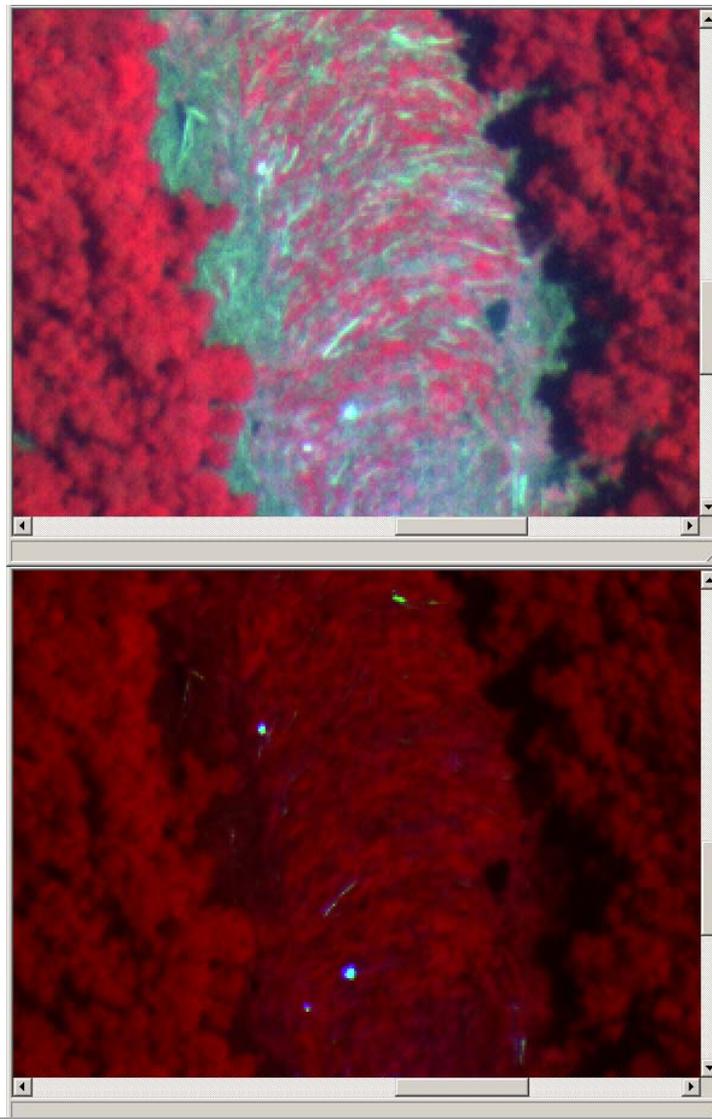
Figure 4. Two view of DuncanTech imagery used to identify non-natural debris points. The top image shows the original imagery used to visually identify SW, while the lower image shows the same area, but after adjusting the brightness of the red and blue bands to highlight the highly reflective debris.

- Identified 63 items considered to be solid waste including. (non-natural material).
- An estimation of the solid waste concentration is approximately 1 item per 18,604 sq. ft.
- There is no evidence of a concentration of waste items.

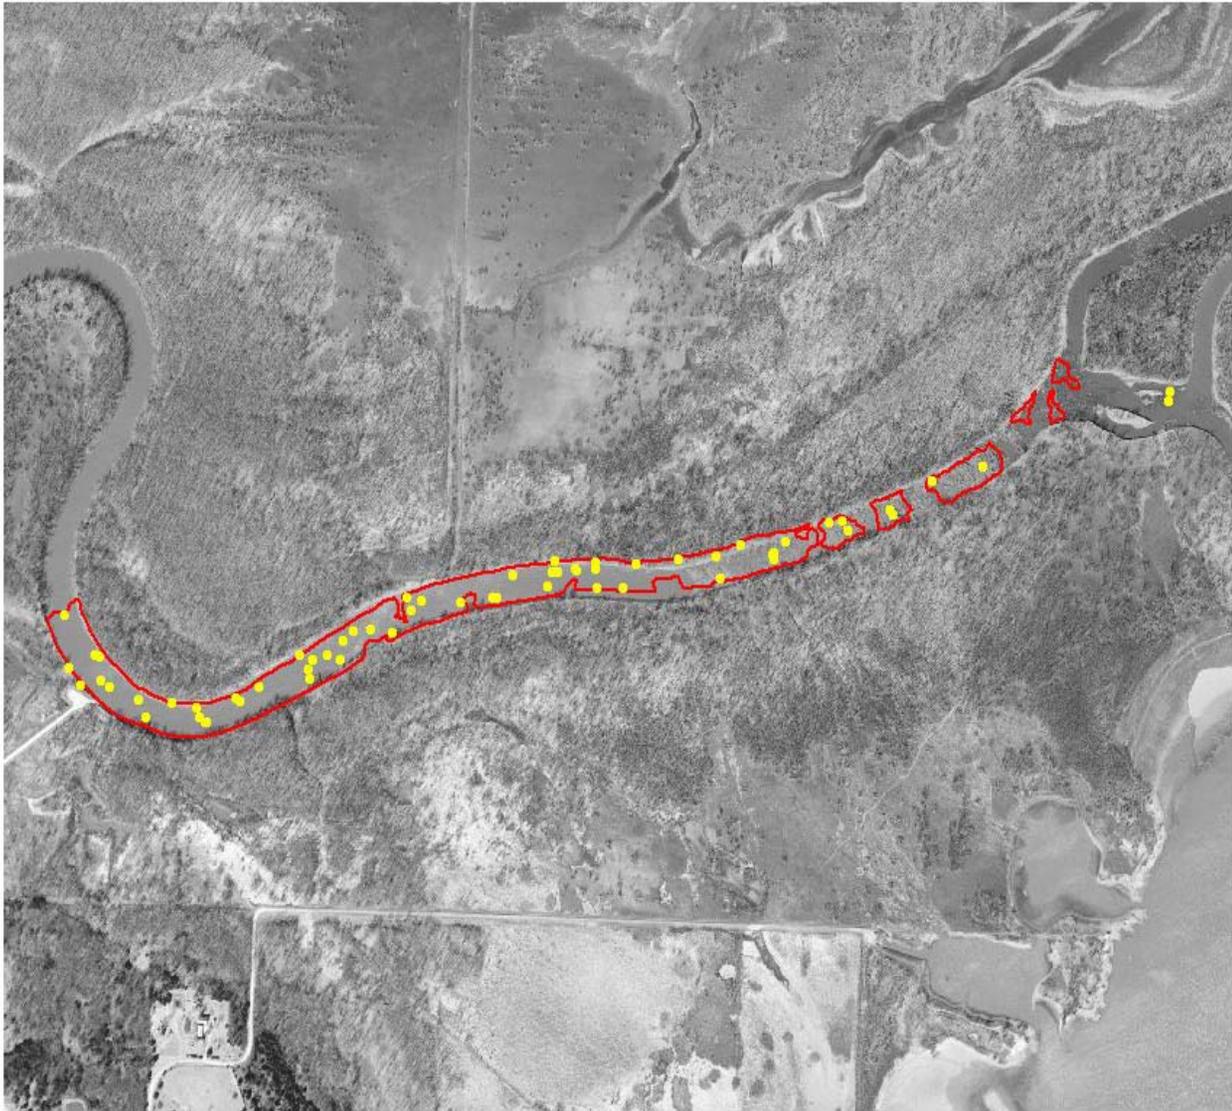
Background: DOQQ photograph
February 2, 2002
