ENVIRONMENTAL ASSESSMENT

TAR CREEK SECTION 111 PROJECT
PLUGGING OF VARIOUS MINE SHAFTS

March 2005
Work Order No. 03886.525.007

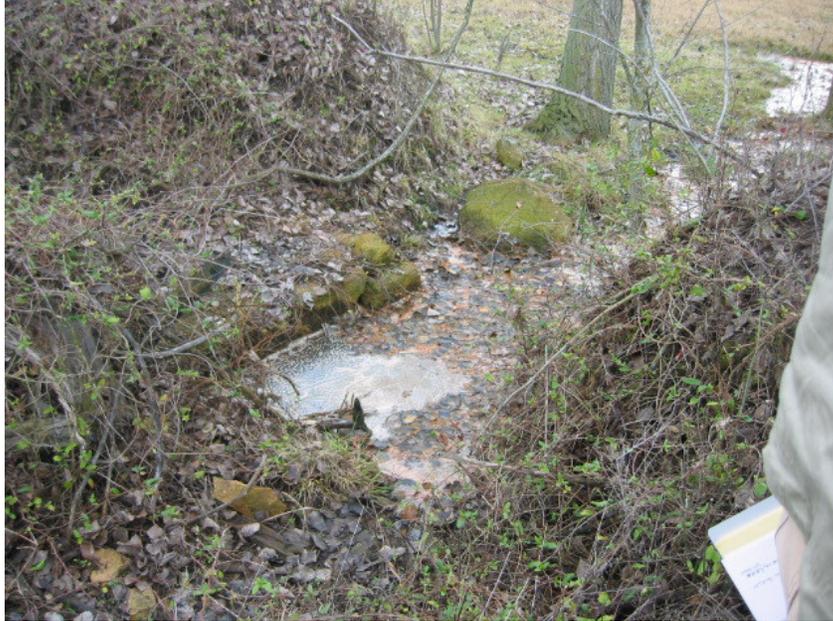
PHOTOGRAPH No. 1

Description: Photographs 1 and 2 are views of Mine Shaft Site No. 4 – Section 32. Photograph 2 is the view of a wetland located south and west of Mine Shaft.

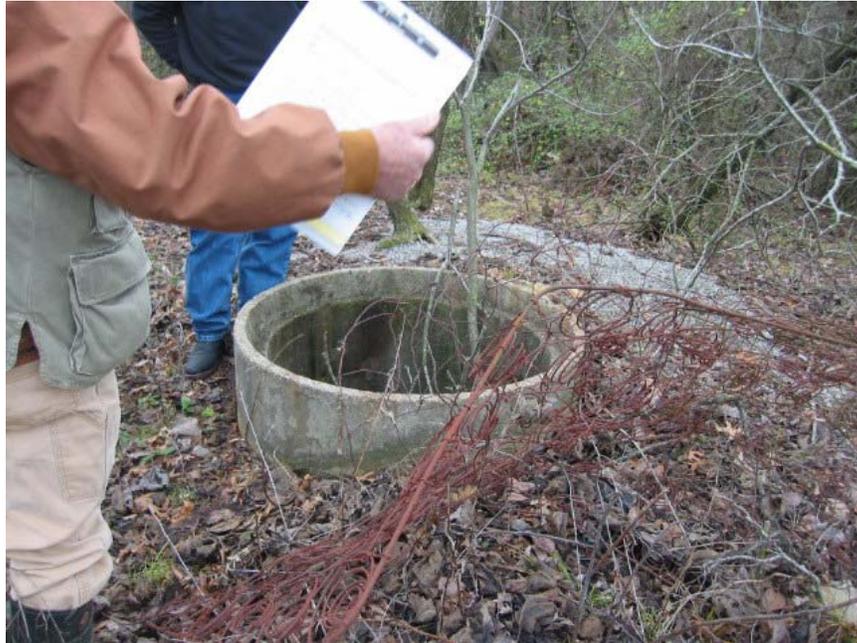
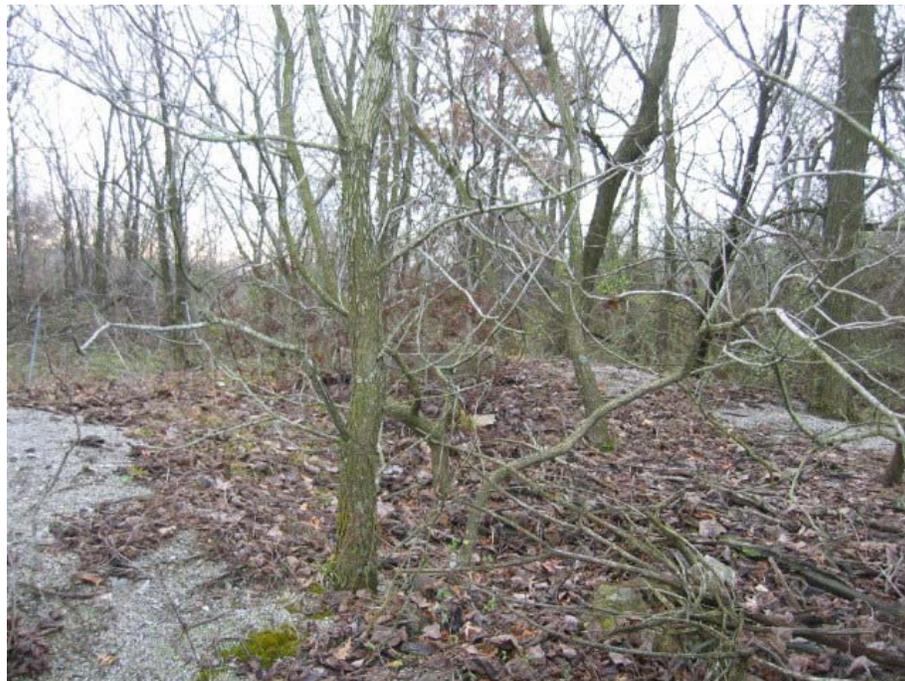
Location: Mine Shaft Site No. 27- Section 30

Description: Photographs 3 and 4 are views of Mine Shaft Site No. 27- Section 30.
Photograph 4 is the view of catalpa trees surrounding Mine Shaft Site No. 27.

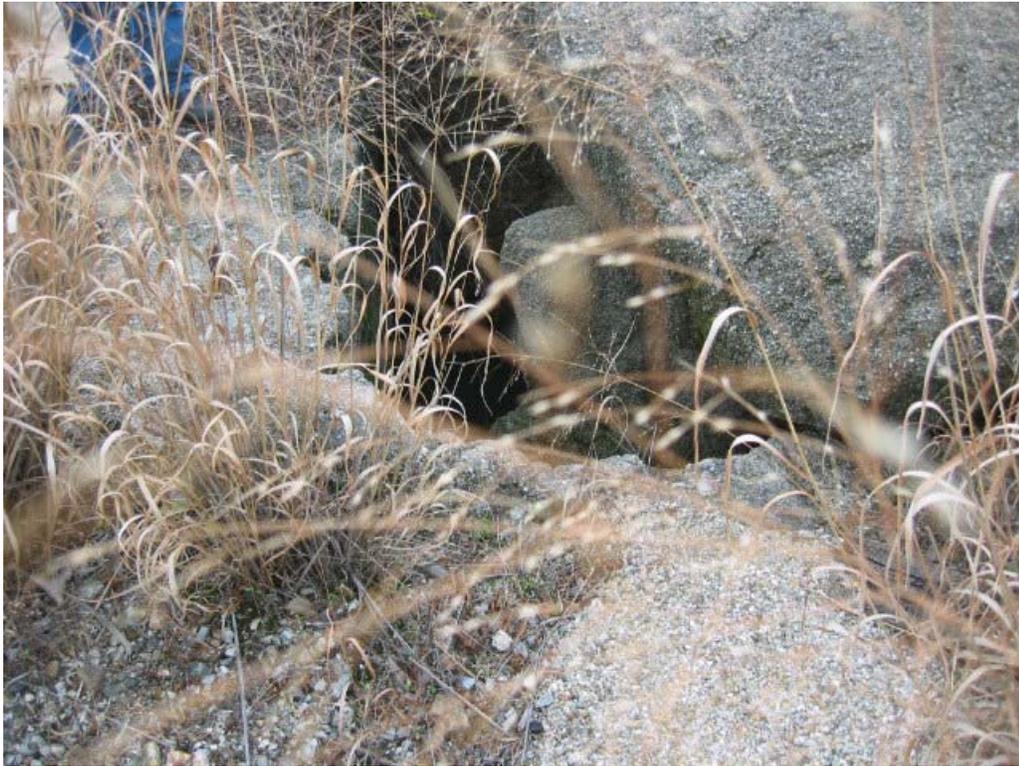
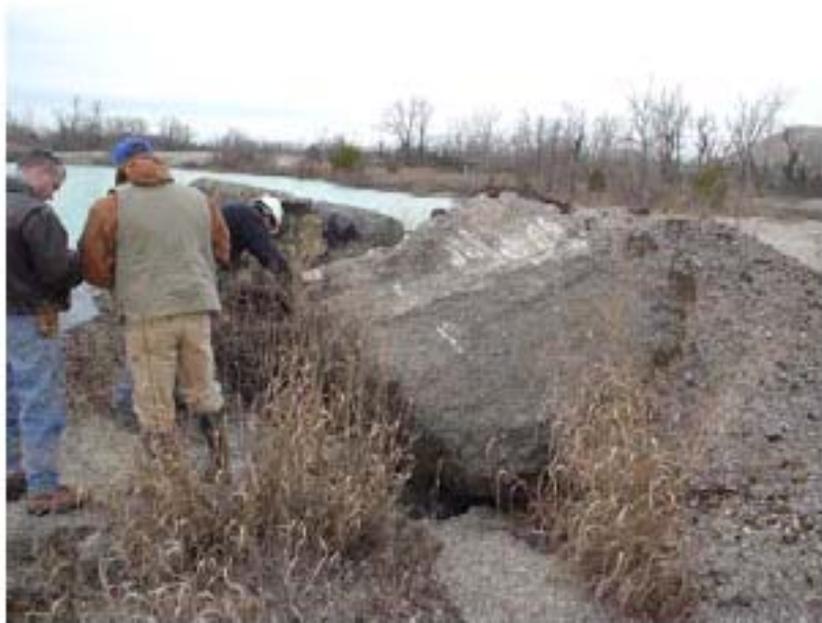
Location: Mine Shaft Site No. 03- Section 29

Description: Photographs 5 and 6 are views of Mine Shaft Site No. 03- Section 29.

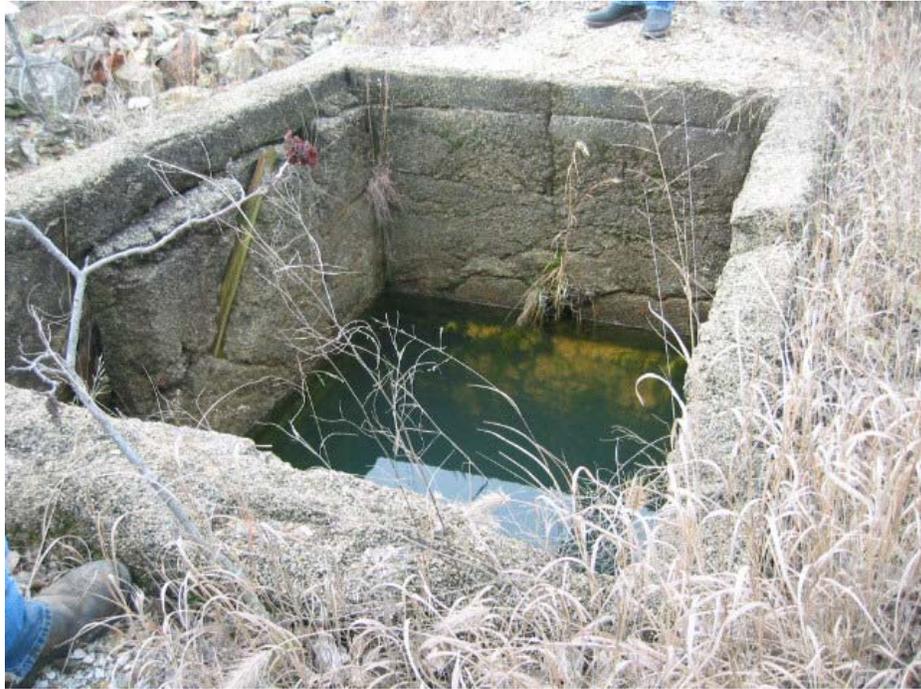
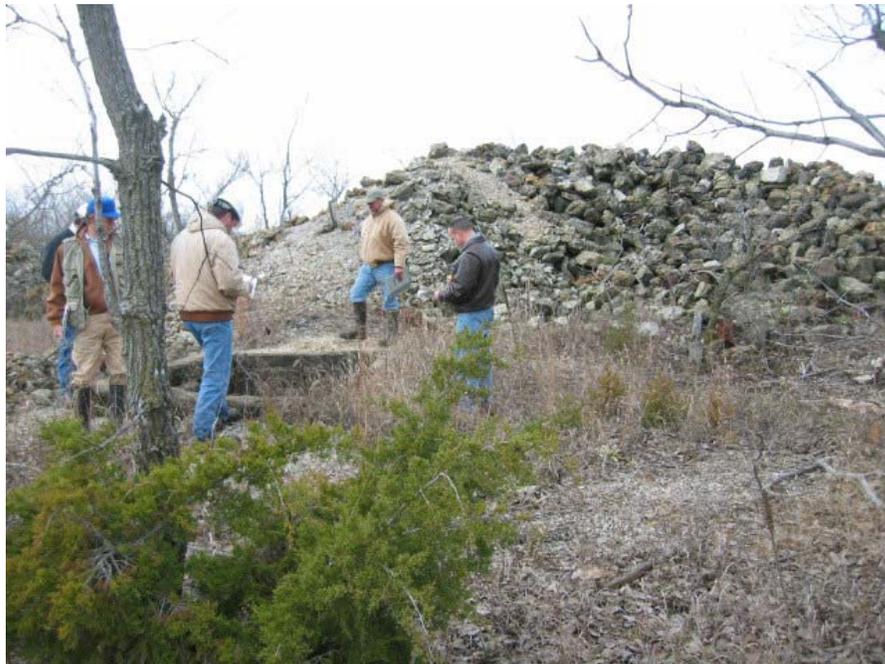
Location: Mine Shaft Site No. 72- Section 29

Description: Photograph 7 and 8 are views of Mine Shaft Site No. 72- Section 29.

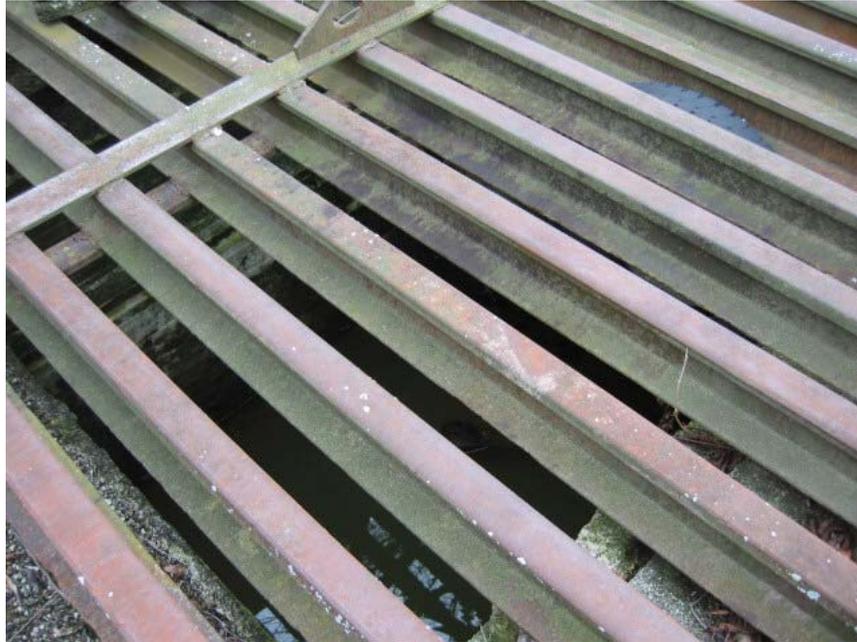
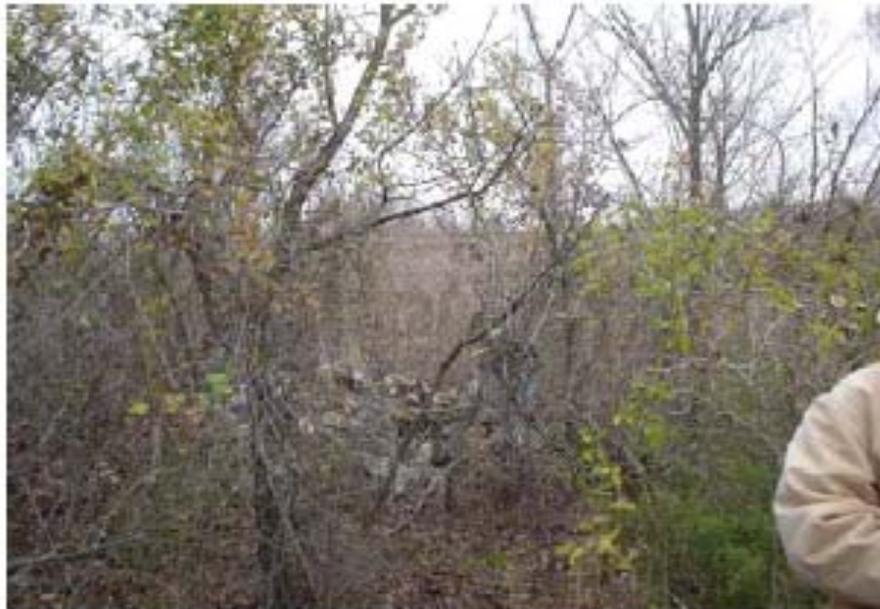
Location: Mine Shaft Site No. 11- Section 29

Description: Photographs 9 and 10 are views of Mine Shaft Site No. 11- Section 29. Photograph 10 shows the area of Mine Shaft Site No. 11-Section 29 view from the access road.

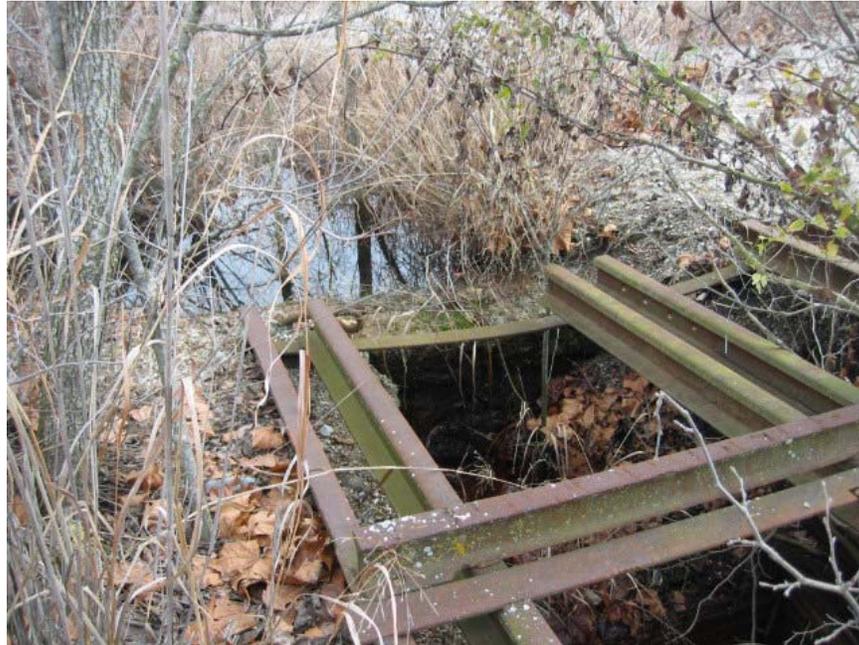
Location: Mine Shaft Site No. 18- Section 29

This shaft is located in the SE ¼ of the NW ¼ of Section 29 Township 29N, Range 23E in Ottawa County, Oklahoma. It is located in a wooded area with four metal beams marking the shaft opening. Deteriorated wood cribbing was observed at the top of the shaft and water and debris are visible several feet below ground surface. The vegetation in the area near the shaft includes some trees, a few herbaceous plants, and some woody vegetation. Wildlife habitat in the area of the shaft is of poor quality. This site is shown in photograph No. 11 in Appendix A.

Description: Photograph 11 is a view of Mine Shaft Site No. 18- Section 29.

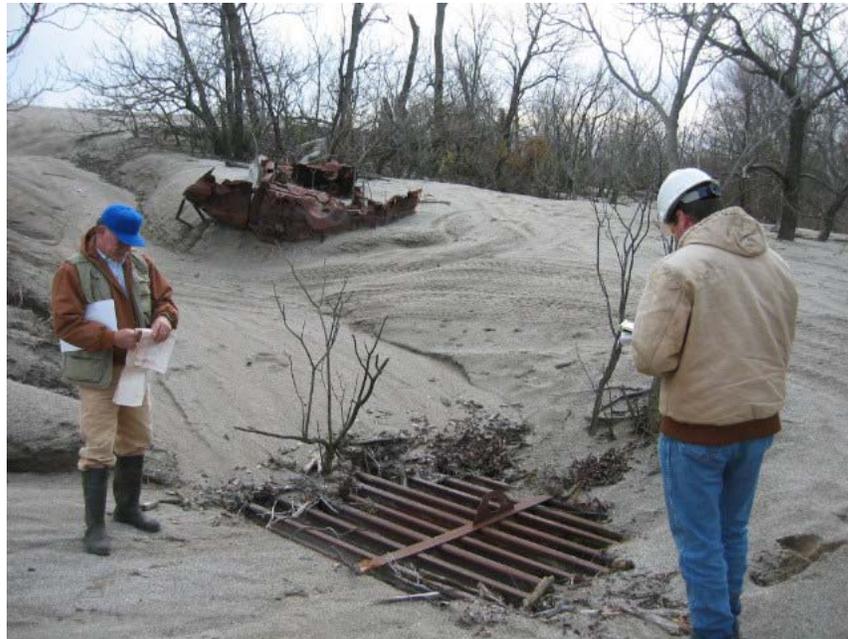
Location: Mine Shaft Site No. 15- Section 29

Description: Photograph 12 shows Mine Shaft Site No. 15- Section 29.

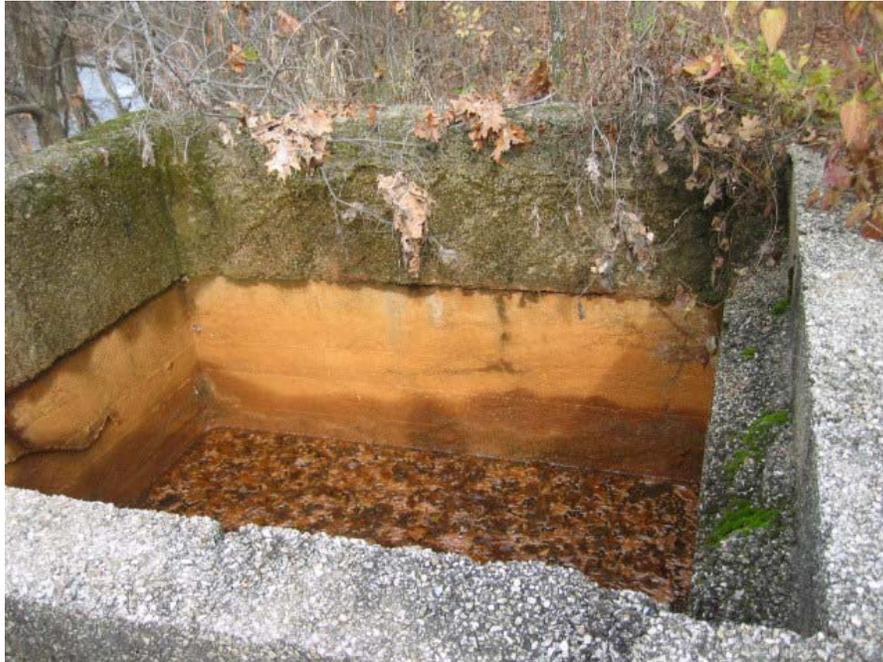
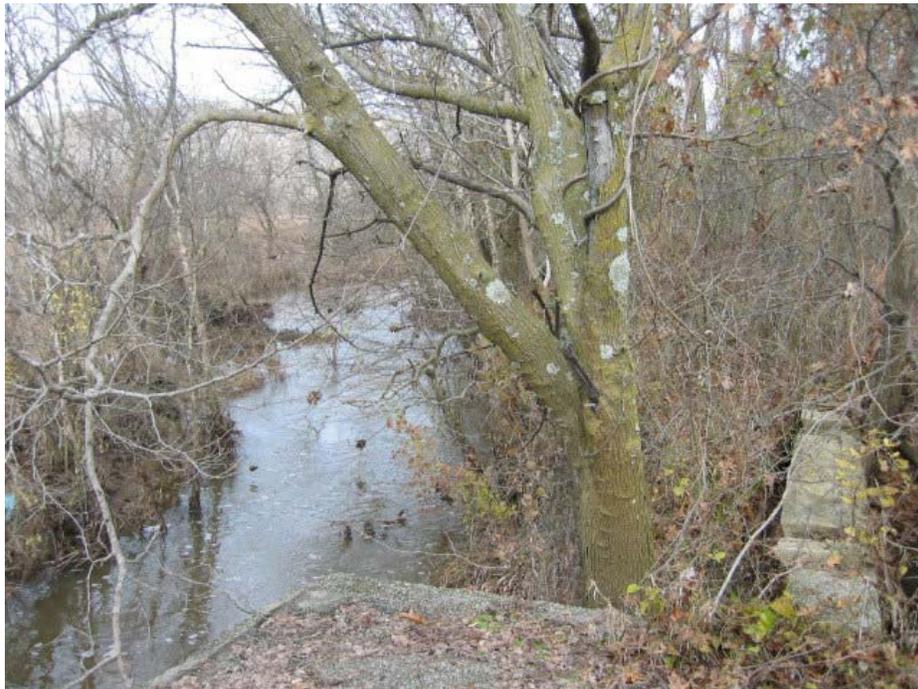
Location: Mine Shaft Site No. 70- Section 29

Description: Photographs 13 and 14 are views of Mine Shaft Site No. 70- Section 29. Photograph 14 shows Tar creek adjacent to mine shaft.

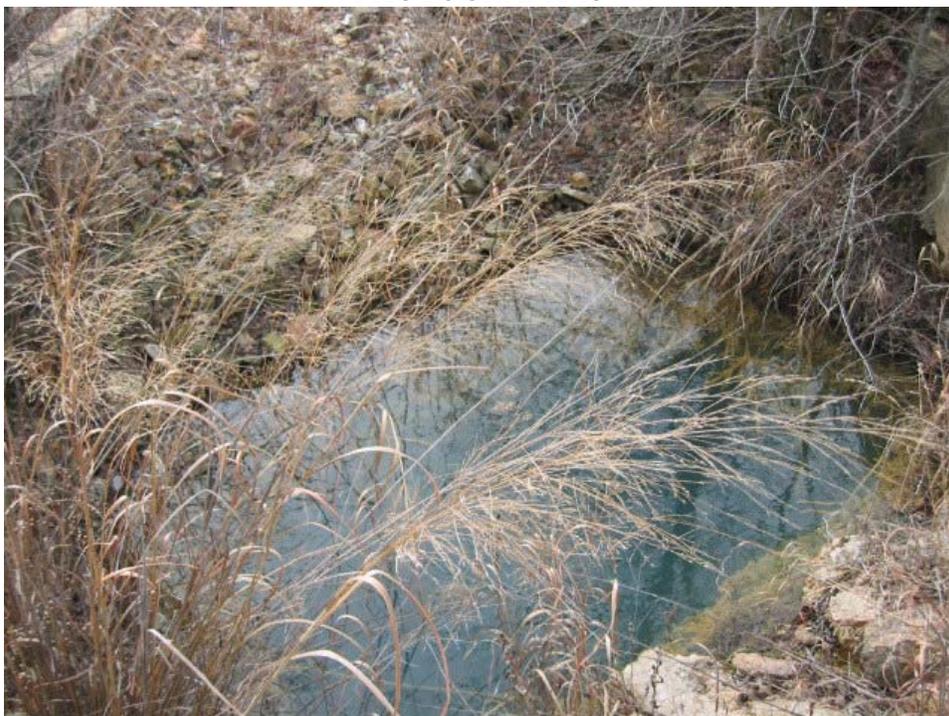
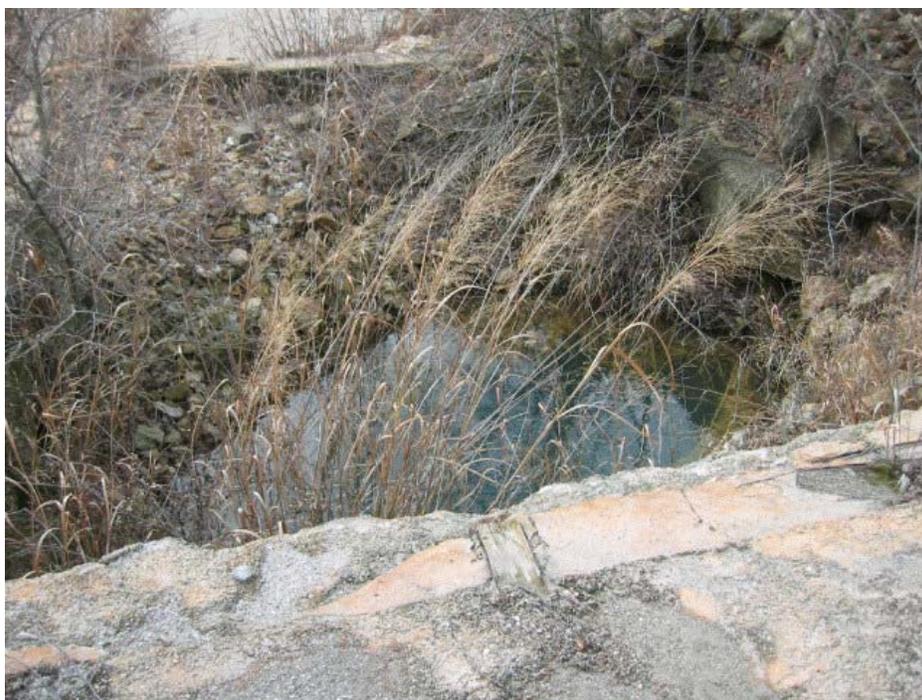
Location: Mine Shaft Site No. 69- Section 29

Description: Photographs 15 and 16 are views of Mine Shaft Site No. 69- Section 29.

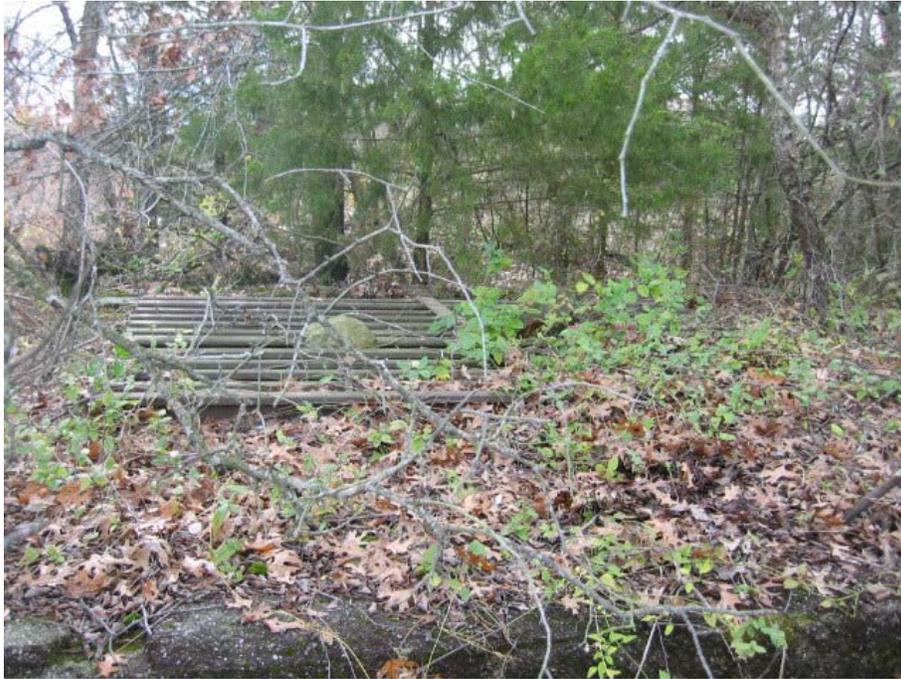
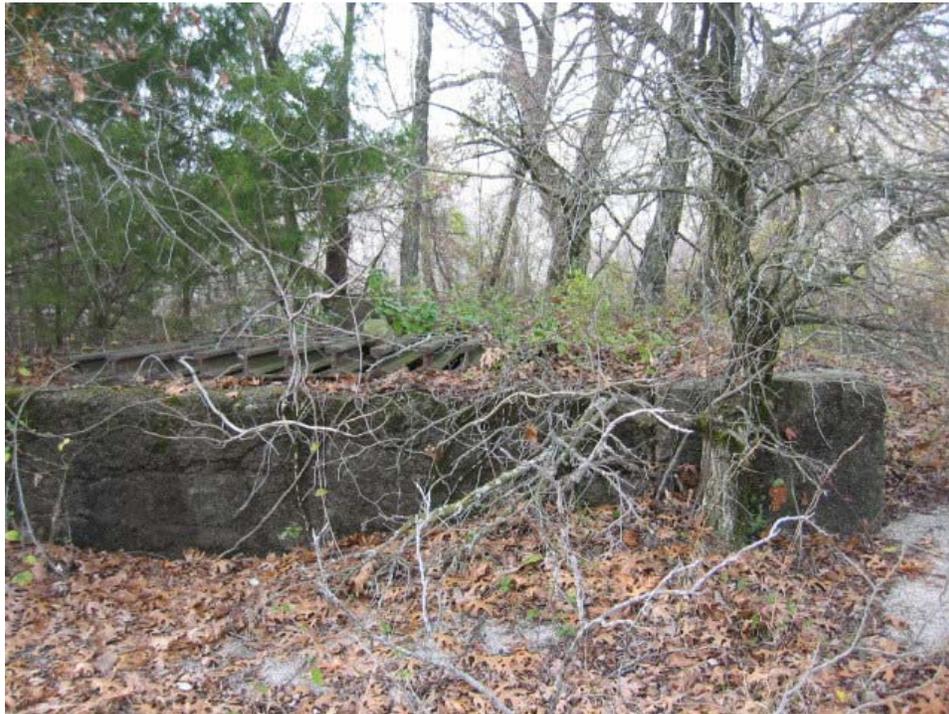
Location: Mine Shaft Site No. 14- Section 29

Description: Photographs 17 and 18 are views of Mine Shaft Site No. 14- Section 29.

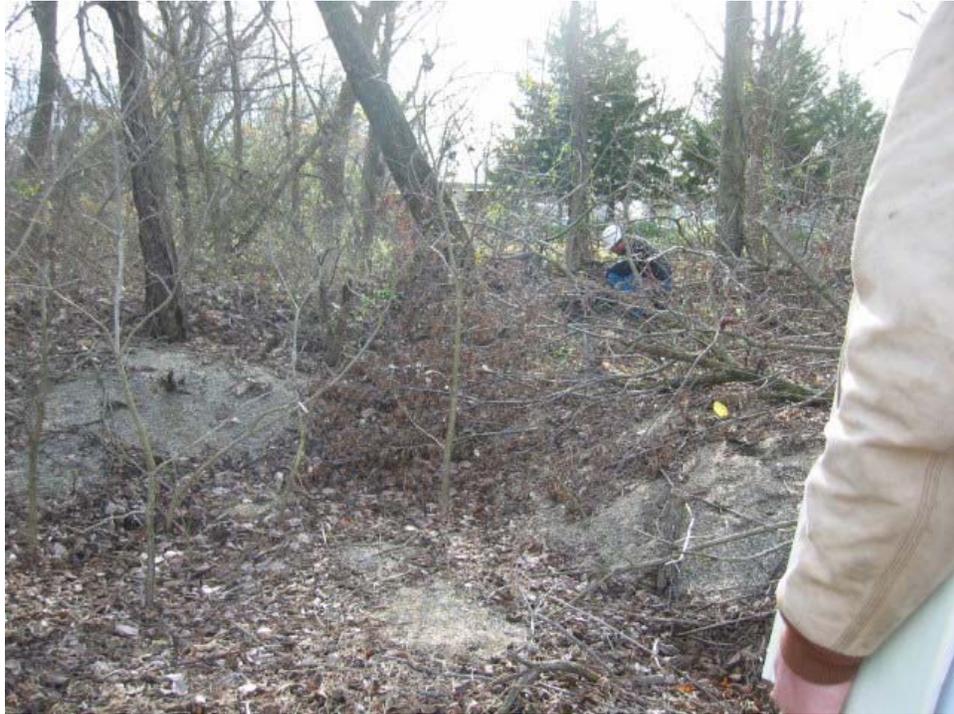
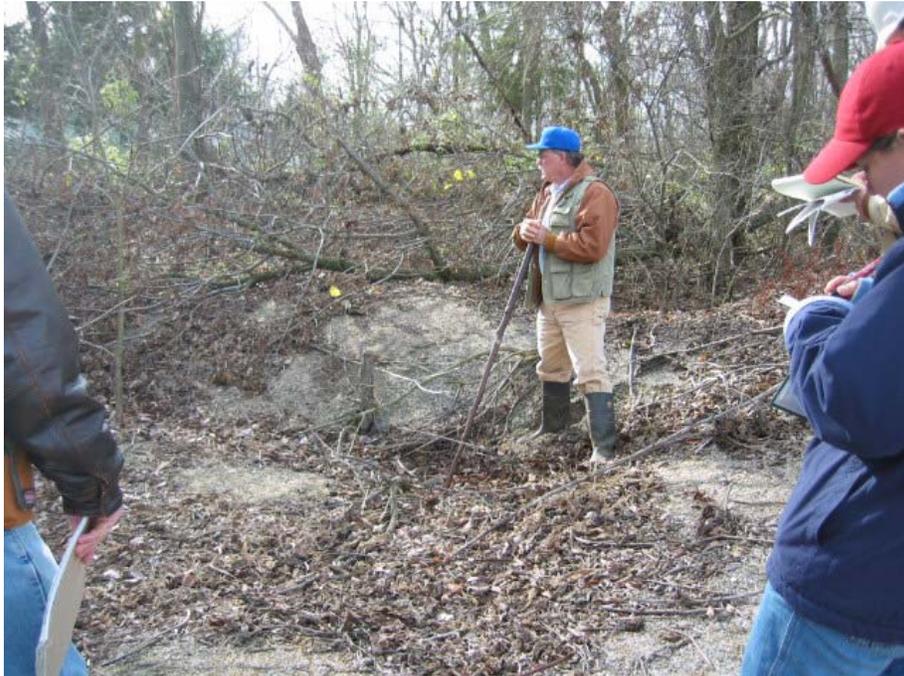
Location: Mine Shaft Site No. 49- Section 20

Description: Photographs 19 and 20 are views of Mine Shaft Site No. 14- Section 20.

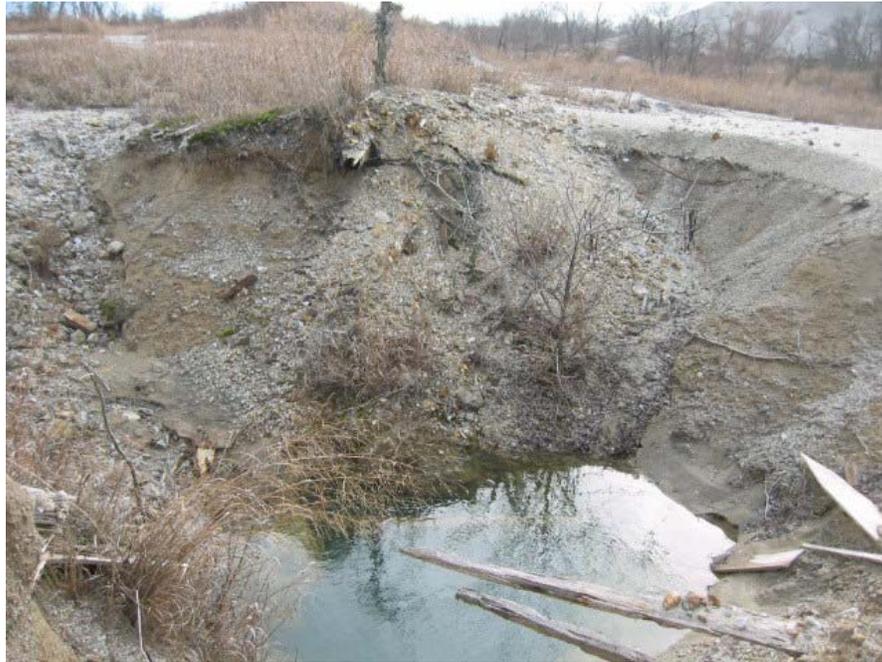
Location: Mine Shaft Site No. 65- Section 29

Description: Photograph 21 shows Mine Shaft Site No. 65- Section 29.

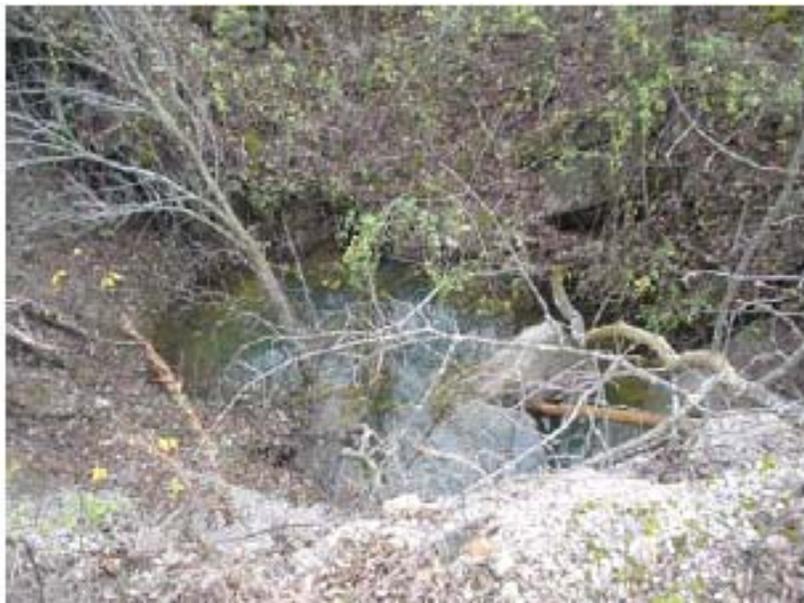
Location: Mine Shaft Site No. 42- Section 29

This shaft, formerly noted as No. 43 – Section 29, was corrected by Ed Keheley in March 2005 to Shaft 42 – Section 29. It is located in the NW ¼ of the SE ¼ of Section 29 Township 29N, Range 23E in Ottawa County, Oklahoma on the Skelton mine. A collapse feature in the midst of a heavily wooded area denotes the shaft opening which is a few feet below ground surface and filled with water. The vegetation near the shaft includes a few trees, shrubs and grasses. Wildlife habitat in the area of the shaft is of fair quality. This site is shown in photograph No. 22 in Appendix A.

Description: Photographs 22 shows Mine Shaft Site No. 43- Section 29.

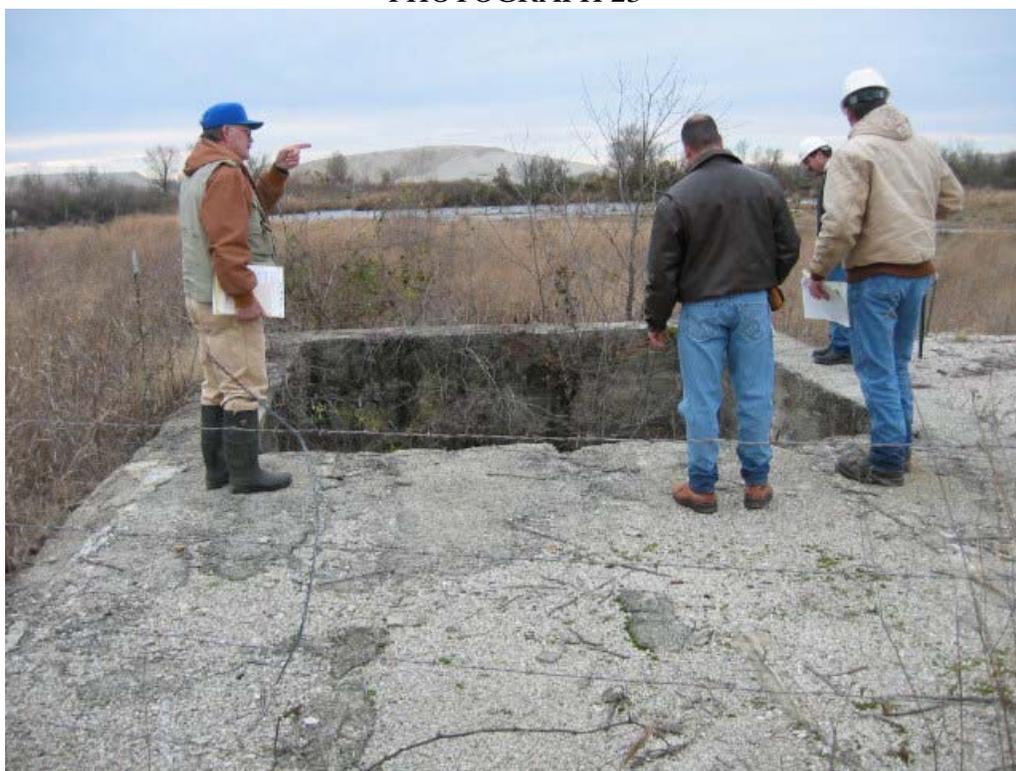
Location: Mine Shaft Site No. 59- Section 29

Description: Photograph 23 is a view of Mine Shaft Site No. 59- Section 29.

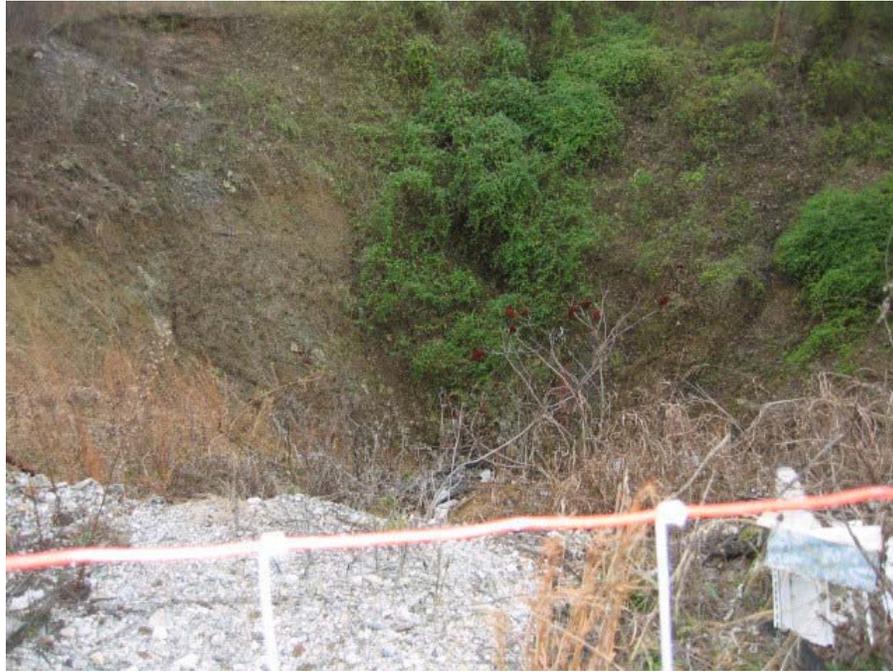
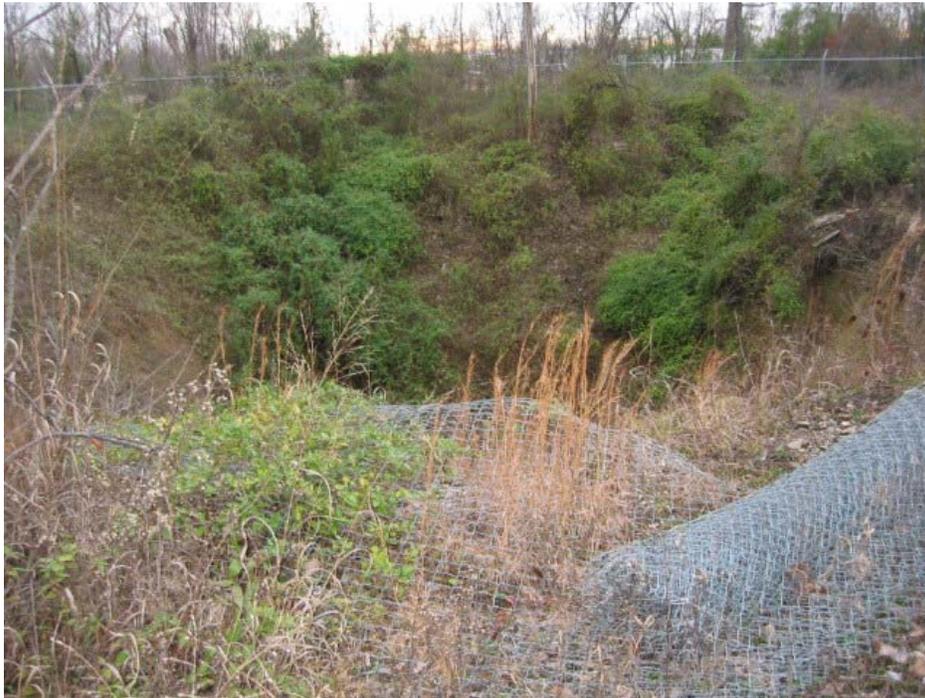
Location: Mine Shaft Site No. 16- Section 14.

Description: Photographs 24 and 25 are views of Mine Shaft Site No. 16- Section 14. This picture clearly shows the large collapse and surrounding vegetation.

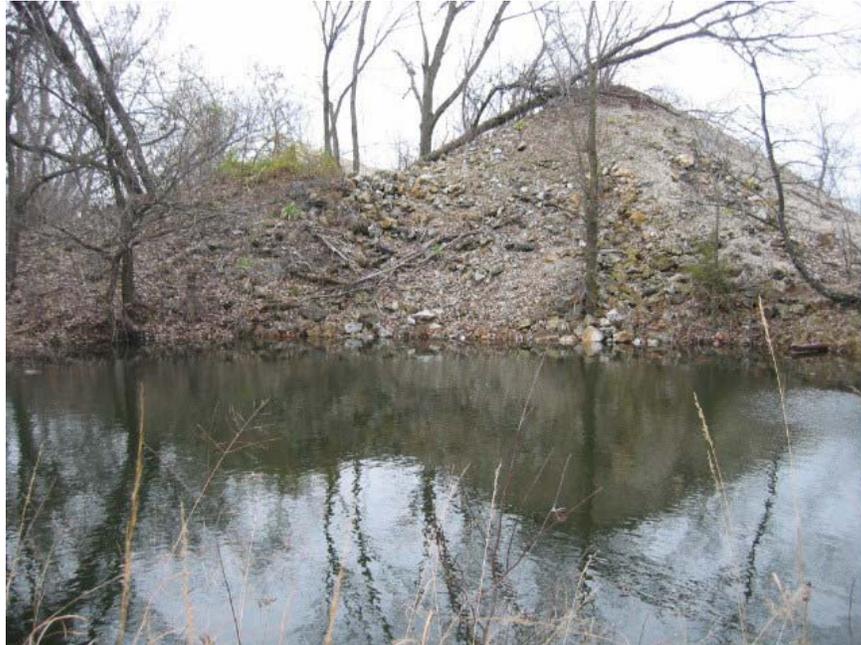
Location: Mine Shaft Site No. 15- Section 14.

Description: Photograph 26 shows Mine Shaft Site No. 15- Section 14. Surface-collapse was full of water at that time.

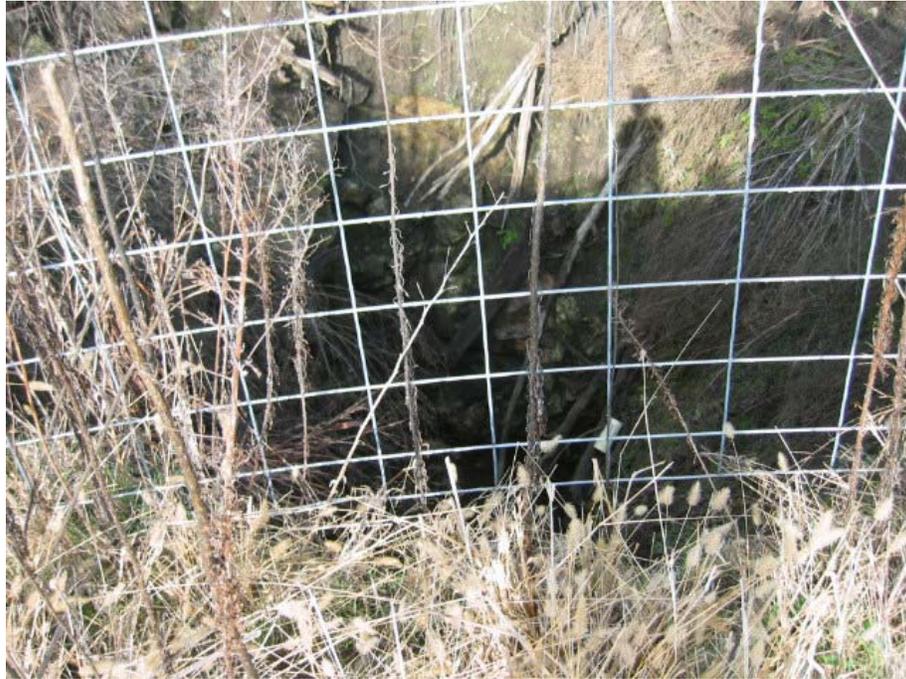
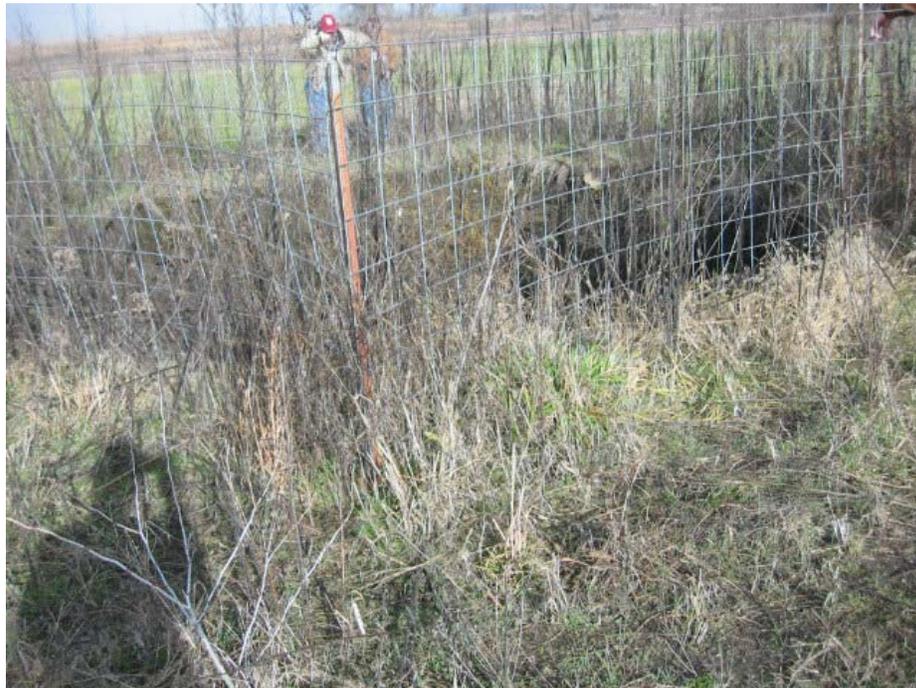
Location: Mine Shaft Site No. 20- Section 33.

Description: Photographs 27 and 28 are views of Mine Shaft Site No. 20- Section 33. Photograph 28 shows part of the fescue pasture in which this shaft is located.

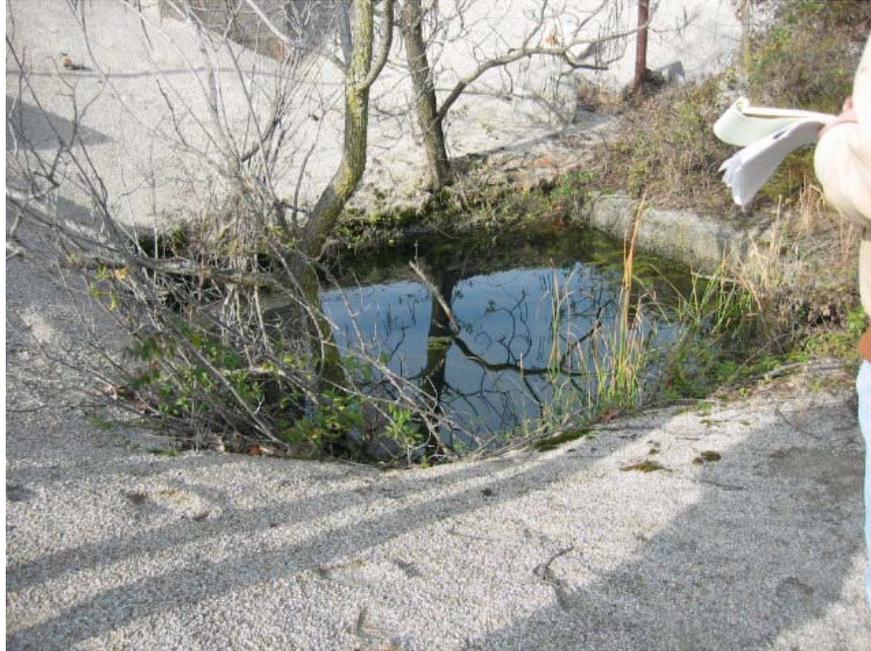
Location: Mine Shaft Site No. 25- Section 29.

Description: Photograph 29 shows Mine Shaft Site No. 25- Section 29. Chat material, two catalpa trees and sumac surround this site.

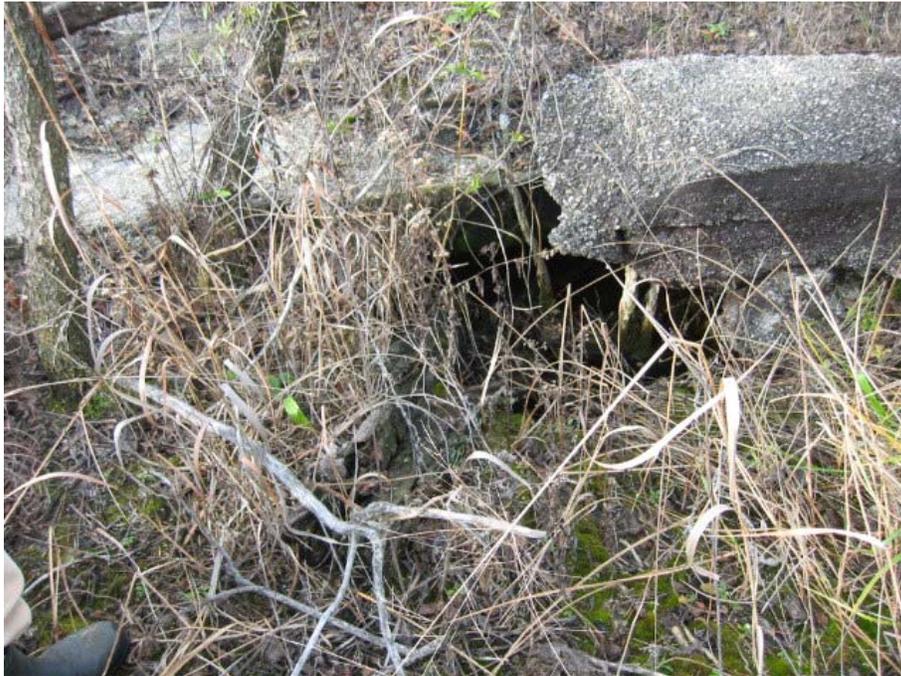
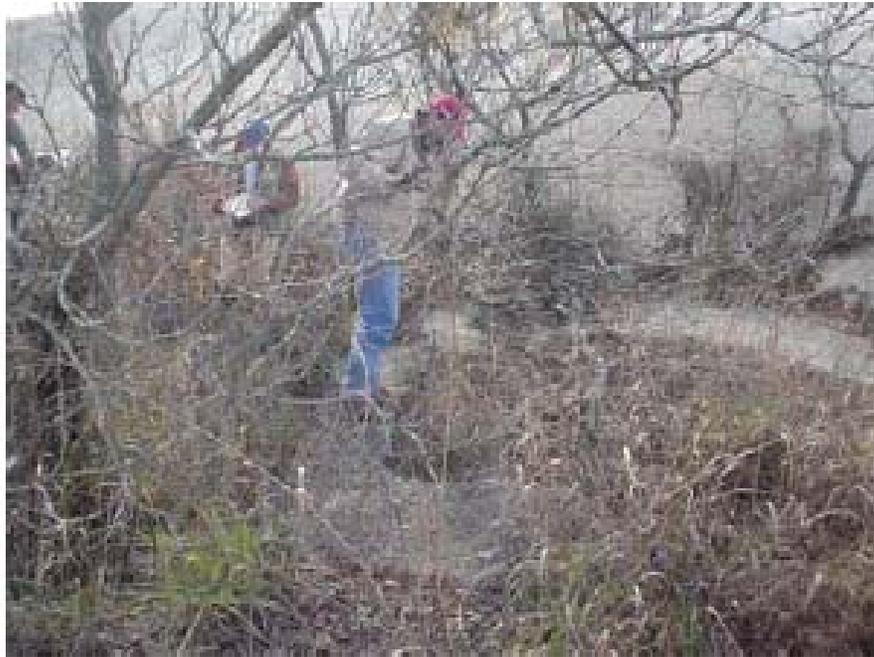
Location: Mine Shaft Site No. 37- Section 20.

Description: Photographs 30 and 31 are views of Mine Shaft Site No. 37- Section 20. Mine Shaft located at the base of a chat pile.

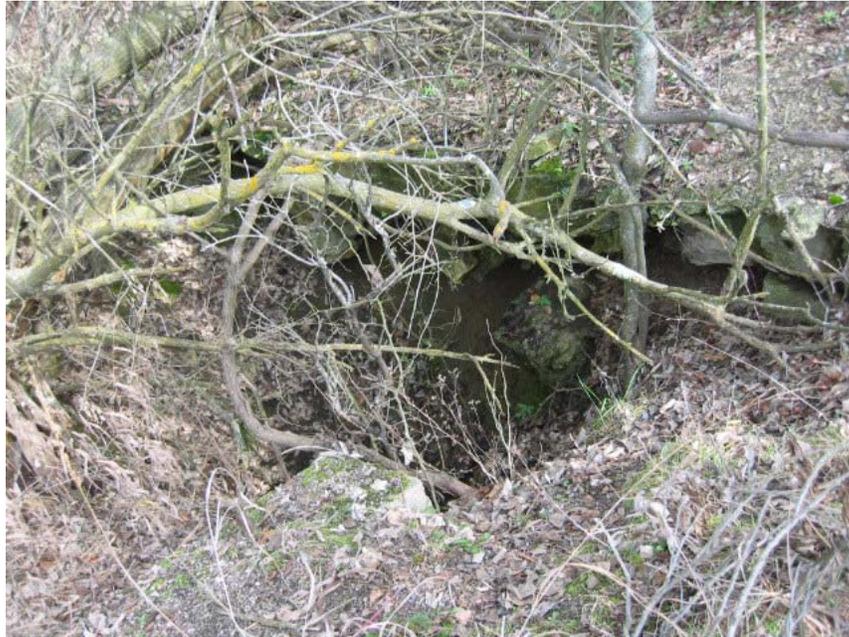
Location: Mine Shaft Site No. 2- Section 13.

Description: Photograph 32 is a view of Mine Shaft Site No. 2- Section 13.

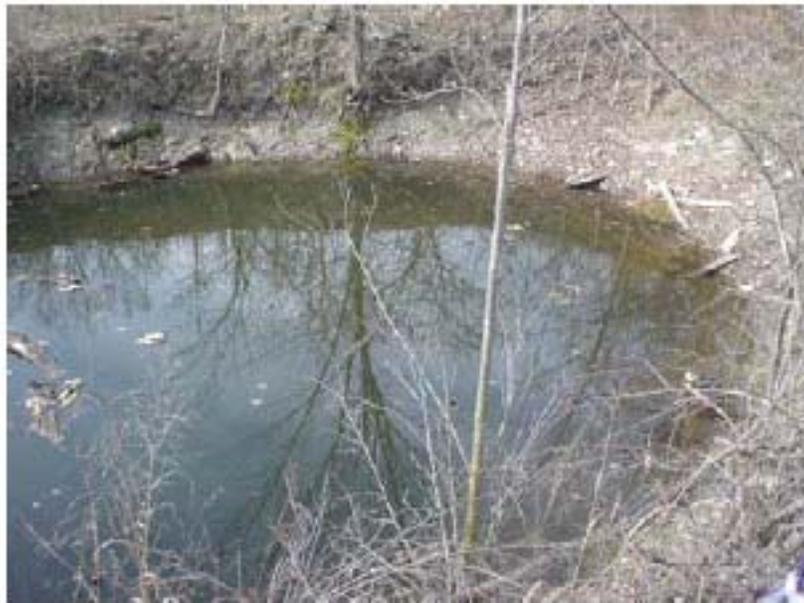
Location: Mine Shaft Site No. 1- Section 13.

Description: Photograph 33 is a view of Mine Shaft Site No. 1- Section 13.

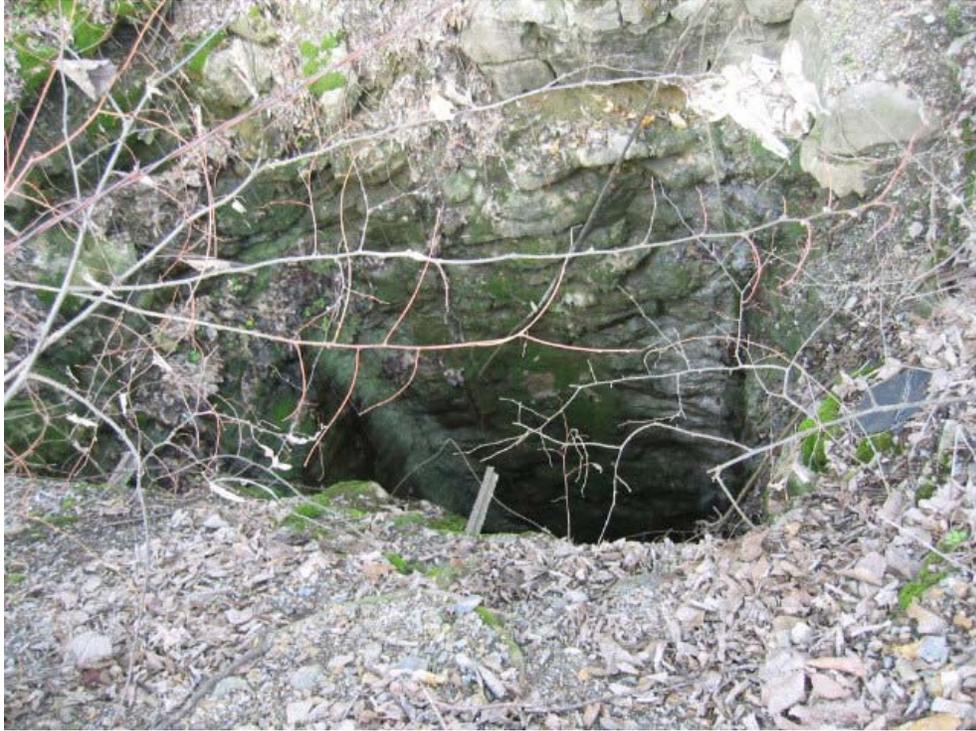
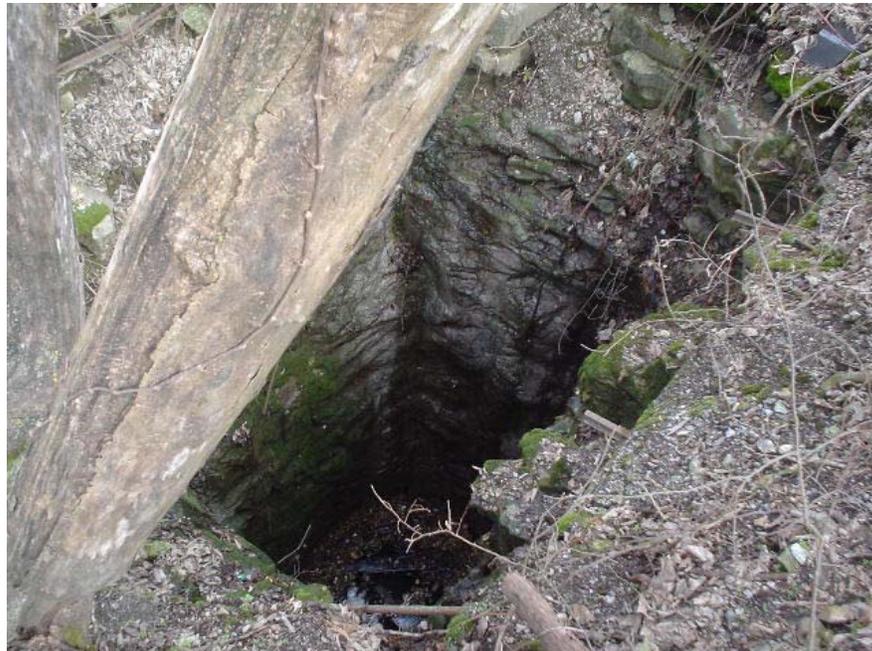
Location: Mine Shaft Site No. 9- Section 35.

Description: Photographs 34 and 35 are views of Mine Shaft Site No. 9- Section 35.

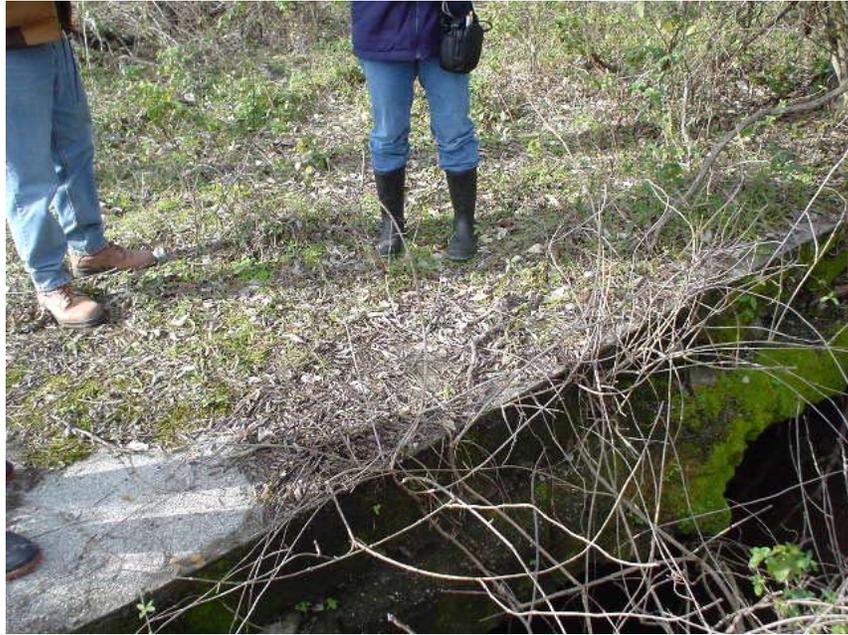
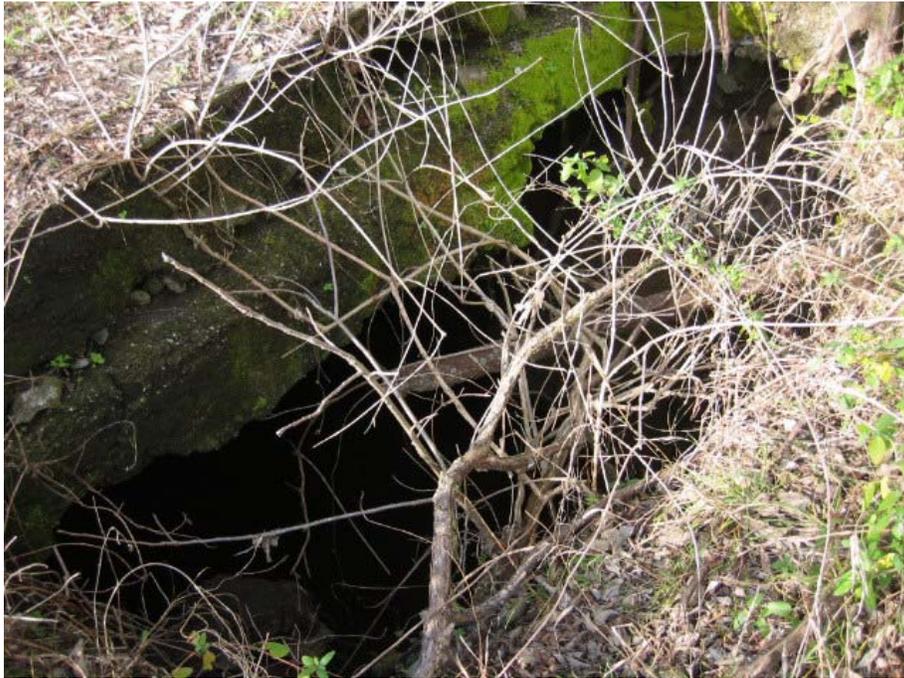
Location: Mine Shaft Site No. 5- Section 35.

Description: Photographs 36 and 37 show the surface of the collapse. Photograph 37 views the inside of the mine shaft.
