ENVIRONMENTAL ASSESSMENT

TAR CREEK SECTION 111 PROJECT
PLUGGING OF VARIOUS MINE SHAFTS

March 2005
Work Order No. 03886.525.007

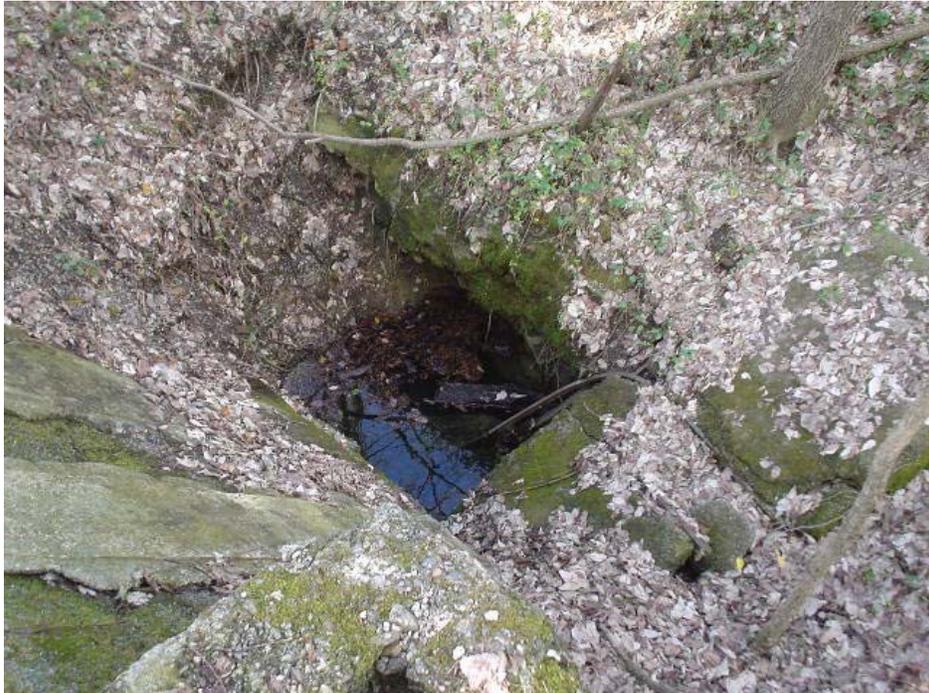
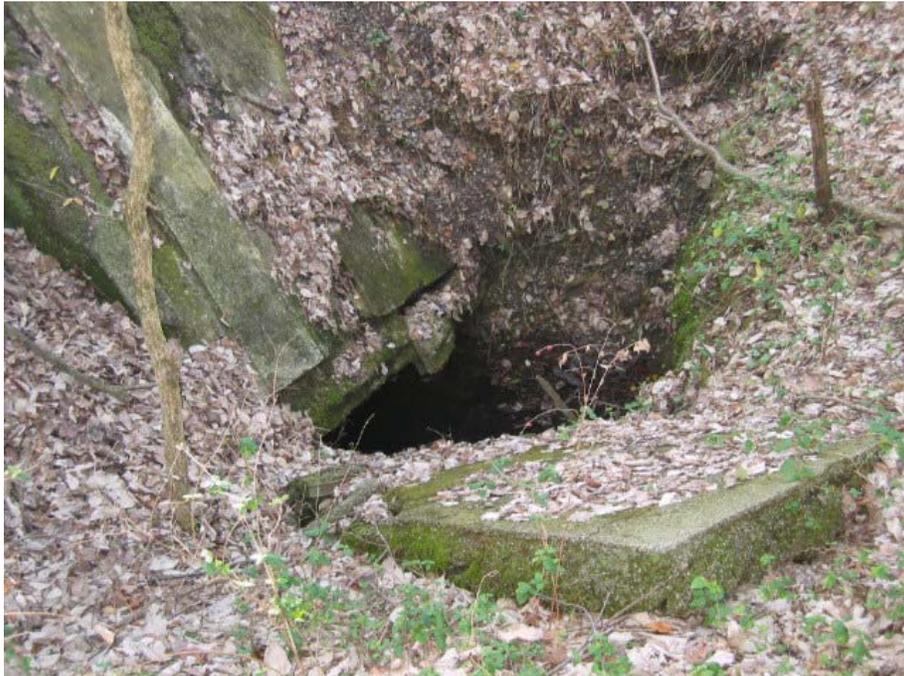
Location: Mine Shaft Site No. 4- Section 35.

Description: Photographs 38 and 39 are views of Mine Shaft Site No. 4-Section 35.

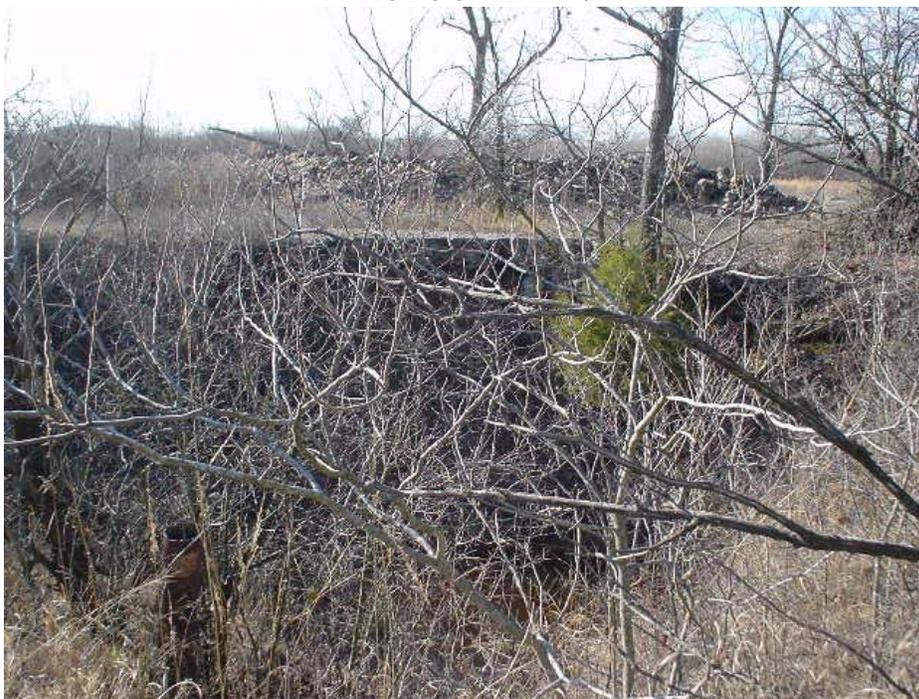
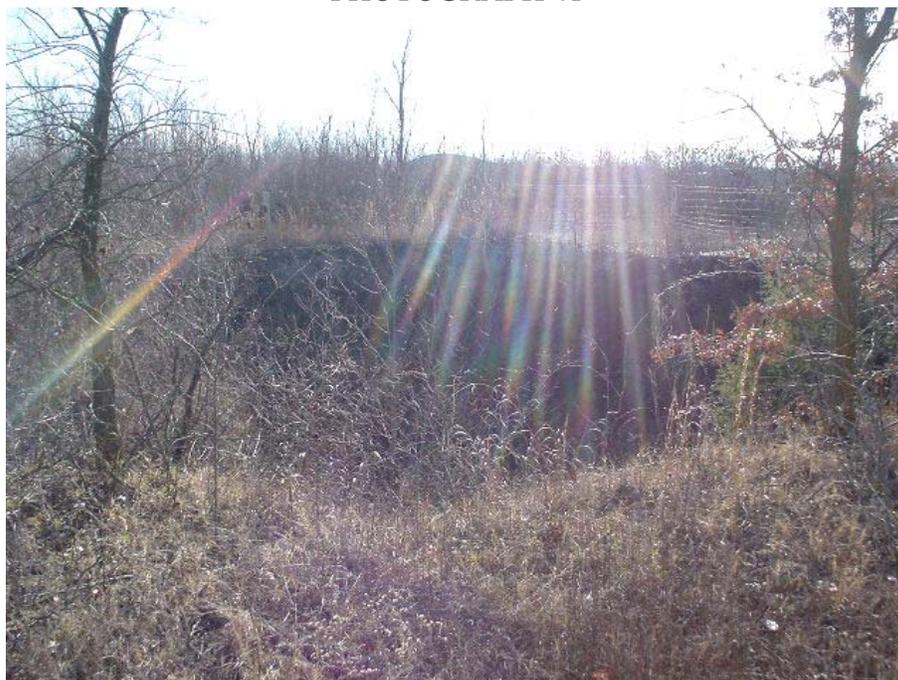
Location: Mine Shaft Site No. 3- Section 38.

Description: Photographs 40 and 41 are views of Mine Shaft Site No. 3-Section 38.

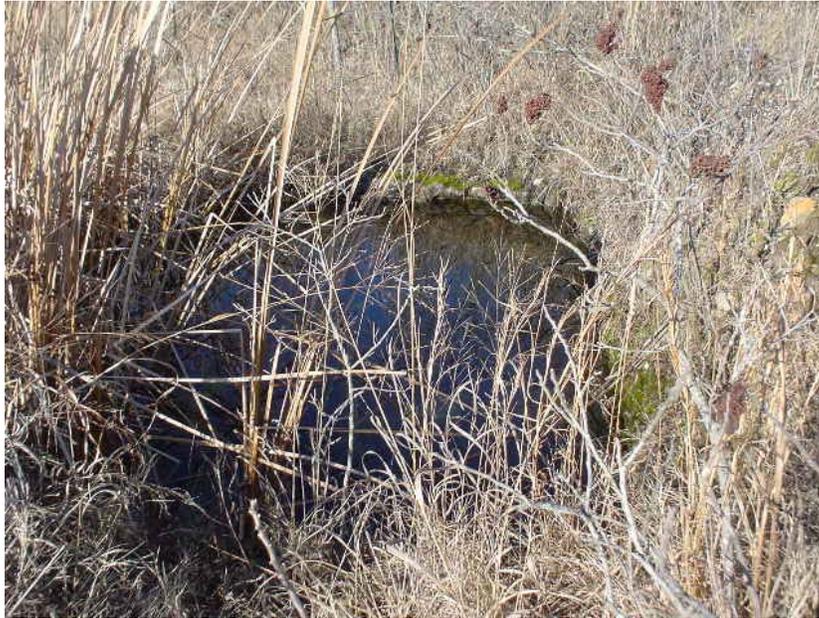
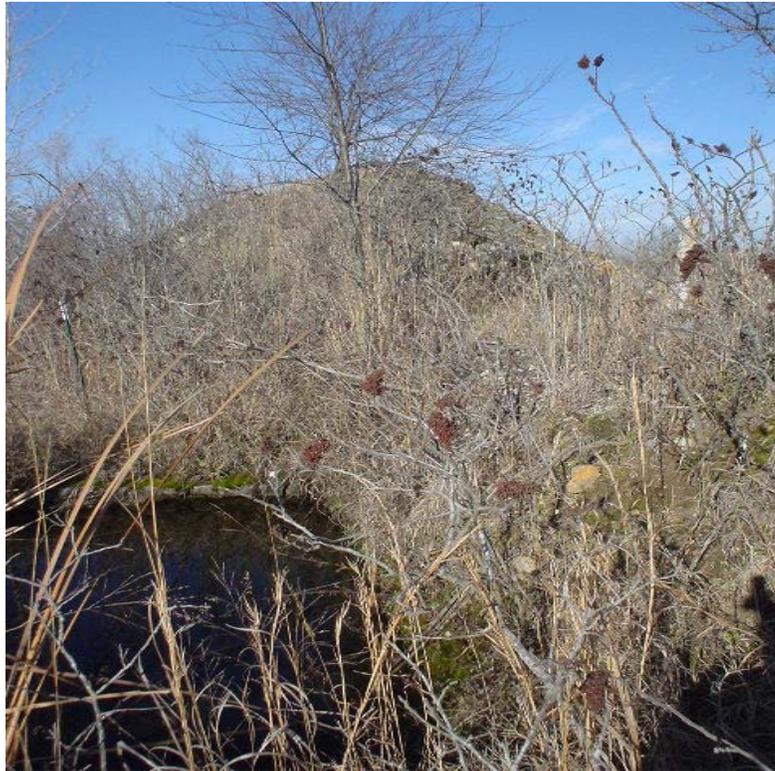
Location: Mine Shaft Site No. 5- Section 28.

Description: Photographs 42 and 43 are views of Mine Shaft Site No. 5 Section 28. An old mill site is located next to this mine shaft.

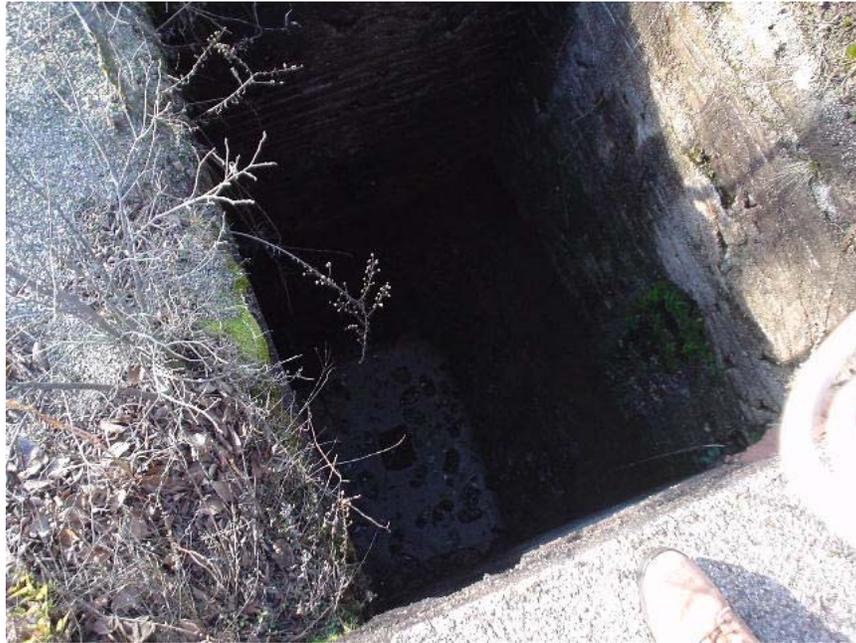
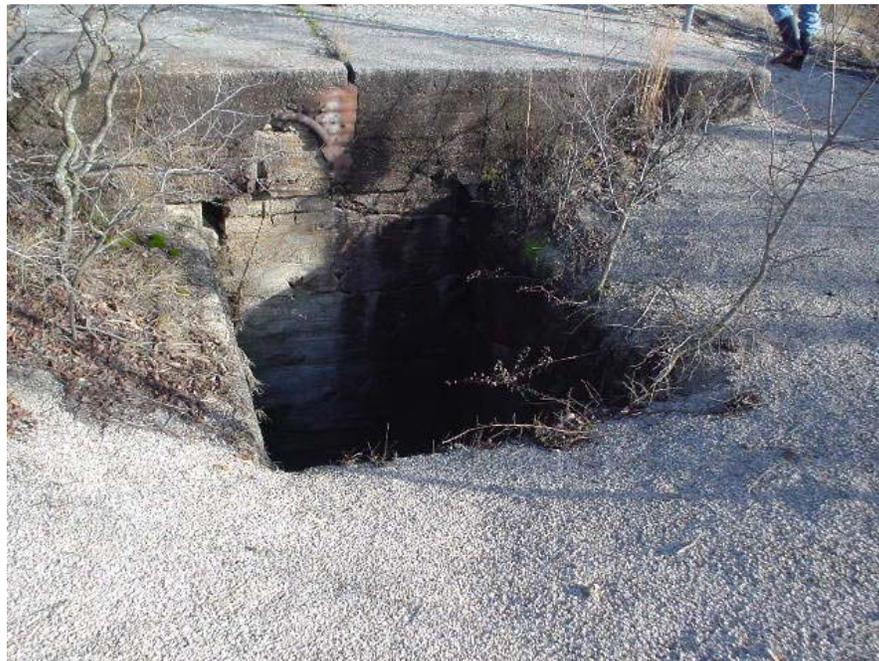
Location: Mine Shaft Site No. 6- Section 28.

Description: Photographs 44 and 45 are views of Mine Shaft Site No. 6 Section 28. Chat material surrounds this site.

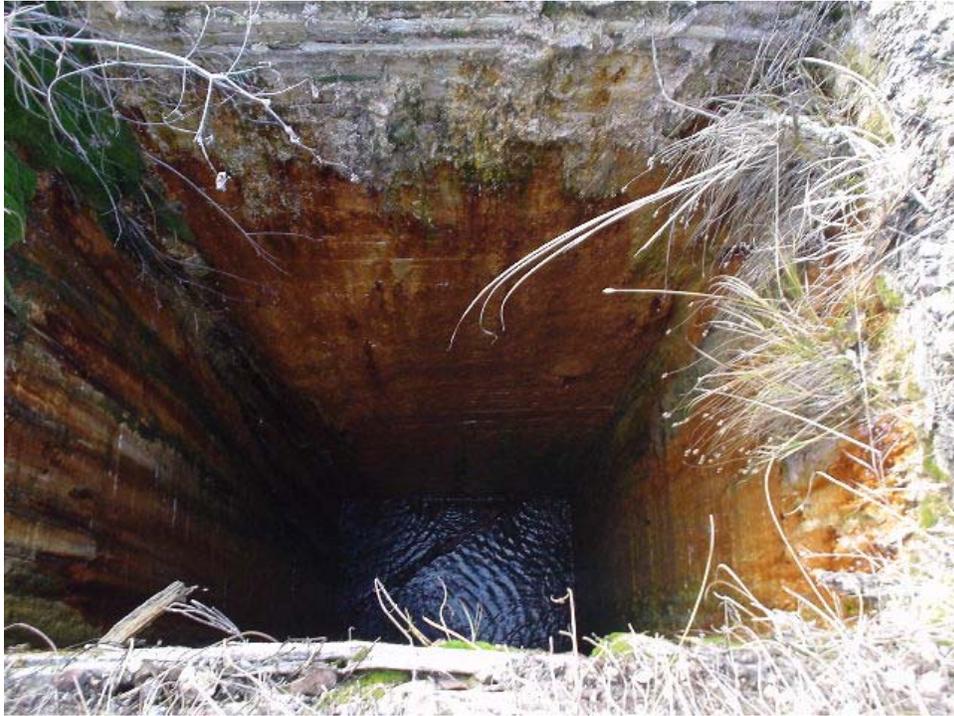
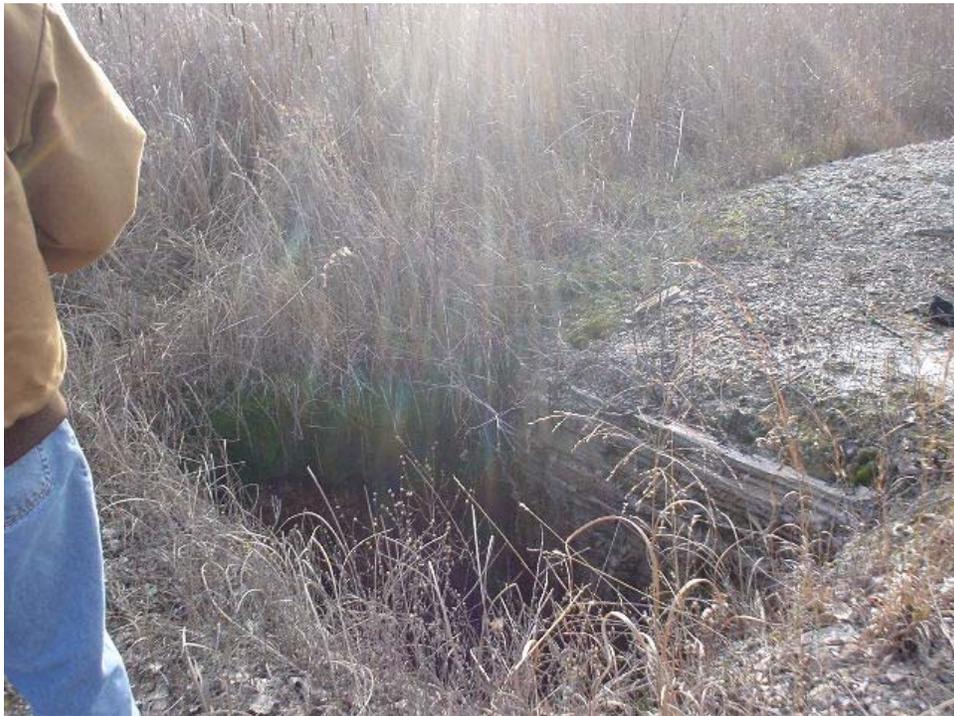
Location: Mine Shaft Site No. 11- Section 28.

Description: Photographs 46 and 47 are views of Mine Shaft Site No. 11 Section 28.

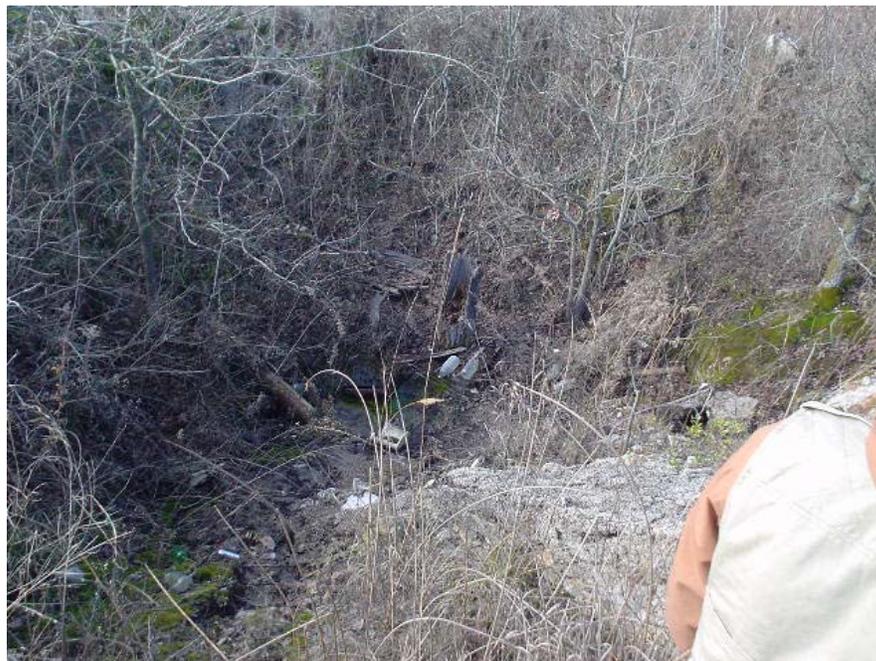
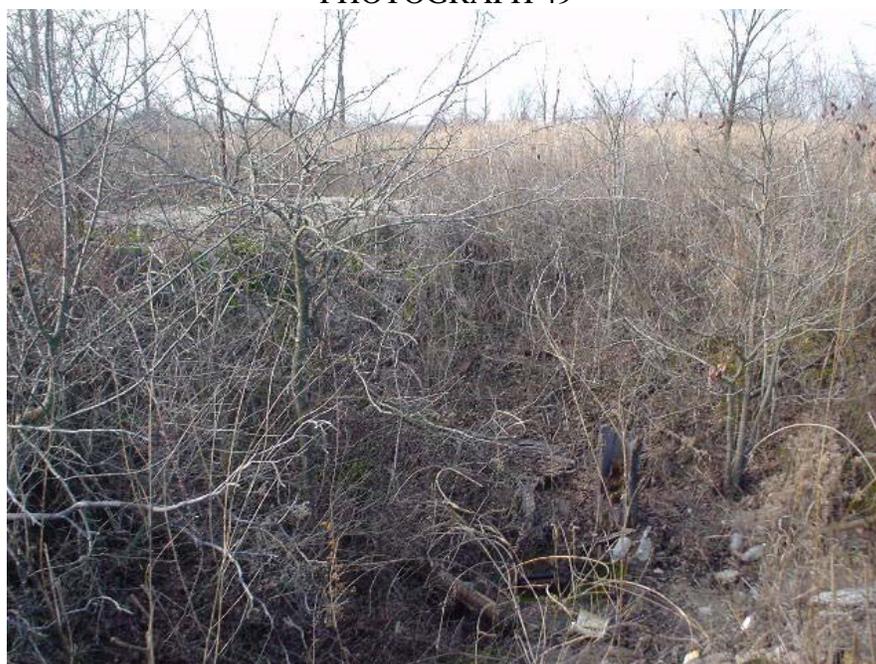
Location: Mine Shaft Site No. 10- Section 28.

Description: Photographs 48 and 49 are views of Mine Shaft Site No. 10 Section 28.

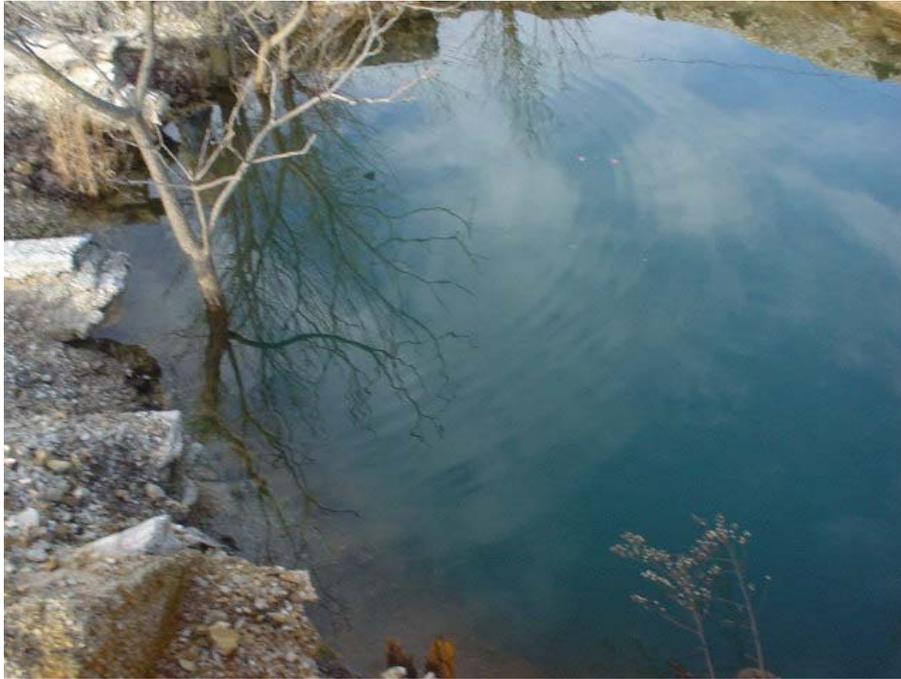
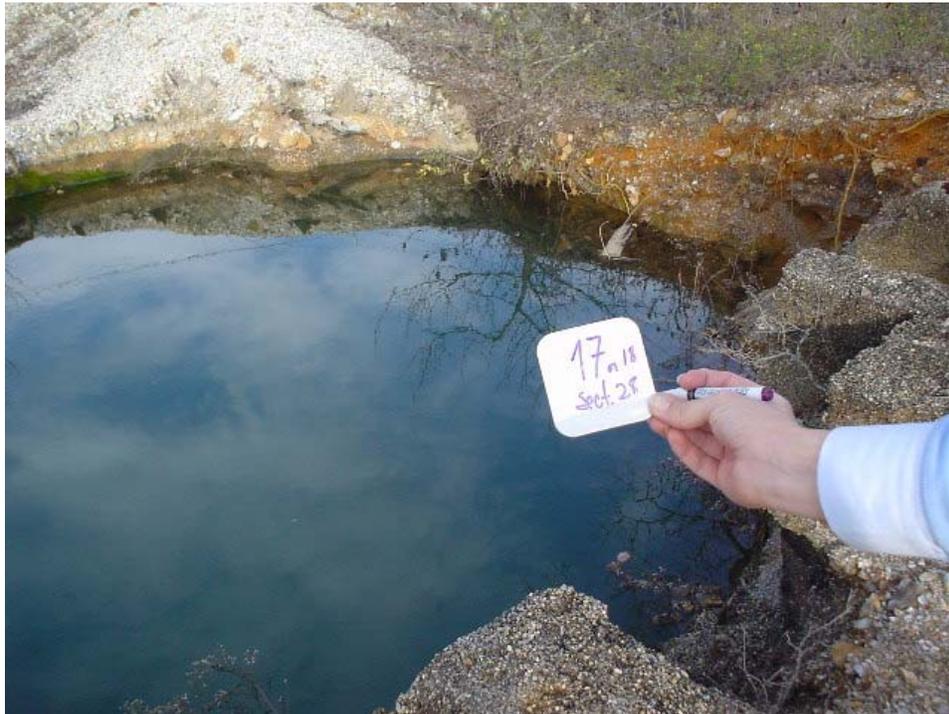
Location: Mine Shaft Site No. 17- Section 28.

Description: Photographs 50 and 51 are views of Mine Shaft Site No. 17 Section 28.

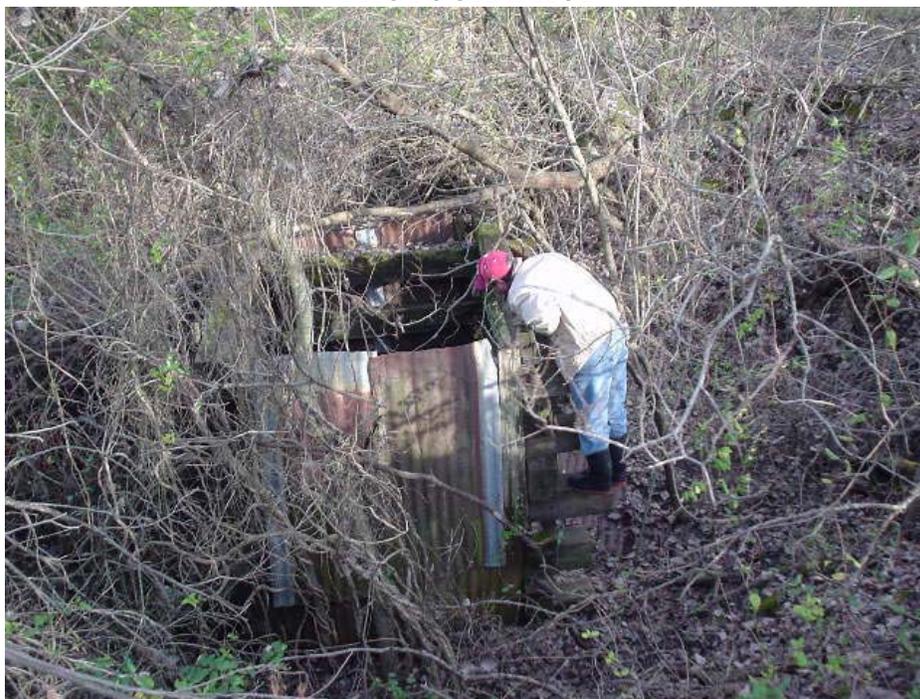
Location: Mine Shaft Site No. 14- Section 28.

Description: Photograph 52 shows Mine Shaft Site No. 14 Section 28.

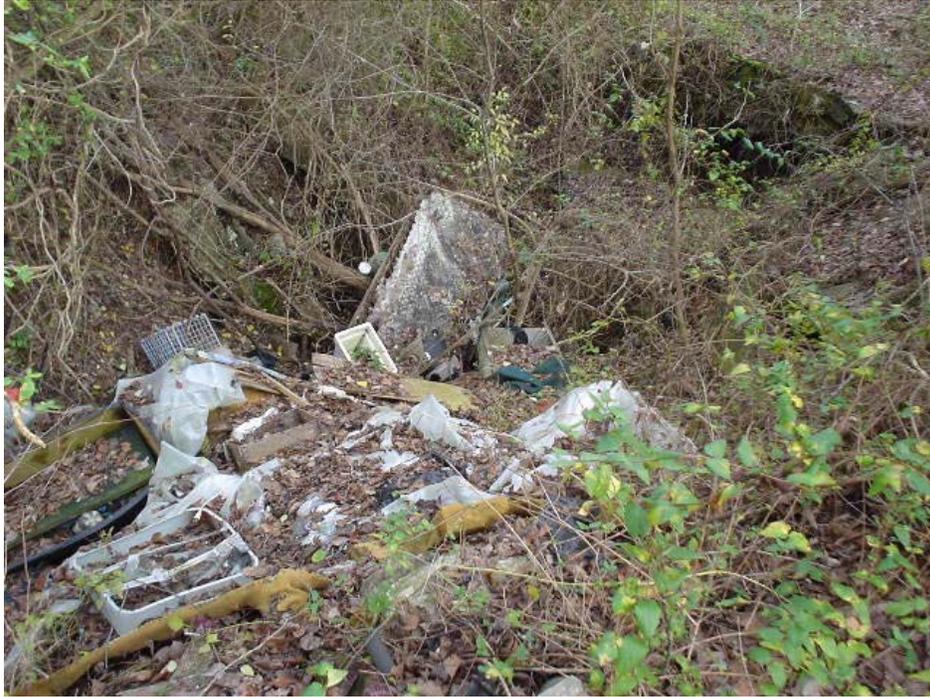
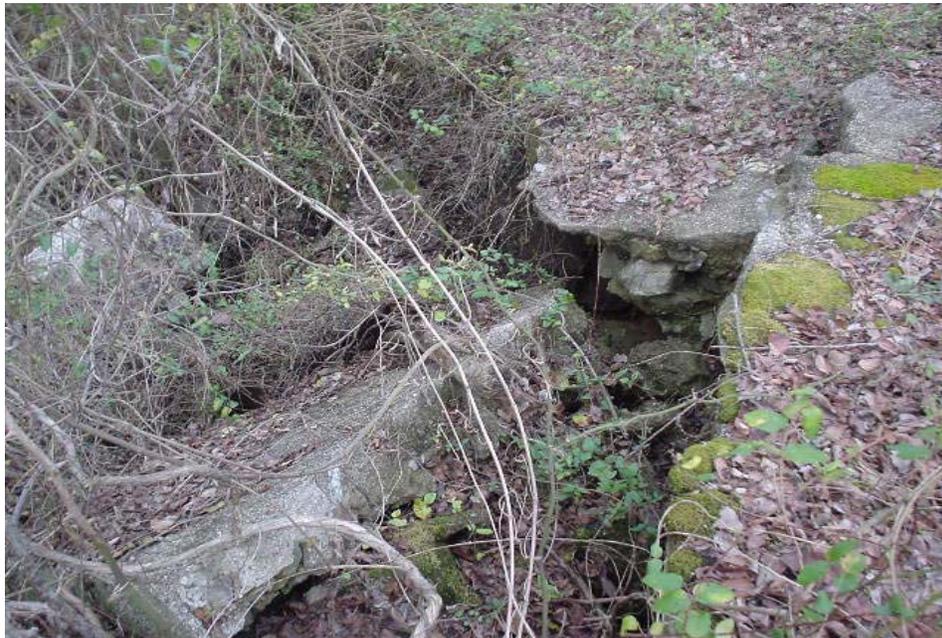
Location: Mine Shaft Site No. 14- Section 21.

Description: Photographs 53 and 54 are views of Mine Shaft Site No. 14 Section 21. Picture shows dumping of trash.

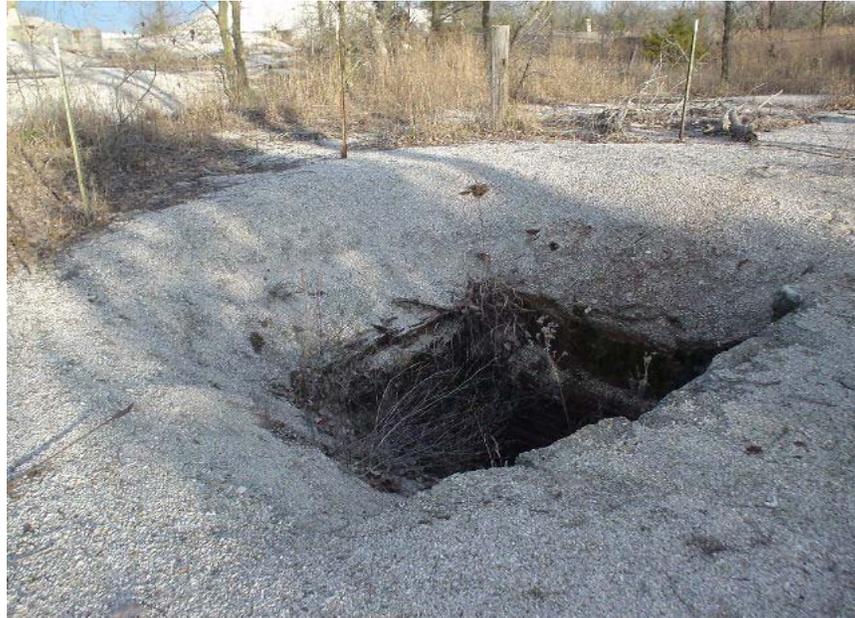
Location: Mine Shaft Site No. 15- Section 16.

Description: Photograph 55 shows Mine Shaft Site No. 15 Section 16.

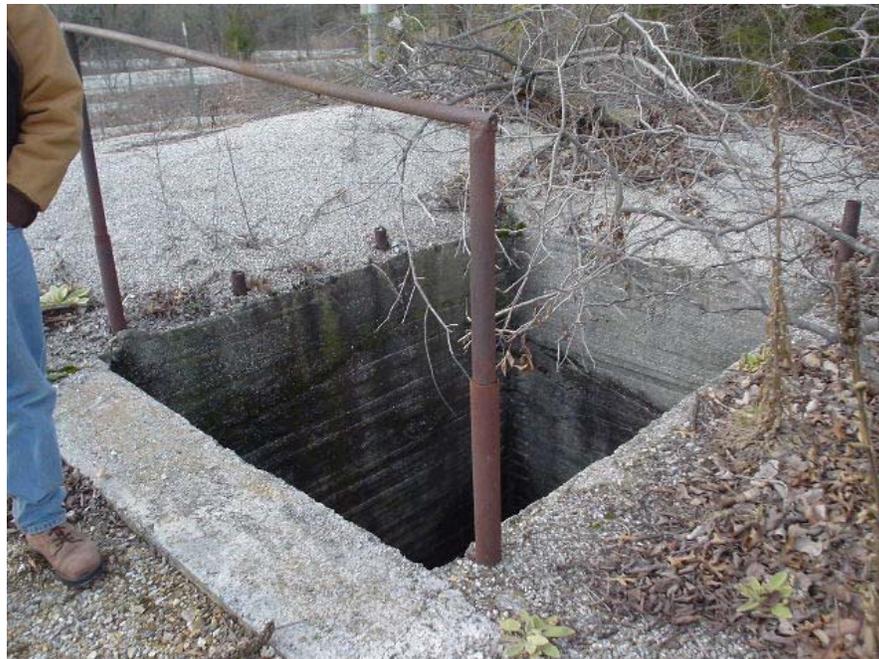
Location: Mine Shaft Site No. 11- Section 16.

Description: Photograph 56 shows Mine Shaft Site No. 11 Section 16.

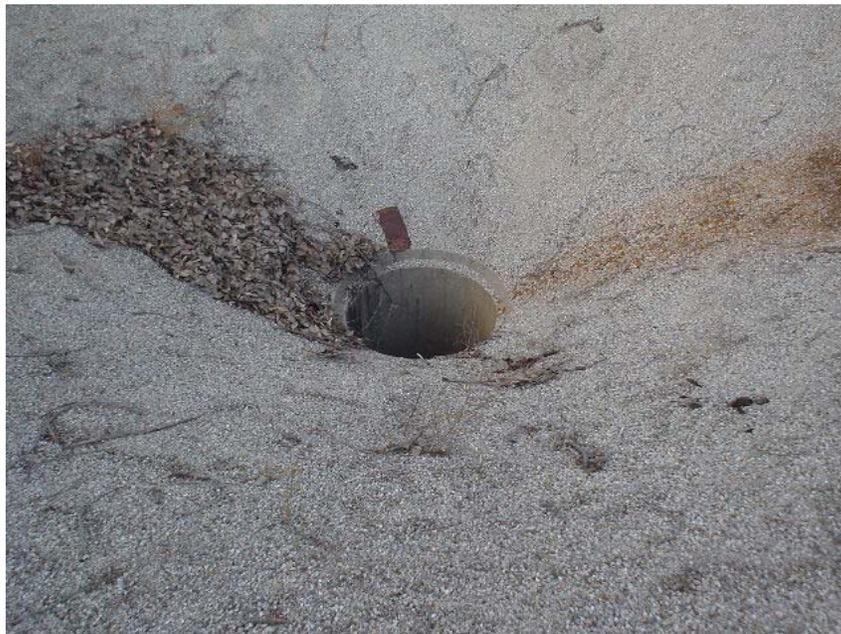
PHOTOGRAPH 57

Description: Photographs 57 and 58 are views of Mine Shaft Site No. 12 Section 16.

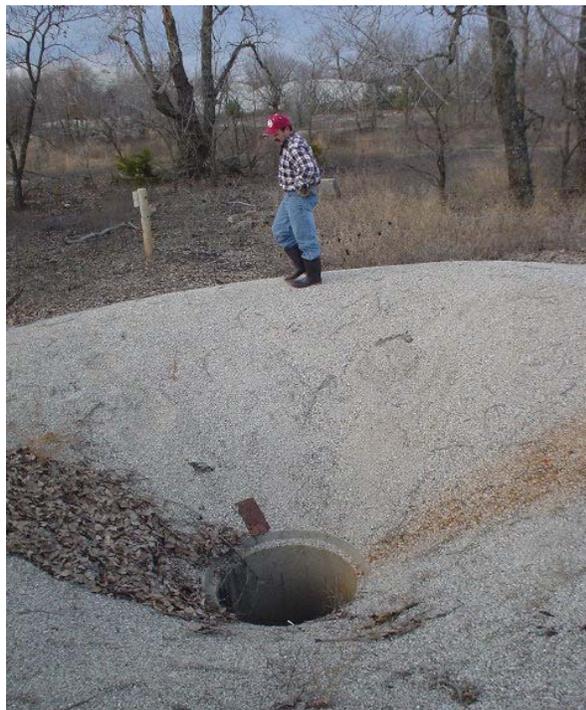
PHOTOGRAPH 58

Location: Mine Shaft Site No. 12- Section 16.

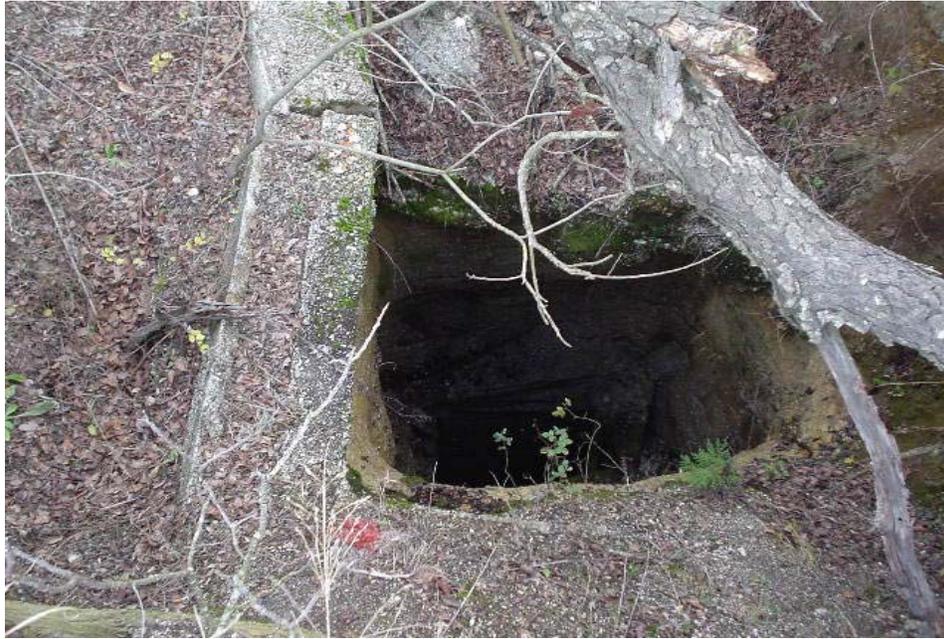
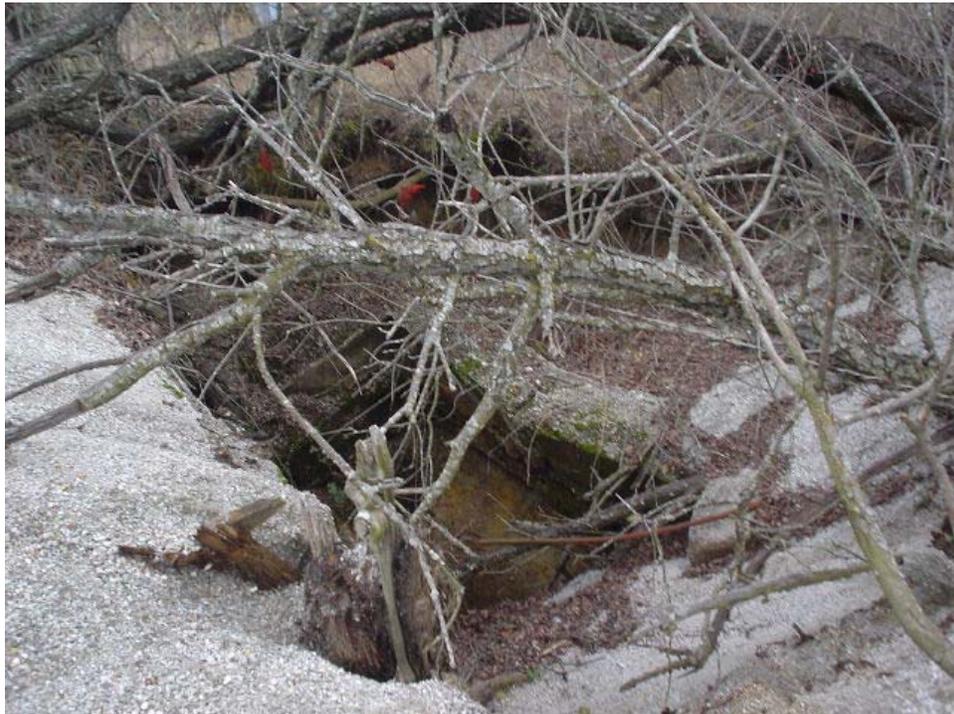
Location: Mine Shaft Site No. 9- Section 16.

Description: Photographs 59 and 60 are views of Mine Shaft Site No. 9 Section 16.

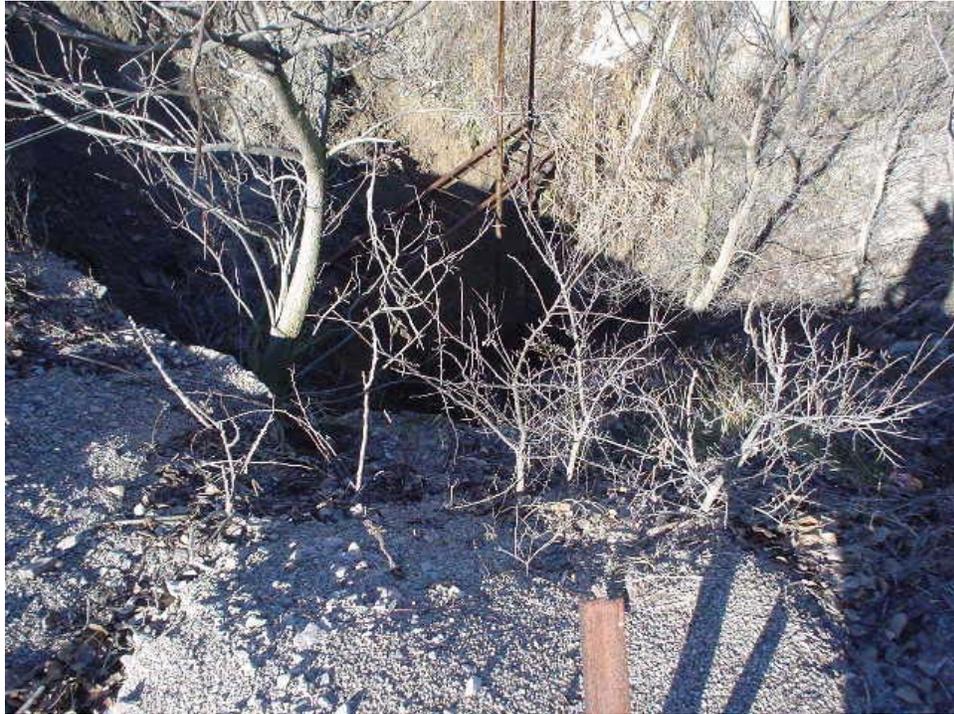
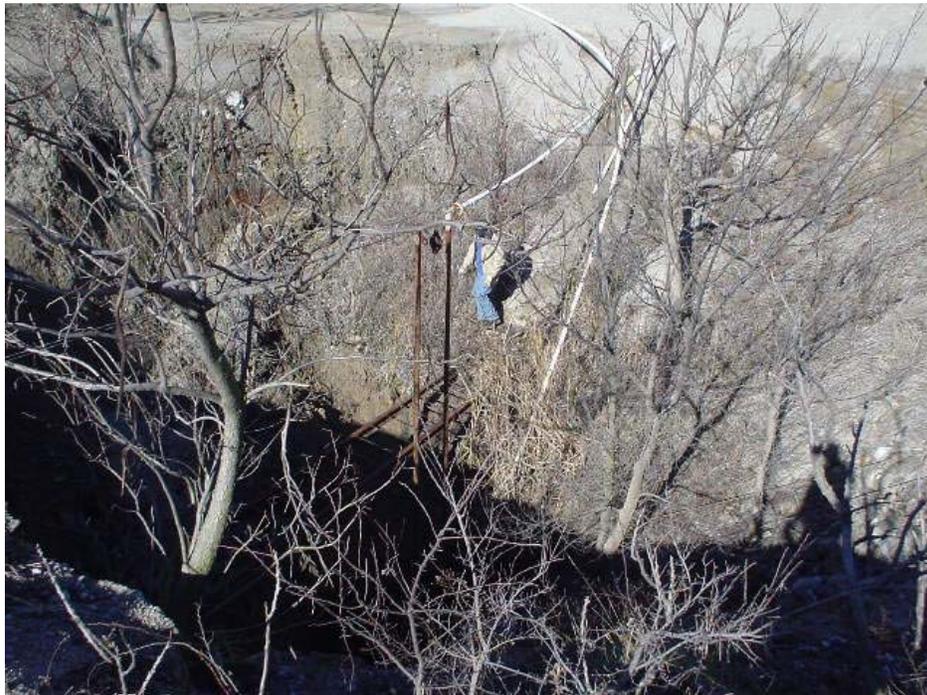
Location: Mine Shaft Site No. 7- Section 17.

Description: Photographs 61 and 62 are views of Mine Shaft Site No. 7 Section 17. This Mine Shaft is located north of Pitcher, Oklahoma.

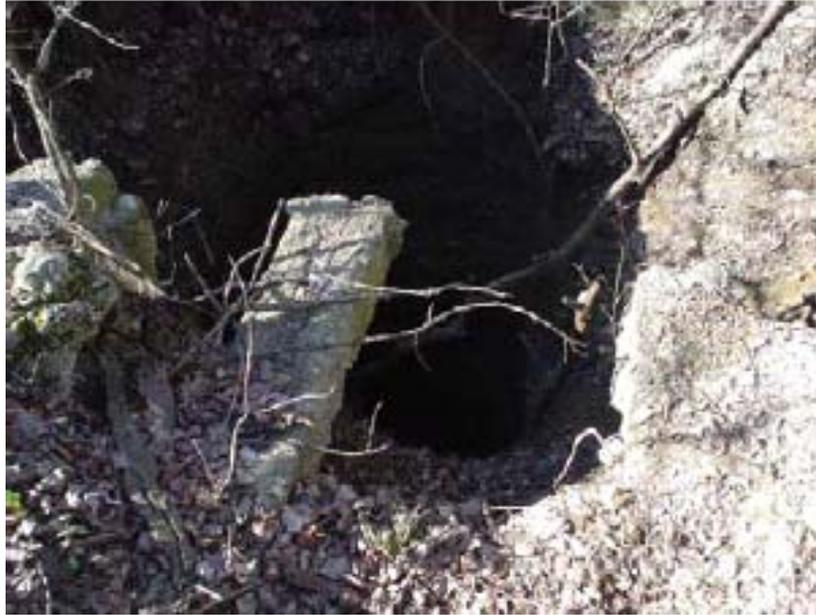
PHOTOGRAPH 63

Description: Photographs 63 and 64 are views of Mine Shaft Site No. 12 -Section 36. Mine shaft filled with concrete debris.

This shaft is in the SE ¼ of the SW ¼ of Section 36 Township 29N, Range 22E in Ottawa County, Oklahoma on the Scamming Hill mine. The mine shaft is located in a somewhat wooded area adjacent to a fescue pasture. The shaft is filled with concrete debris and water in the shaft is not visible. The vegetation near the shaft includes herbaceous plants, some grasses and a few trees. The habitat is of poor quality for wildlife. This site is shown in photographs No. 63 and 64 in Appendix A

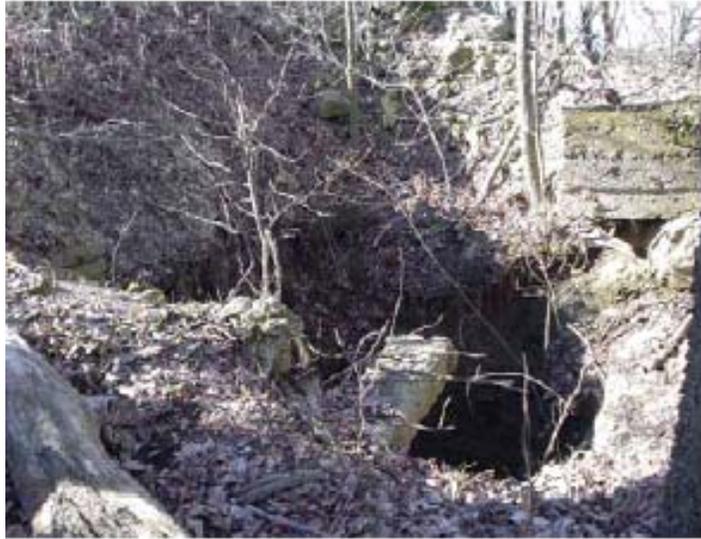
PHOTOGRAPH 65

Description: Photograph 65 shows Mine Shaft Site No. 13 -Section 36. Mine Shaft located north of Commerce, Oklahoma. Concrete debris present.

This shaft is in the NE ¼ of the SW ¼ of Section 36 Township 29N, Range 22E in Ottawa County, Oklahoma on the Scammon Hill mine. The mine shaft is located in a wooded area adjacent to a soybean field. The shaft opening is filled with debris and leaves; however, water in the shaft is visible within several feet from the ground surface. The vegetation near the shaft includes woody vegetation and several trees. Wildlife habitat is of poor quality. This site is shown in photograph No. 65 in Appendix A

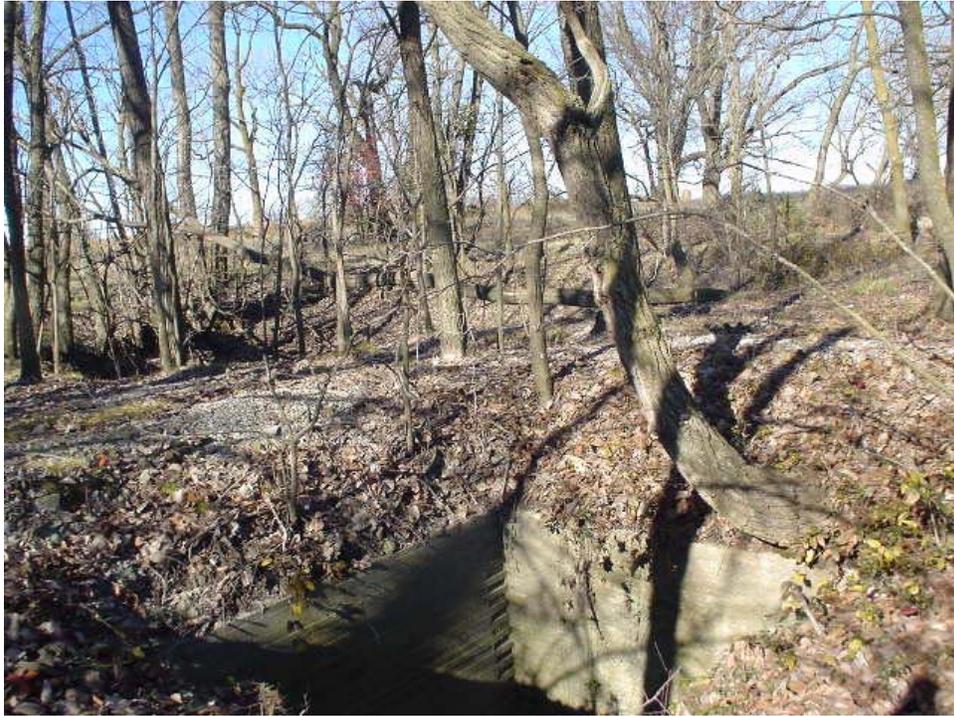
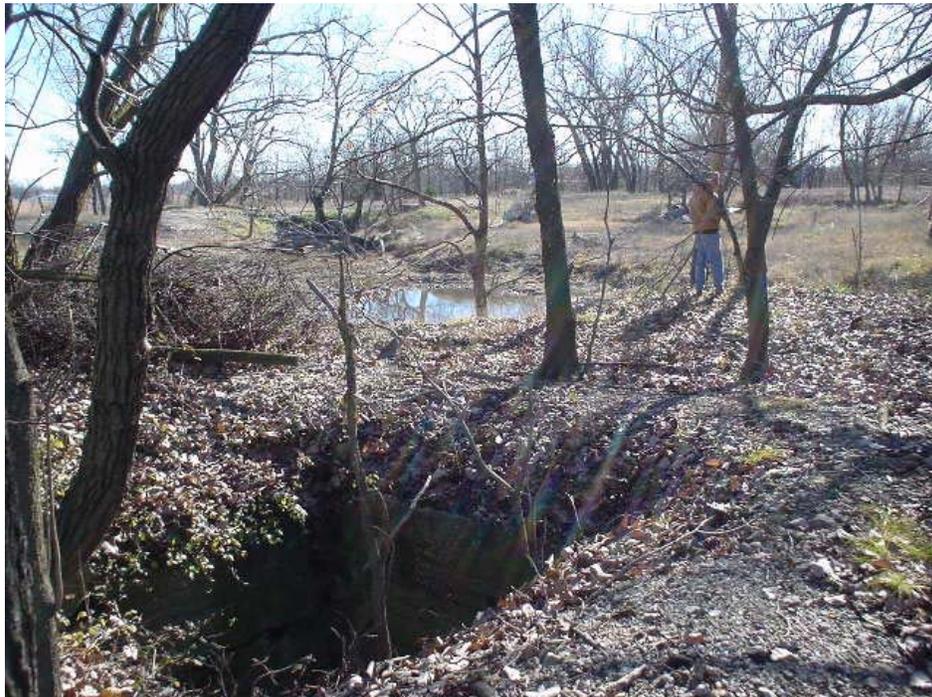
Location: Mine Shaft Site No. 8- Section 36.

Description: Photographs 66 and 67 are views of Mine Shaft Site No. 8 -Section 36. Mine Shaft surrounded by fescue grass pasture.

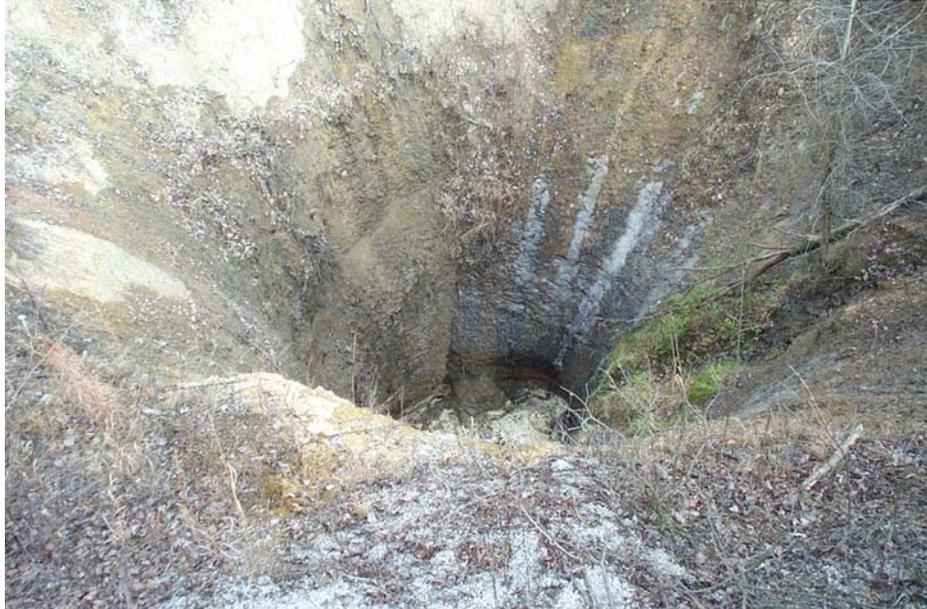
Location: Mine Shaft Site No. 23- Section 23

Description: Photograph 68 shows Mine Shaft Site No. 23 Section 23

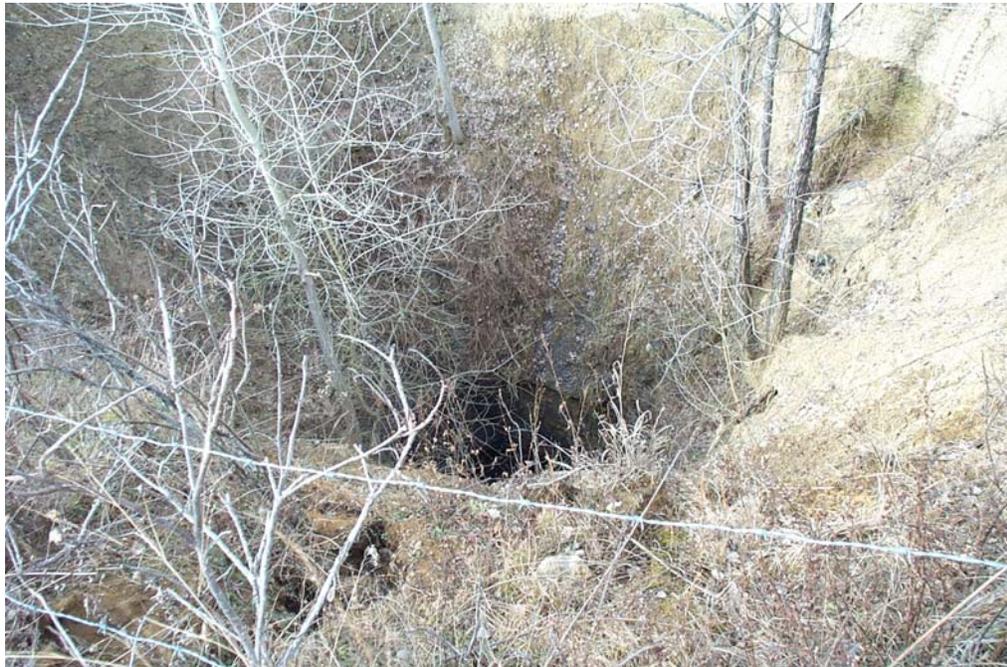
Location: Mine Shaft Site No. 22- Section 23.

Description: Photograph 69 is a view of Mine Shaft Site No. 22 Section 23.
