MITIGATION BANKING INSTRUMENT

DEEP FORK MITIGATION BANK

Lincoln County, Oklahoma

USACE Project Number: SWT-2015-94

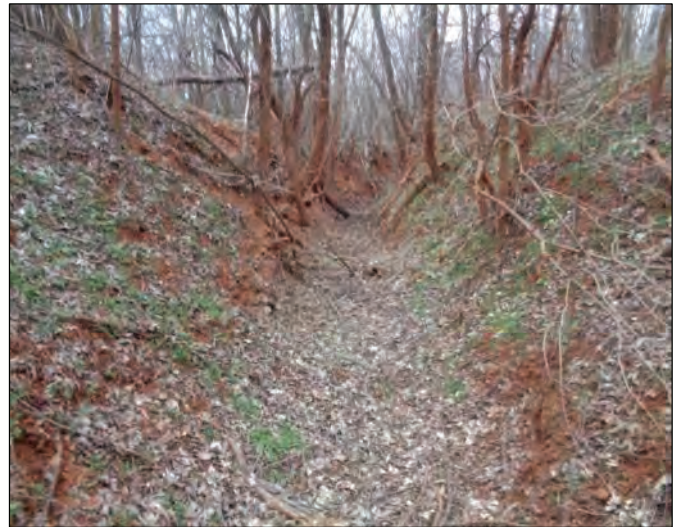
Photograph 4. View of southern-most ephemeral stream near the confluence of main wetland cell drainage channel.

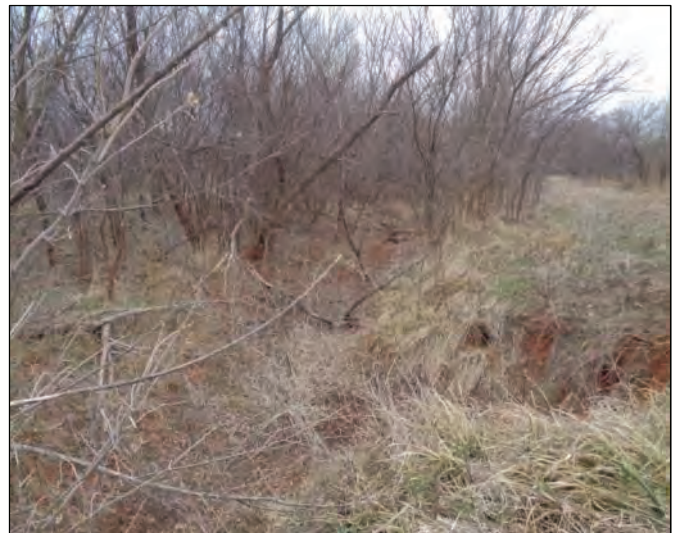
Photograph 6. View of the main wetland cell drainage channel south of the main water control structure.

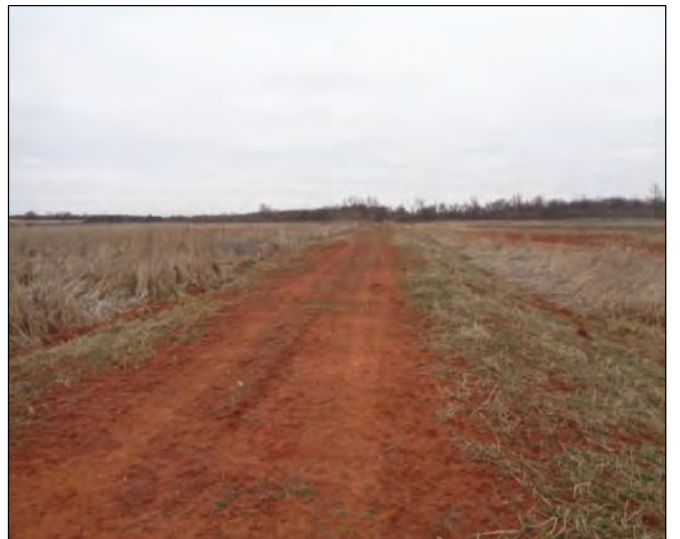
Photograph 36. Another view of one of the many levees that are located within the project site.

There are four moist soil units located on the DFMB site. All four locations are surrounded by a constructed levee (Photographs 35-37), natural stream levee, old tram (Photograph 38), hill land, or the levee/spoil pile adjacent to the Deep Fork River. The three moist soil units located west of the river can capture or release rainfall runoff, or outbanked water, through a series of water control structures (Photograph 40). Each unit has two to three control structures that can be opened or closed manually to manipulate water levels in each unit. The fourth moist soil unit, located in the northeast portion of the site, was created by the construction of a levee on the adjacent property to the east, and the outflow is restricted by a levee along the river and a natural levee along the old Deep Fork channel to the south.

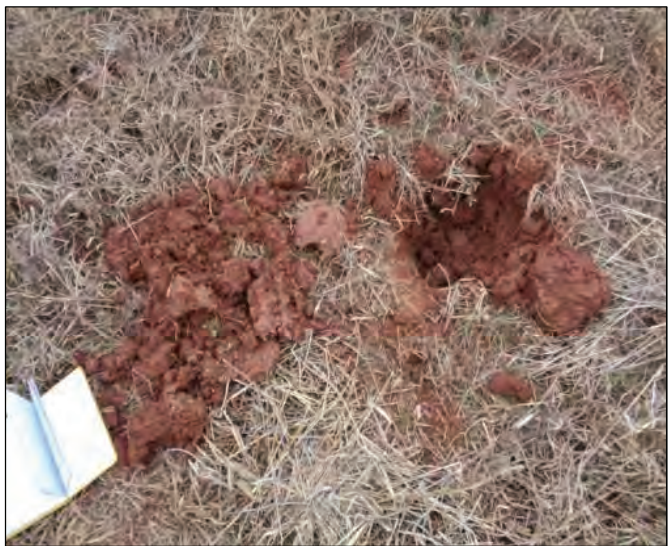
Photograph 39. View of typical soil profile located in the emergent wetland habitat.

Soil samples were observed between the surface and approximately 16 inches below grade within each of the dominant habitat types. The depth of each sample was sufficient to determine changes in upper horizons and to observe field indicators of hydric soils. Field data indicate that the majority of the site is underlain by heavy clay, similar to the mapped Miller and Ustibuck series, except for the riparian areas adjacent to the river and tributary streams, and the upland areas. Based on the field examination, the areas mapped as Easpur loam contained heavy clays are more akin to the Miller and Ustibuck series (Photograph 39). The wetland criterion for hydric soils was met at all 10 sample locations established to characterize the site (Appendix C – Data Sheets). All of the soils encountered within the DFMB, except for the uplands, consisted of silt loams to heavy clays, and exhibited a red color. Therefore, the soils were determined to be problem soils formed from red parent material. All of the data locations, except for the uplands, were located in the floodplain and exhibited some degree of wetland hydrology.

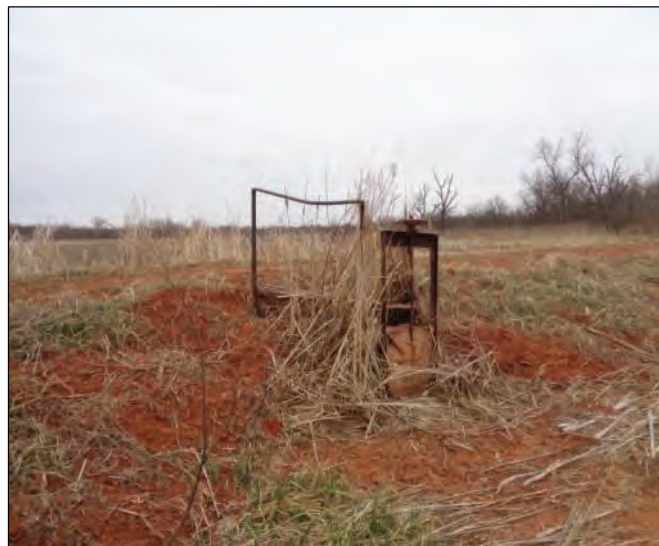
Photograph 40. View of one of the several water control structures associated with the moist soil units.

The ability to retain water within the moist soil units prior to planting trees would provide critical soil moisture that would benefit the tree seedlings greatly. The existing water control structures are not intended to be long-term management tools, but rather will act as short-term insurance until the planted trees have established sufficient root growth. Plans include removing the water control structures one year after planting.
