# **MITIGATION BANKING INSTRUMENT**

Honey Springs Mitigation Bank  
McIntosh County, Oklahoma  
USACE Project Number: SWT-2019-218

May 2020

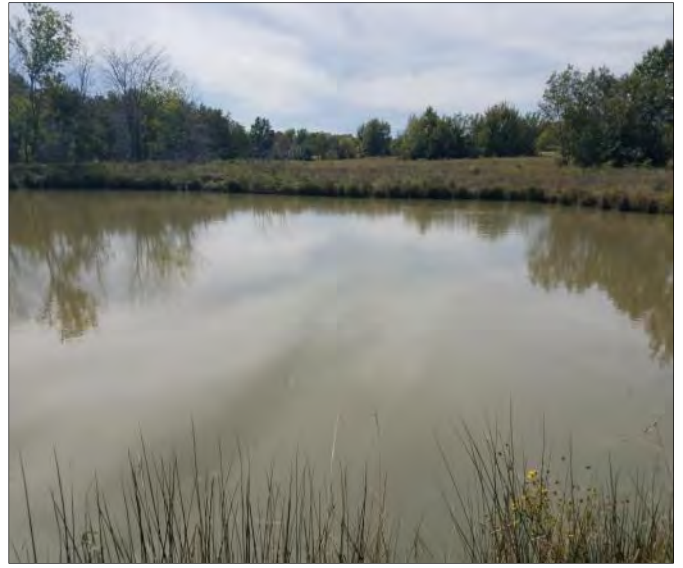
Photograph 68. View of small stock pond located in the upland field habitat near the west property boundary.

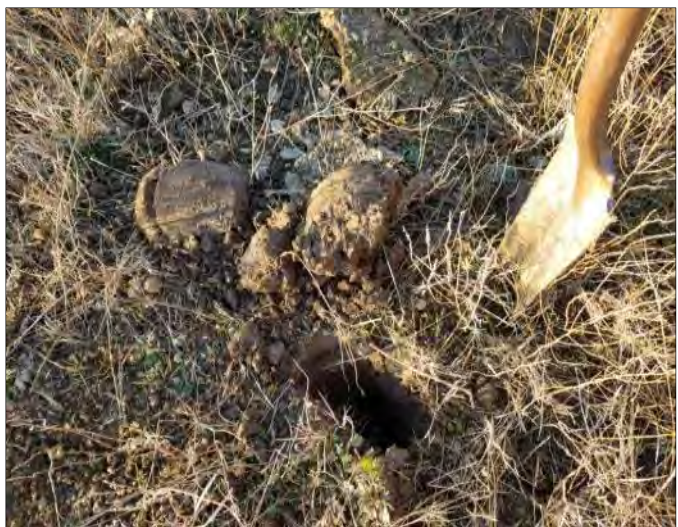
Photograph 29. View of soil profile observed within the Emergent Wetland 1 habitat (Data Sheet OF EWL1).

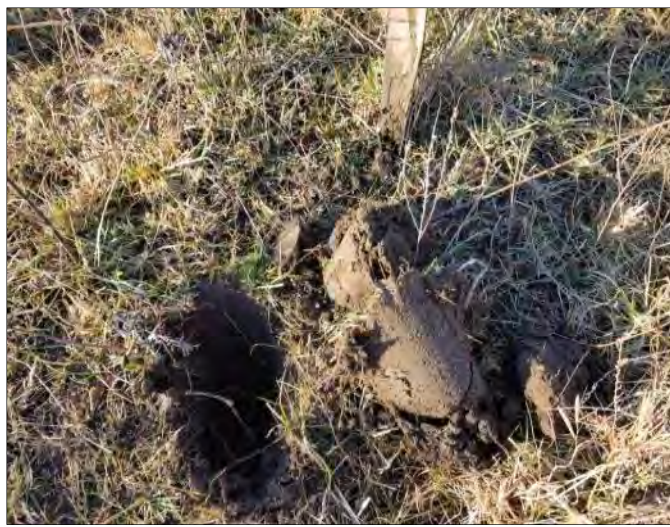
Photograph 30. View of soil profile observed within the Emergent Wetland 2 habitat (Data Sheet OF EWL2)

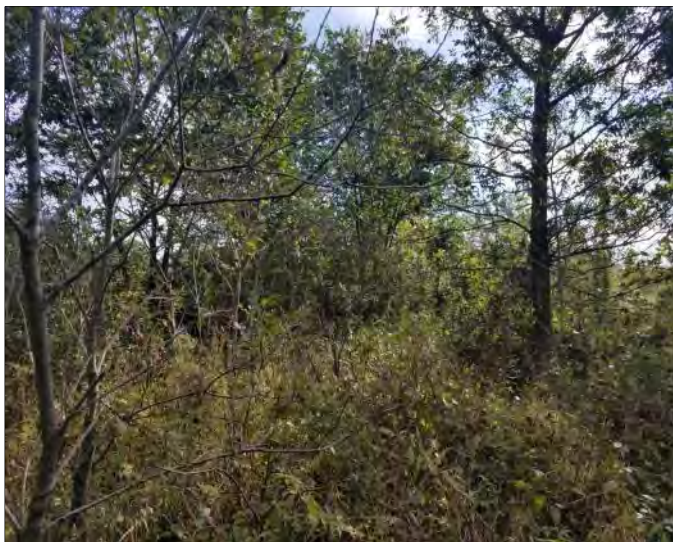
Photograph 31. View of mixed shrub/scrub and emergent wetland habitat associated with Intermittent Stream #2.

A total of 13.3 acres of mixed shrub/scrub and emergent wetland riparian habitat were identified within the HSMB – Old Field Tract (Photographs 31-41). The vegetation dominating these areas consists of pecan, green ash, American elm, Shumard oak, roughleaf dogwood (*Cornus drummondii*), Canada wildrye, giant goldenrod (*Solidago gigantea*), Oklahoma blackberry, broomsedge, velvet panicum, frost grape (*Vitis vulpina*) and poison ivy (*Toxicodendron radicans*).
