APPENDIX L: RAPID GEOMORPHIC ASSESSMENTS (RGA) CONDUCTED FOR THE PROPOSED LOWER BOIS D'ARC CREEK RESERVOIR SITE IN 2008 AND 2016

**L-1: RAPID GEOMORPHIC ASSESSMENT OF BOIS D'ARC CREEK AND ITS
TRIBUTARIES FOR THE LOWER BOIS D'ARC CREEK RESERVOIR
PROJECT (2008)**

**L-2: SUPPLEMENTAL RAPID GEOMORPHIC ASSESSMENT DATA
COLLECTION AT THE PROPOSED LOWER BOIS D'ARC CREEK
RESERVOIR SITE (2016)**

**Rapid Geomorphic Assessment of
Bois d'Arc Creek and its Tributaries for the
Lower Bois d'Arc Creek Reservoir Project**

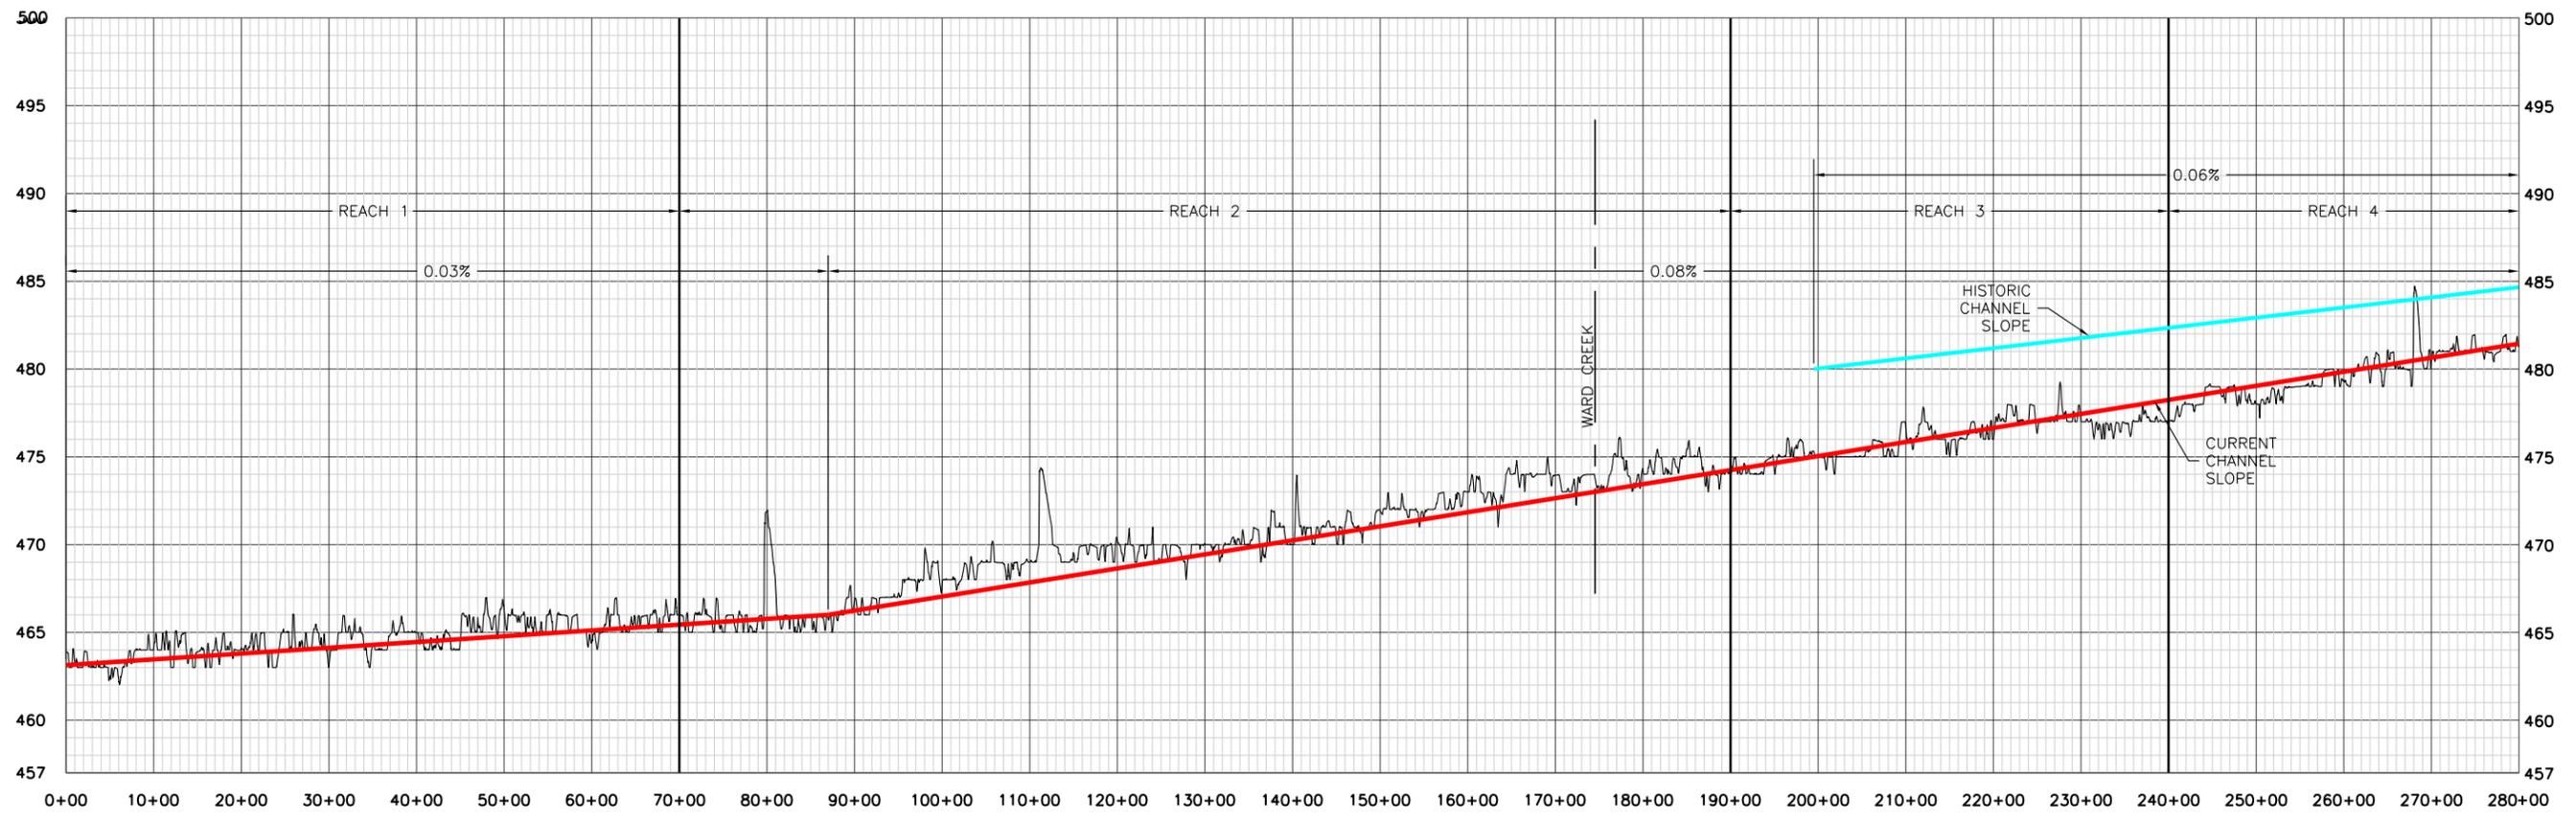
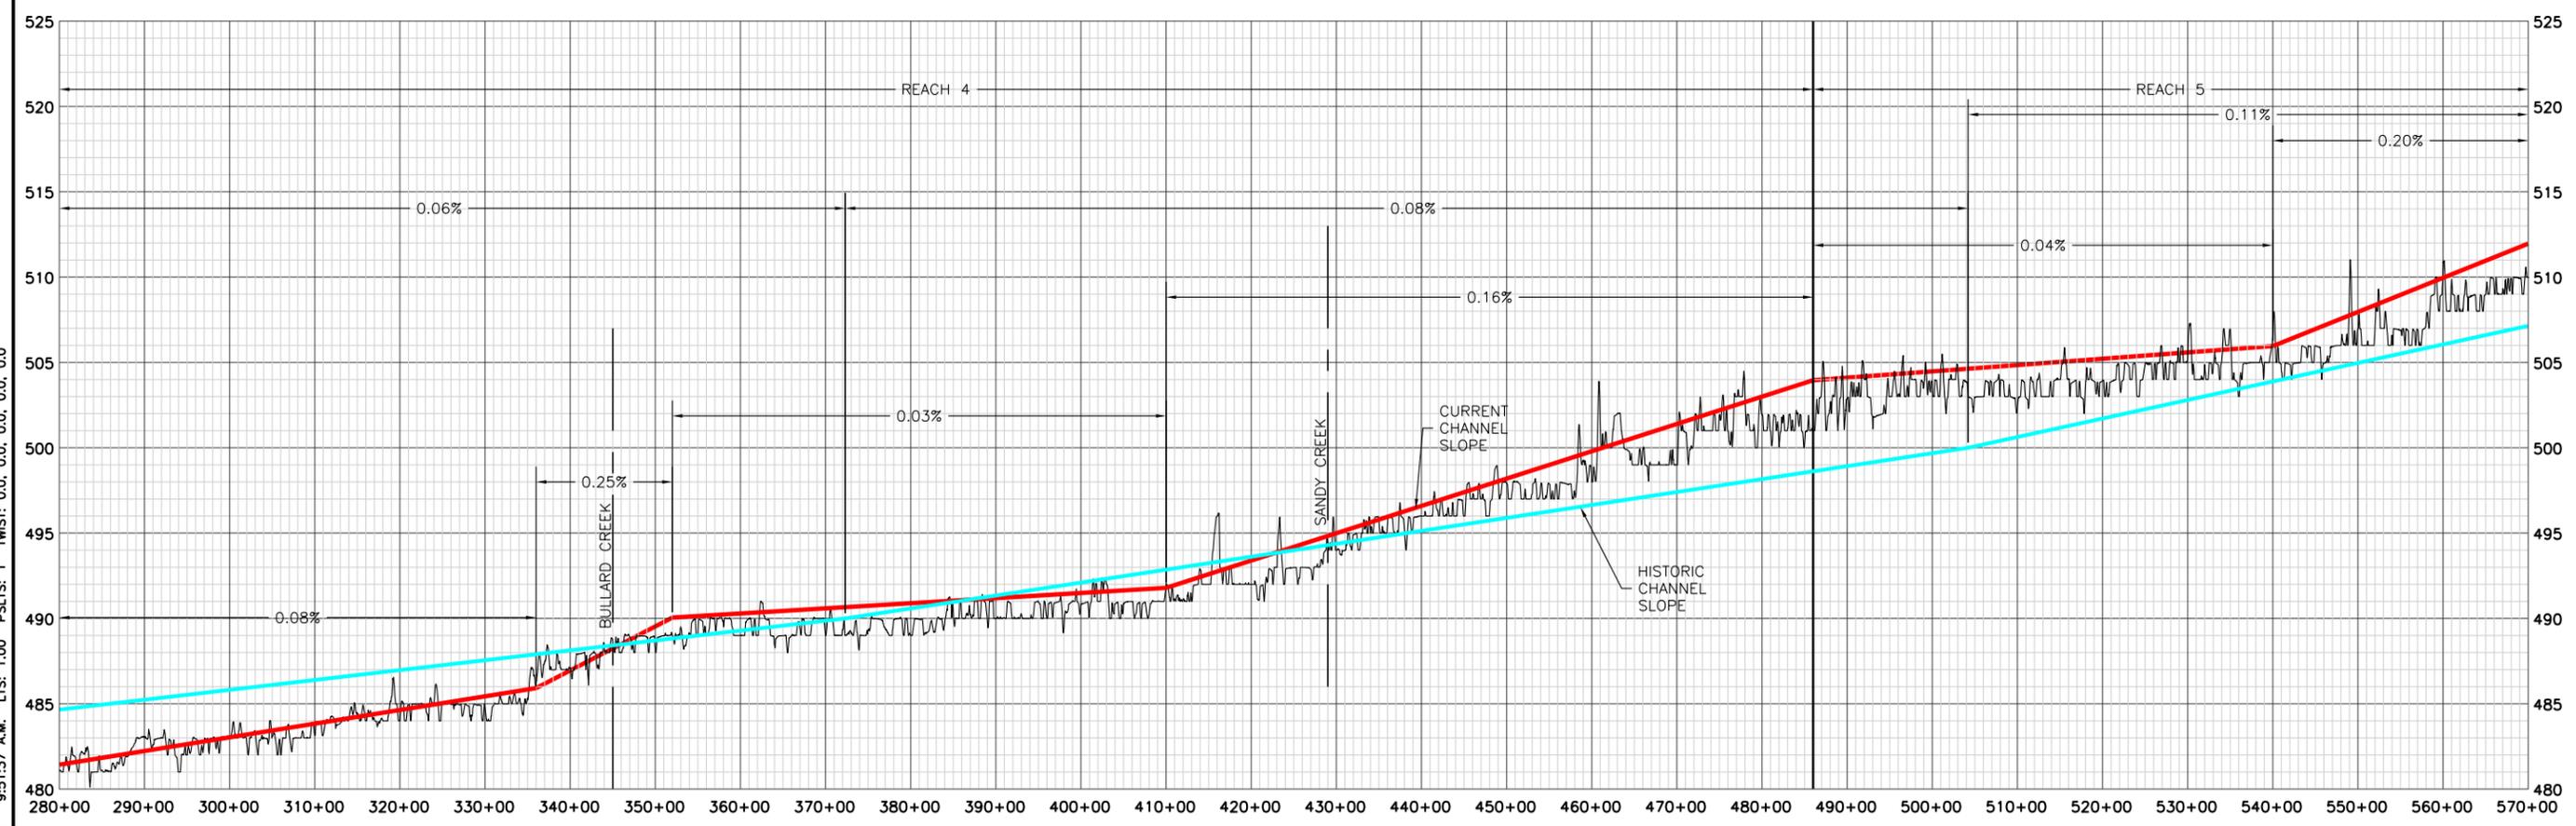
5.2
FIGURE

Approximately sixty-two percent (62%) of the main stem of Bois d’Arc Creek within the proposed reservoir was channelized. Reaches 1, 3, and 5 represent the channelized reaches. Figures 5.4, 5.9, and 5.15 provide examples of the typical channelization that took place along the creek. By comparing the historical map circa 1915 to the aerial imagery of 1950, we concluded that most of the channelization to the creek occurred between 1915 and 1950. Since 1950, several road crossings have been constructed where approximately 3,000 additional feet has been straightened. Due to the manmade alterations to the creek, the flowline has downcut causing a headcut effect propagating up the creek. Evidence of the down cutting can be seen in the longitudinal profiles for Bois d’Arc Creek in Figures 5.2 and 5.3.

As shown in Figure 5.2, the channelization of Reach 1 has propagated upstream to Station 87+00 with an average channel slope of 0.03%. Figure 5.5 provides a typical view of Reach 1 of Bois d'Arc Creek. This reach has an average top width of 140 feet, average depth of 15 feet, with almost vertical side slopes. The riparian vegetation along the banks is moderate, with a mix of grasses along the mid slope and small trees and grasses on the upper slope. The lower banks have little to no vegetation providing little bank protection. Due to the absence of woody shrub species along the slopes, there is a limited root zone causing undercut stream banks. Depositional side bar features are common due to high sediment load from the steep banks and the shallow channel slope. Streambank erosion rates in some areas appear to be high due to undercut banks and mass wasting. There is little habitat potential in this reach, with very little shade over the creek and incised channel banks.

As shown in Figure 5.2, Reach 2 has an average channel slope of 0.08%, but channelization of the downstream reach is causing a headcut into this reach. Figures 5.7 and 5.8 provide typical views of Reach 2 of Bois d'Arc Creek.

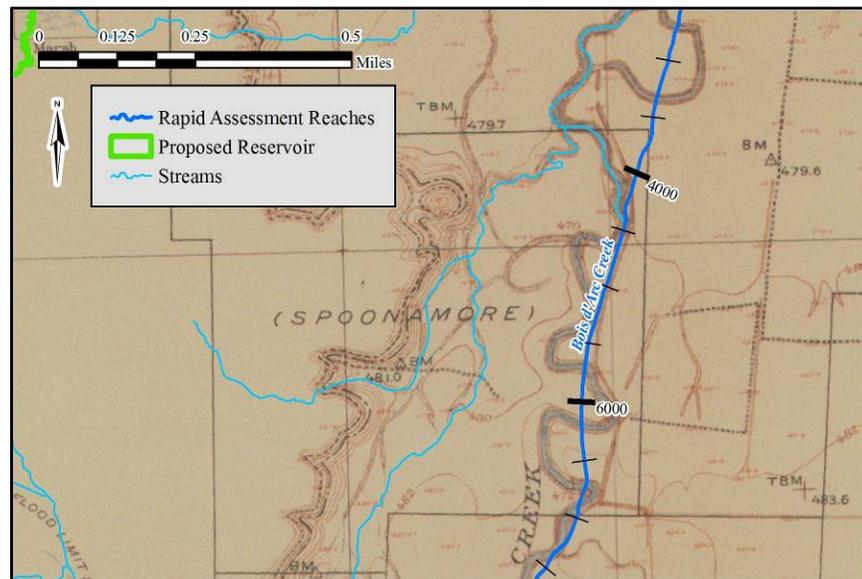
Figure 5.4 - Comparison of Historic to Existing Channel Alignment for Reach 1 of Bois d'Arc Creek

Reach 1 of Bois d'Arc Creek (Figure 5.1) is the most downstream reach of the study area, accounting for approximately 8% of the total stream length. Comparing the alignment of this reach today to the circa 1915 map, shows that the entire 7,000 feet of the reach has been straightened. An example of the channelization of this reach is shown in Figure 5.4.

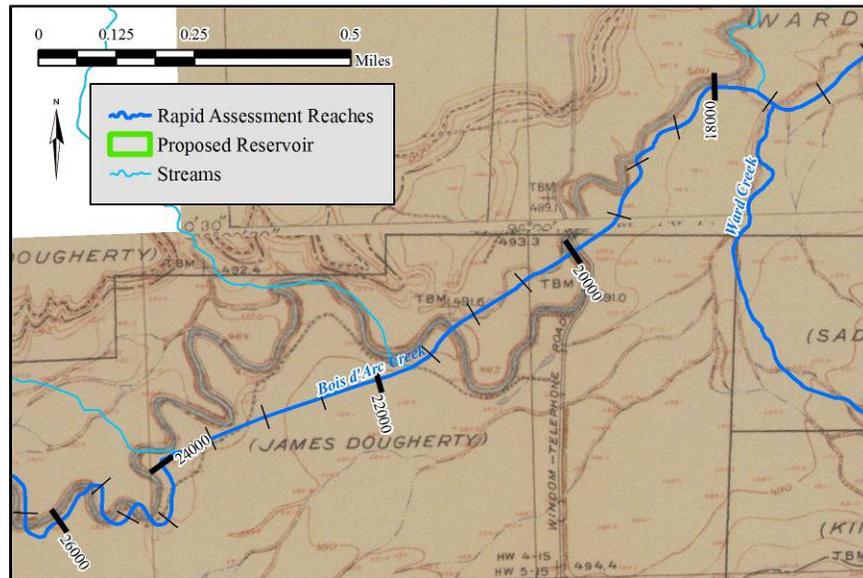
Figure 5.9 - Comparison of Historic to Existing Channel Alignment for Reach 3 of Bois d'Arc Creek

Reach 3 of Bois d'Arc Creek (Figure 5.1) stretches from Station 190+00 to 240+00, covering approximately 6% of the total stream length. Comparing the alignment of this reach today to the circa 1915 map, shows that the entire 5,000 feet of the reach has been straightened. An example of the channelization of this reach is shown as Figure 5.9.

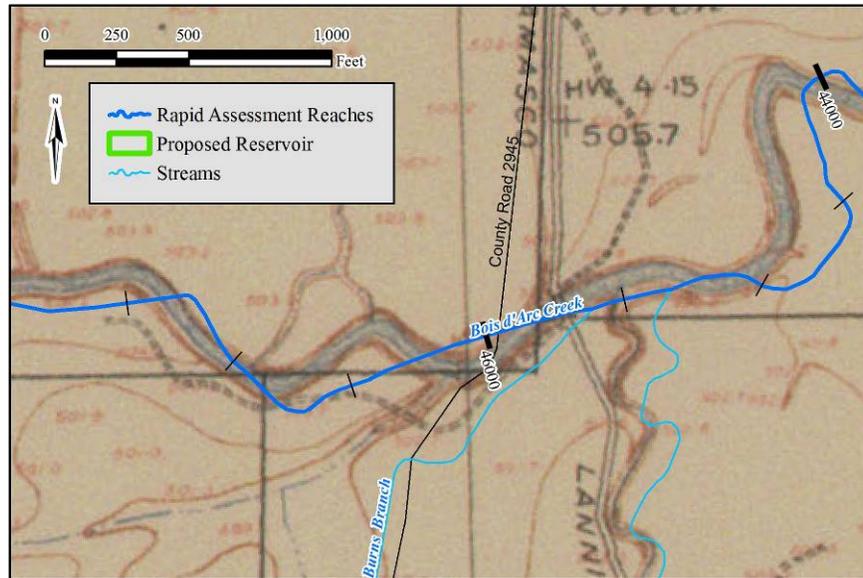
Figure 5.12 - Comparison of Historic to Existing Channel Alignment for Reach 4 of Bois d'Arc Creek

Reach 4 of Bois d'Arc Creek (Figure 5.1) stretches from Station 240+00 to 486+00, covering approximately 27% of the total stream length. Most of this reach has not been straightened and resembles quite closely the 1915 meandering alignment. However, 1,500 feet of the reach was straightened between 1915 and 1950 to accommodate County Road 2945 (Figure 5.12).

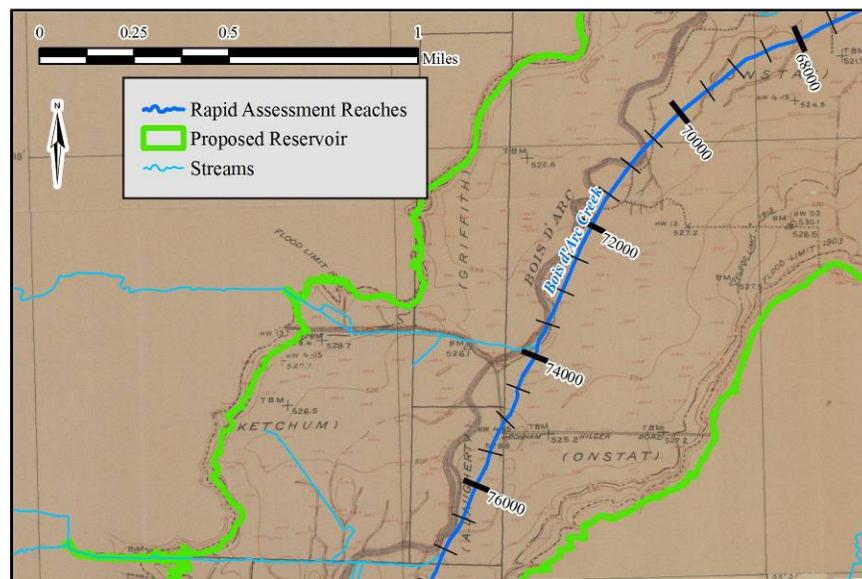
Figure 5.15 - Comparison of Historic to Existing Channel Alignment for Reach 5 of Bois d'Arc Creek

Reach 5 of Bois d'Arc Creek (Figure 5.1) is the most upstream reach of the study area, covering approximately 46% of the total stream length. The entire 40,700 feet of the reach has been straightened. An example of the channelization of this reach is shown as Figure 5.15.

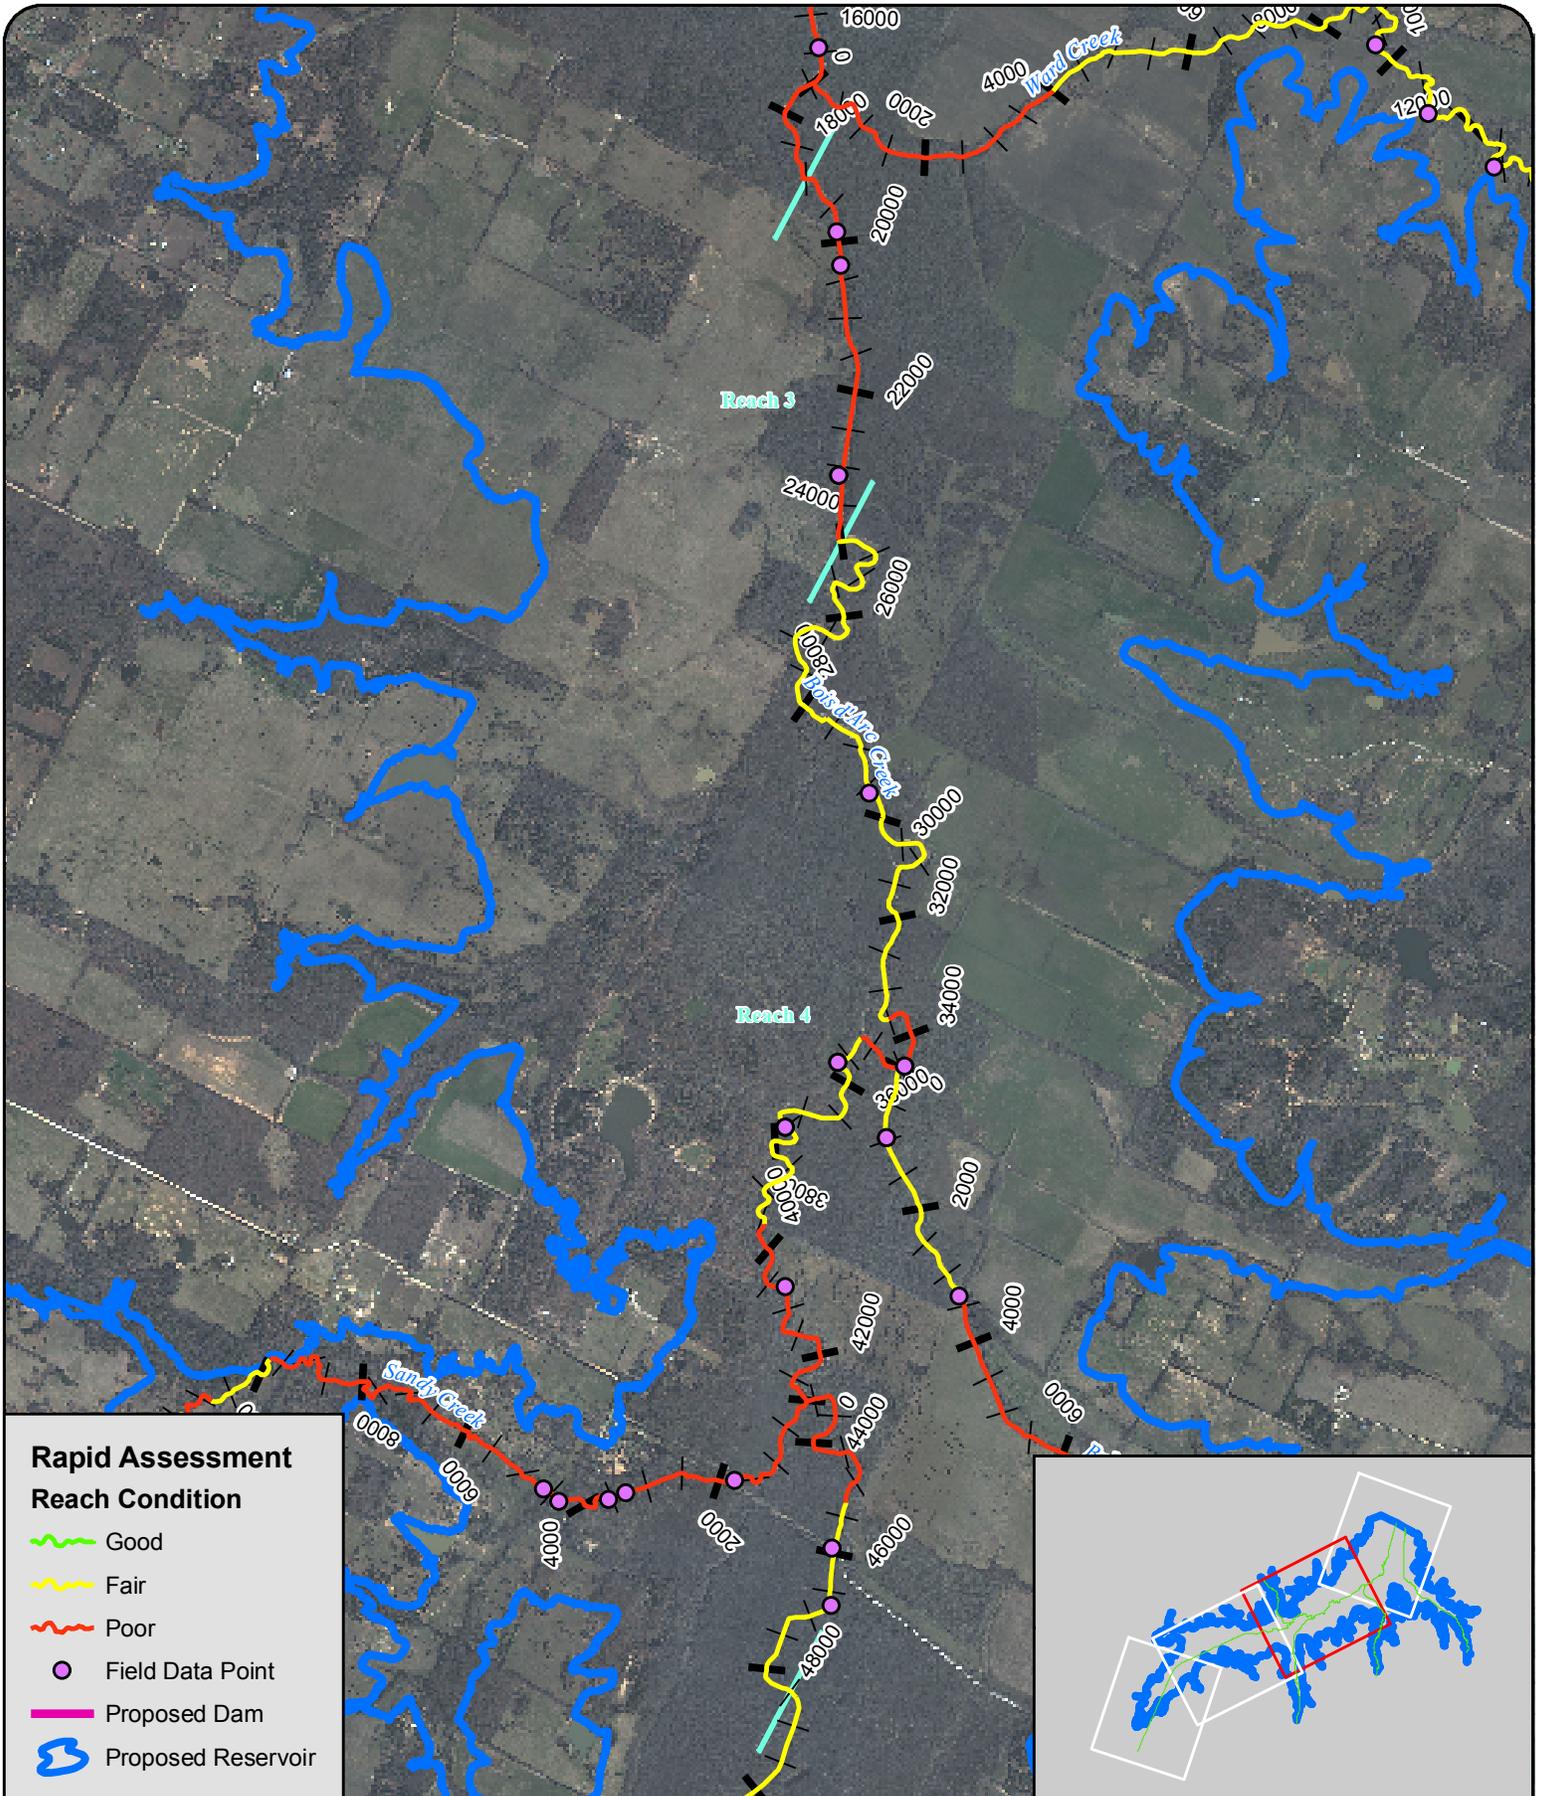
FIGURE
5.20

In terms of the rapid assessment classification of Reach 2 of Bois d'Arc Creek, the upper reaches of this creek seem to be in Type III of the channel evolution process. Downstream of F.M. 1396, the creek seems to be in transition between Types III and IV, with an inner berm forming inside the channel (Figure 5.8b). The stability of this reach is predominantly poor, with approximately 45% of the reach given a "fair" rating and the other 55% a "poor" rating. The rapid geomorphic classification for this reach is presented as Figure 5.20 at the end of this section.

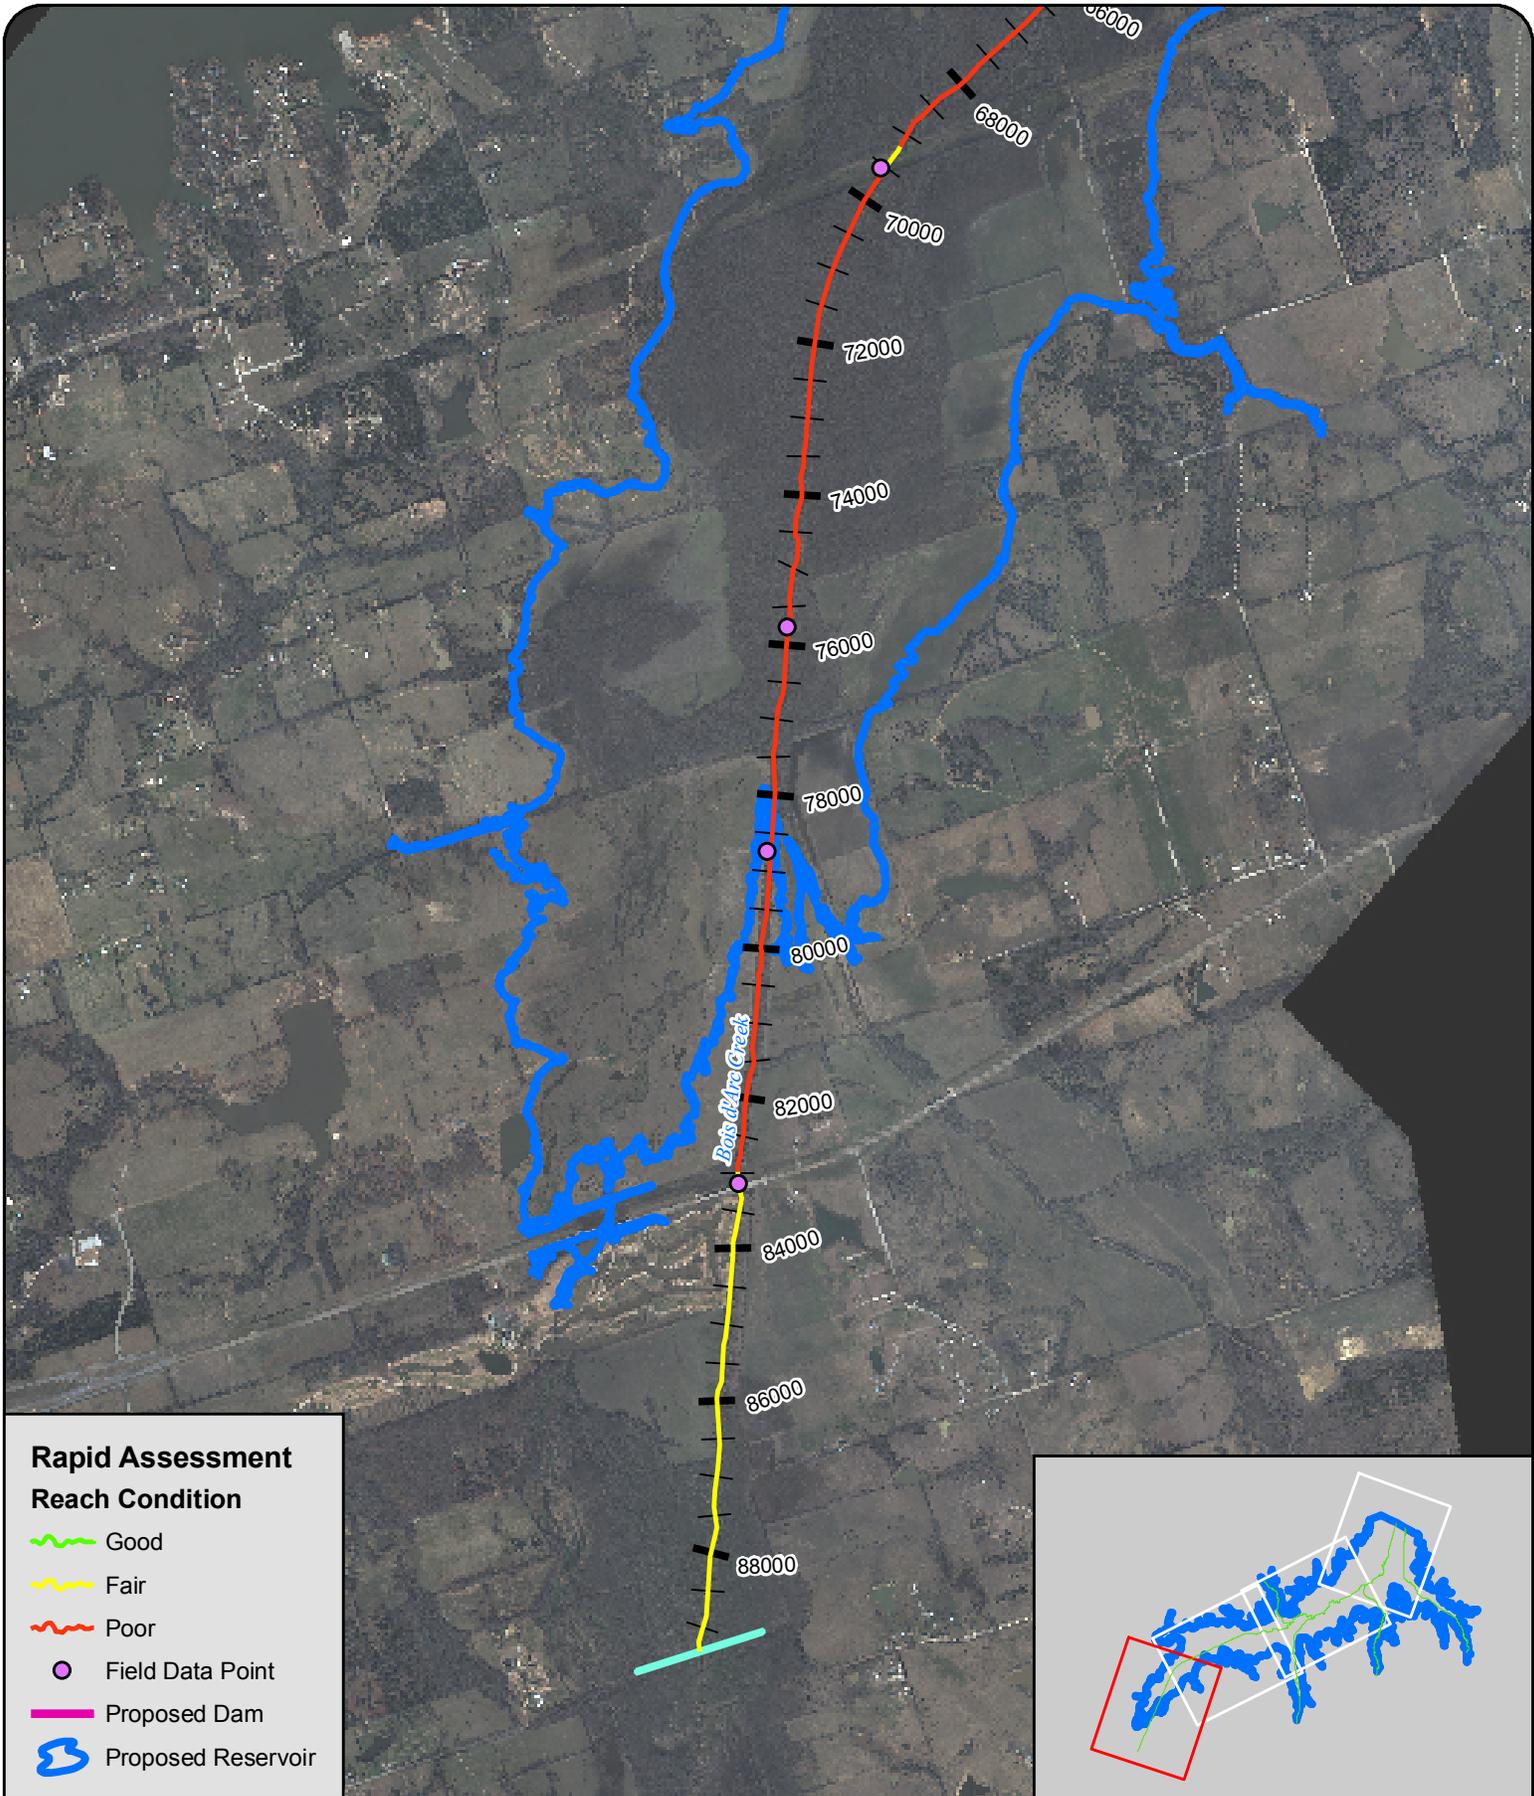
FIGURE
5.22

In terms of the rapid assessment classification of Reach 5 of Bois d'Arc Creek, this reach is predominantly in poor stability conditions, with approximately 37% of the reach given a "fair" rating and the other 63% given a "poor" rating. The rapid geomorphic classification for this reach is presented in Figures 5.22 and 5.23 at the end of this section.

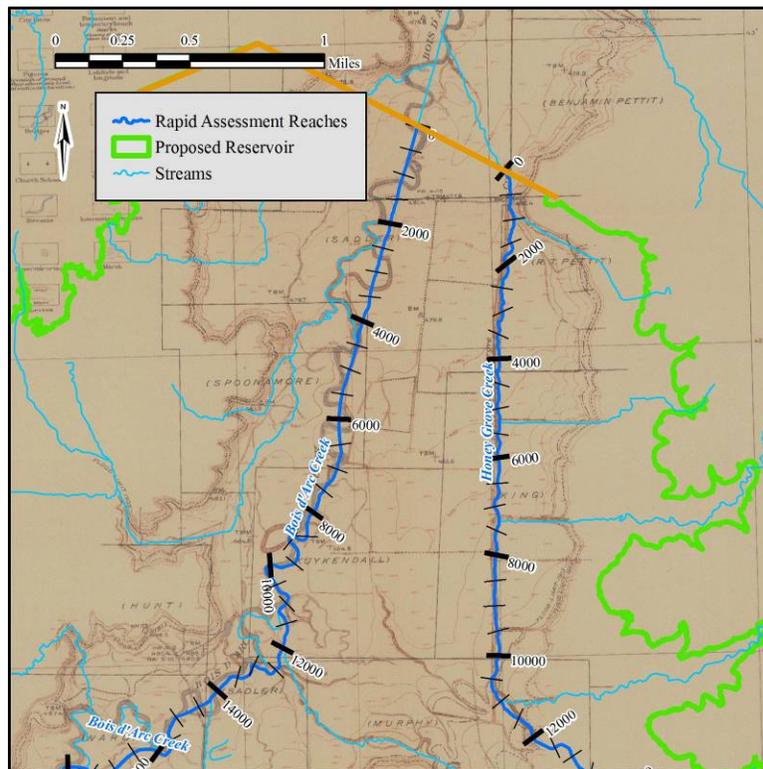
Figure 5.24 - Comparison of Historic to Existing Channel Alignment on Honey Grove Creek.

Based on the 1915 map of the streams, it appears that approximately 9,500 linear feet of Honey Grove Creek (nearly 30%), within the reservoir, were channelized prior to 1915. Figure 5.24 shows a portion of the reach that was channelized. Our interpretation that this portion of Honey Grove Creek was channelized is evidenced by depiction of the lower end of the present day creek down to the confluence with Bois d'Arc Creek, as a small localized tributary of the main stem with a small ridge between Bois d'Arc Creek and what appears to be an unfinished channel. It appears that the original Honey Grove Creek channel can still be seen in the 1915 map with its confluence with Bois d'Arc Creek at approximate Bois d'Arc Creek Station 74+00 (Figure 5.24).

Portions of the original channel remain discernable through the 2007 aerial photographs although portions appear to have been filled in and converted to farm land. Comparing the 1915 maps to the 1950 aerial shows that the lower 3,000 feet of the present day Honey Grove Creek (downstream of the reservoir) is a manmade channel and the natural channel has been removed for agricultural reasons. We conclude that most of the channelization to the creek occurred between 1915 and 1950. Due to the manmade alterations to the creek, the flowline has downcut causing a headcut to propagate up the creek. Evidence of the down cutting can be seen in the longitudinal profile for Honey Grove Creek in Figure 5.25.

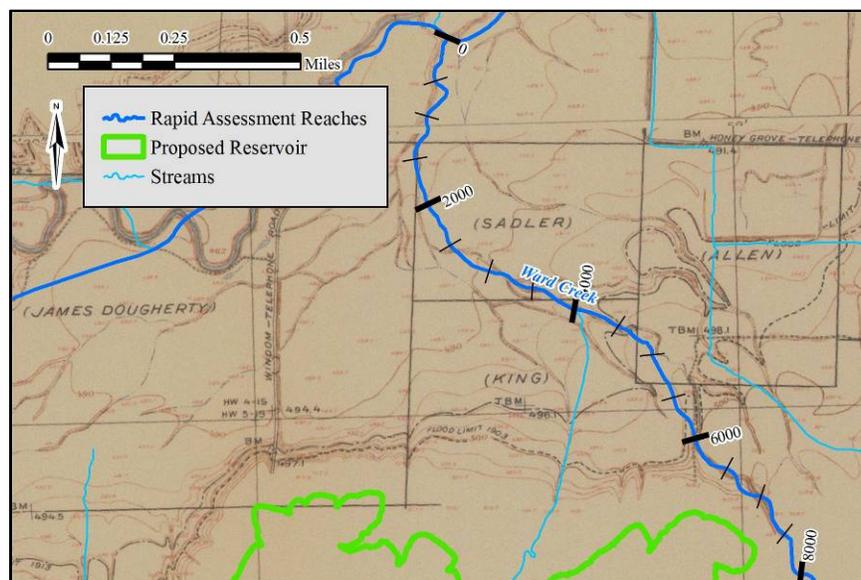
Figure 5.30 - Comparison of Historic to Existing Channel Alignment on Ward Creek.

Comparing the 1950 aerial photograph to the 1915 map of Ward Creek show that approximately 3,500 to 4,000 feet (approximately 10%) of this stream was channelized between approximate Stations 25+00 and 60+00 (Figure 5.30). Although this section was channelized, it should be noted that the changes in the pattern of this stream were much less aggressive than the alterations to segments of Bois d'Arc Creek and Honey Grove Creek discussed above, as this section of Ward Creek had low sinuosity prior to the channelization.

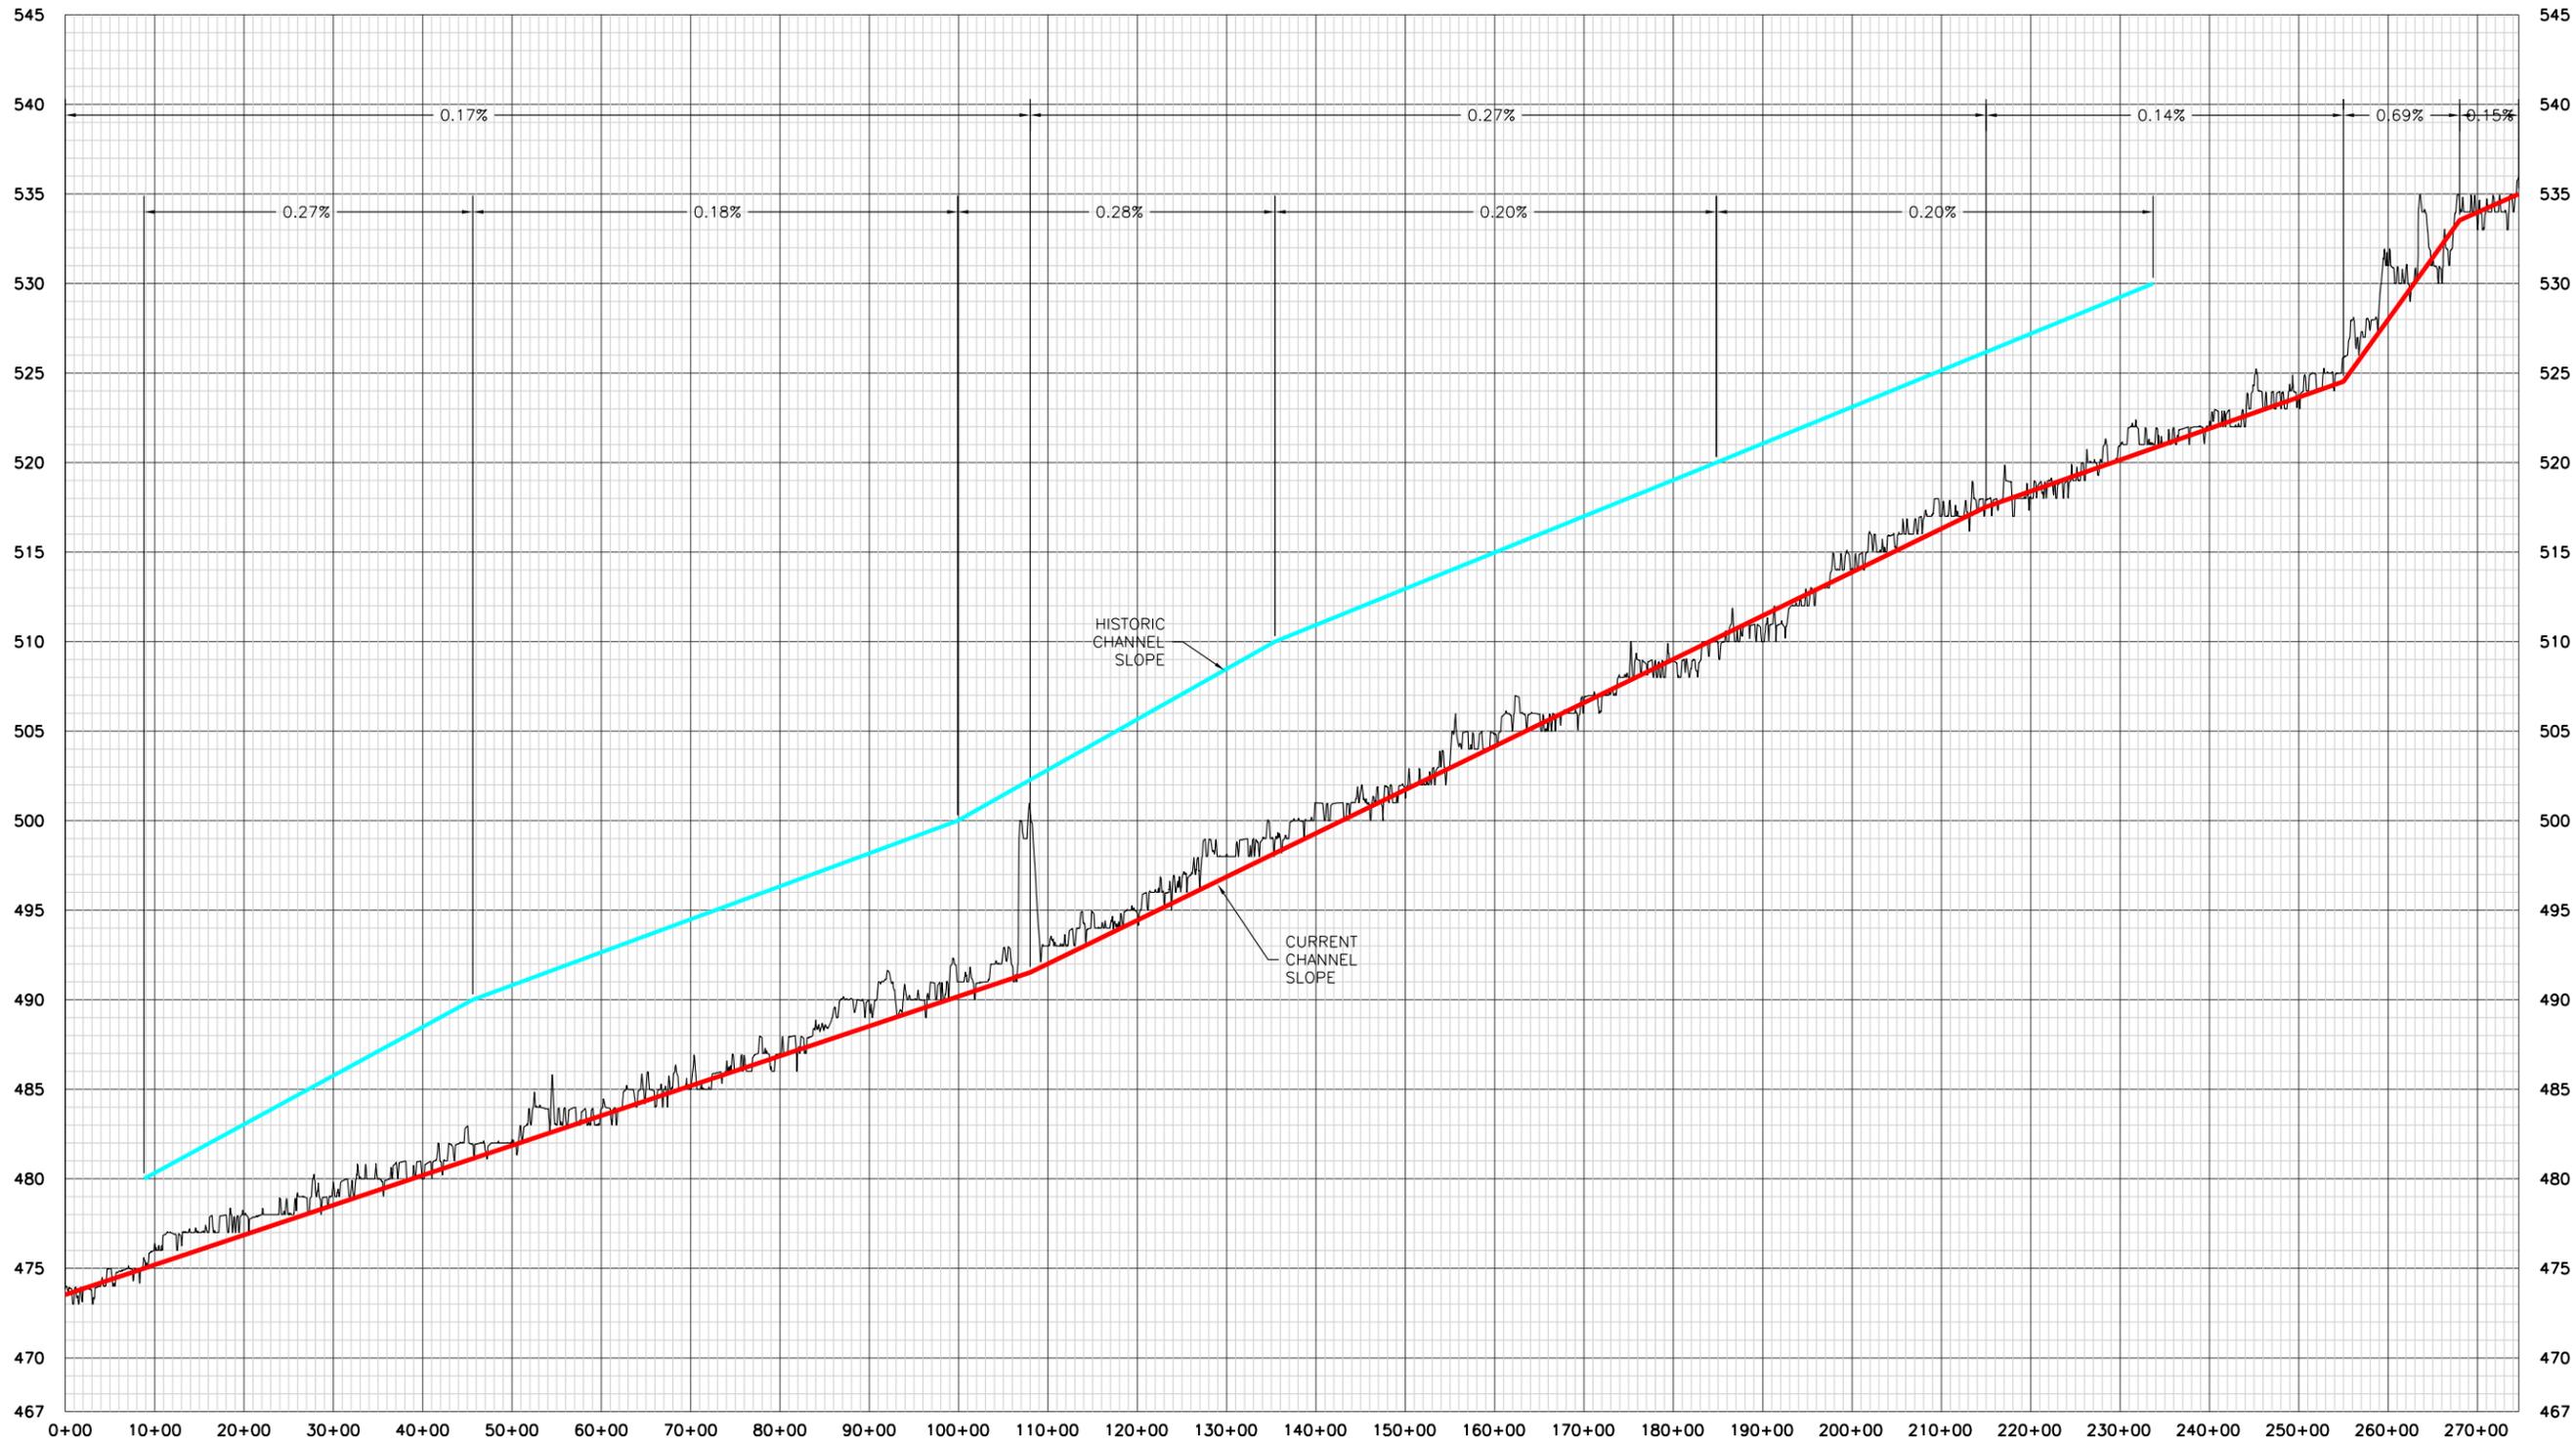
NORTH TEXAS MUNICIPAL WCID
LOWER BOIS D'ARC CREEK PROPOSED RESERVOIR PROJECT
 FLUVIAL GEOMORPHOLOGY
WARD CREEK

As shown in Figure 5.31, Ward Creek has downcut from the confluence with Bois d'Arc Creek upstream to Station 255+00 with an average channel slope of 0.20%. The down cutting and widening of the stream through this reach is evident by comparing the 2007 aerial photographs with the 1950 aeriels. There is a much steeper reach near the end of the proposed inundated portion of Ward Creek with a slope of nearly 0.70%. Depositional side bars are common and, where the stream has downcut, there are signs that a new floodplain is beginning to develop with the channel (Figure 5.32). Streambank erosion rates in some reaches appear to be very high due to mass wasting (Figure 5.33); however, there are long reaches that appear to be recovering with the formation of inner berms and emergent vegetation.

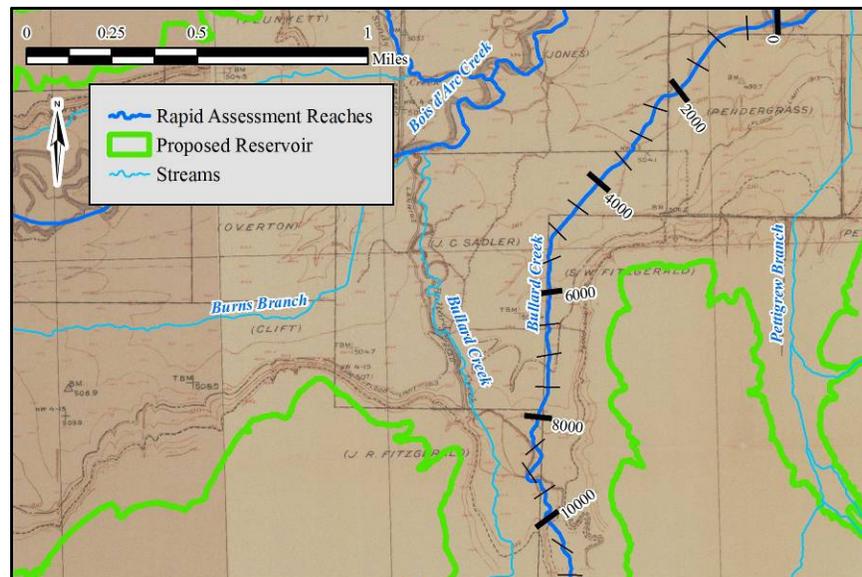
Figure 5.35 - Comparison of Historic to Existing Channel Alignment on Bullard Creek.

Bullard Creek is a large tributary of Bois d'Arc Creek with the stream confluence at approximate Station 345+00 on Bois d'Arc Creek. There are approximately 25,900 feet (4.9 miles) of Bullard Creek in the proposed inundation pool of Lower Bois d'Arc Reservoir. The 1915 map does not encompass the entire reach of Bullard Creek so we could not determine how much of the stream segment was channelized and straightened. However, estimates were made from the information available. Nearly 4,500 linear feet (20%) of Bullard Creek was channelized prior to 1950 (Figure 5.35). This channelization project actually redirected the lower reach of Bullard Creek through a minor tributary resulting in the abandonment of approximately 4,000 linear feet of the original Bullard Creek. The net effect was to channelize and enlarge approximately 8,000 linear feet (30%) of the existing Bullard Creek.

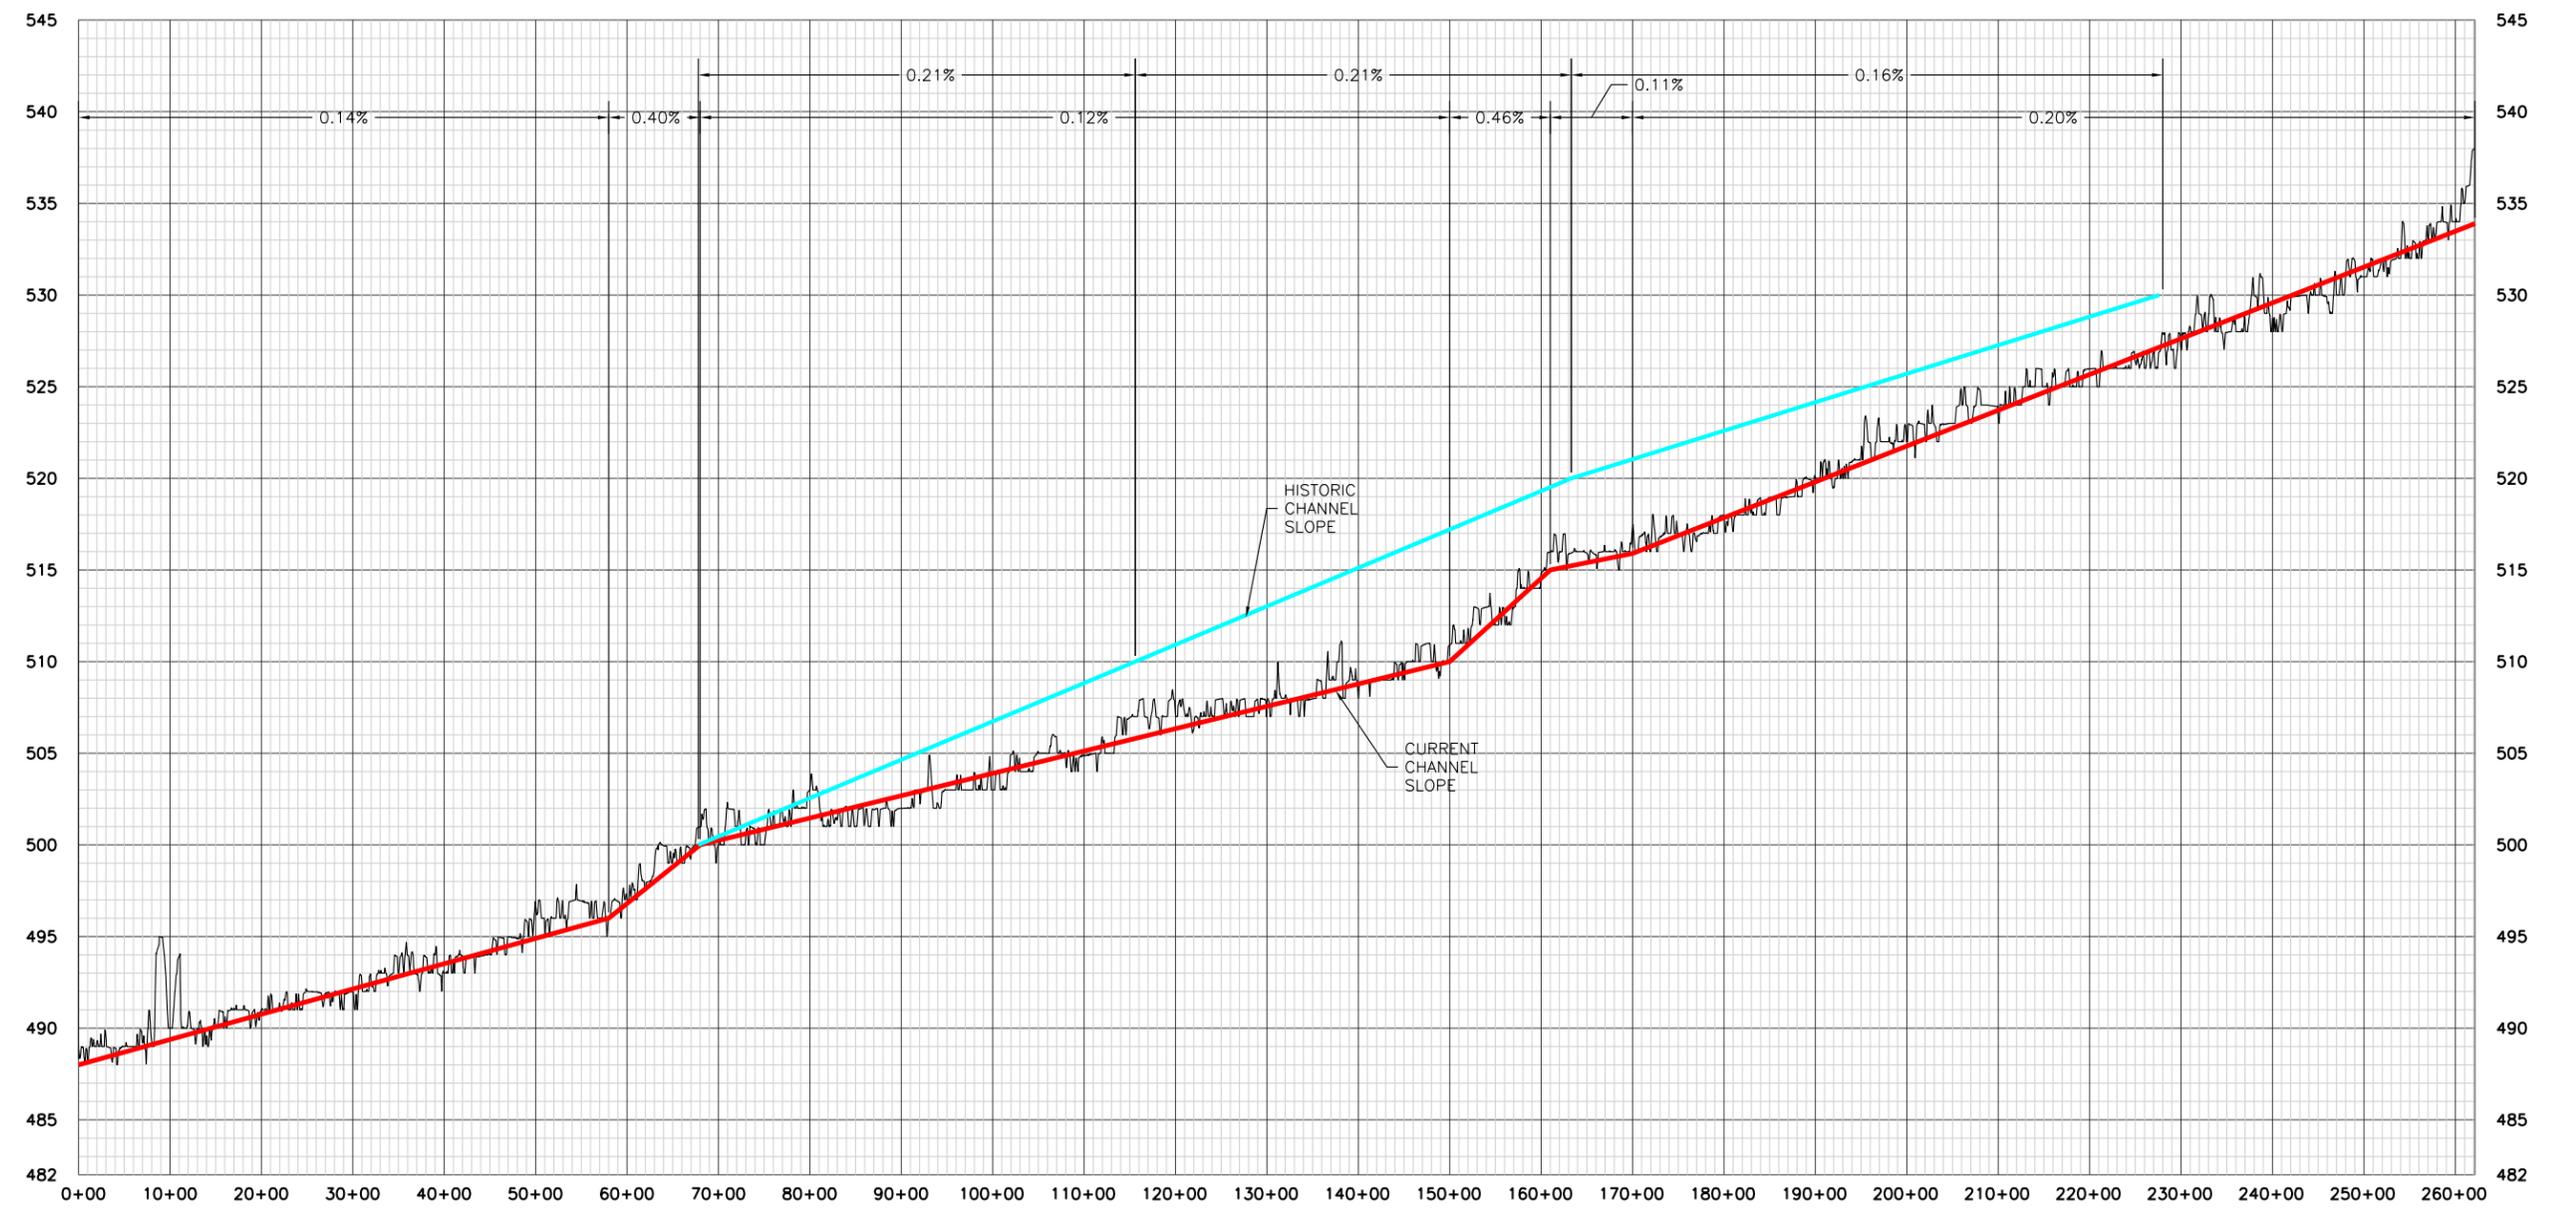
5.36
 FIGURE

As depicted in Figure 5.36, the average slope of Bullard Creek is approximately 0.18% with variations from 0.11% to approximately 0.46%. There are two distinct knickpoints (STA. 68+00 and STA. 161+00) in the Bullard Creek longitudinal profile and field observations suggest that this creek is down cutting in response to the Bullard Creek diversion and down cutting within Bois d'Arc Creek proper.
