APPENDIX L: RAPID GEOMORPHIC ASSESSMENTS (RGA) CONDUCTED FOR THE PROPOSED LOWER BOIS D'ARC CREEK RESERVOIR SITE IN 2008 AND 2016

**L-1: RAPID GEOMORPHIC ASSESSMENT OF BOIS D'ARC CREEK AND ITS
TRIBUTARIES FOR THE LOWER BOIS D'ARC CREEK RESERVOIR
PROJECT (2008)**

**L-2: SUPPLEMENTAL RAPID GEOMORPHIC ASSESSMENT DATA
COLLECTION AT THE PROPOSED LOWER BOIS D'ARC CREEK
RESERVOIR SITE (2016)**

**Rapid Geomorphic Assessment of
Bois d'Arc Creek and its Tributaries for the
Lower Bois d'Arc Creek Reservoir Project**

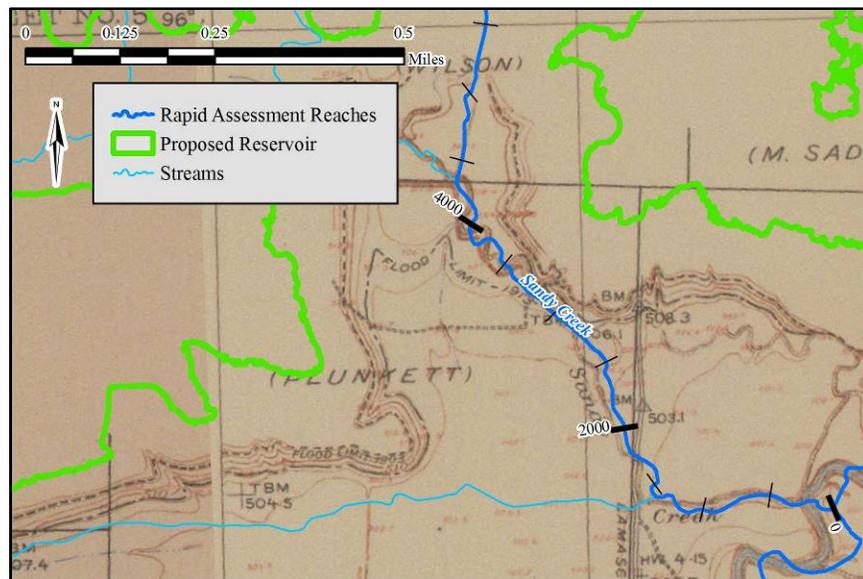
Figure 5.40 - Comparison of Historic to Existing Channel Alignment on Sandy Creek.

The 1915 map does not encompass the entire reach of Sandy Creek so it was difficult to determine how much of the stream segment was channelized/straightened. From the 1950 aerial photographs, we estimated that approximately 2,200 linear feet (15%) of Sandy Creek, from Station 43+00 to 65+00 was channelized between 1915 and 1950 (Figure 5.40).

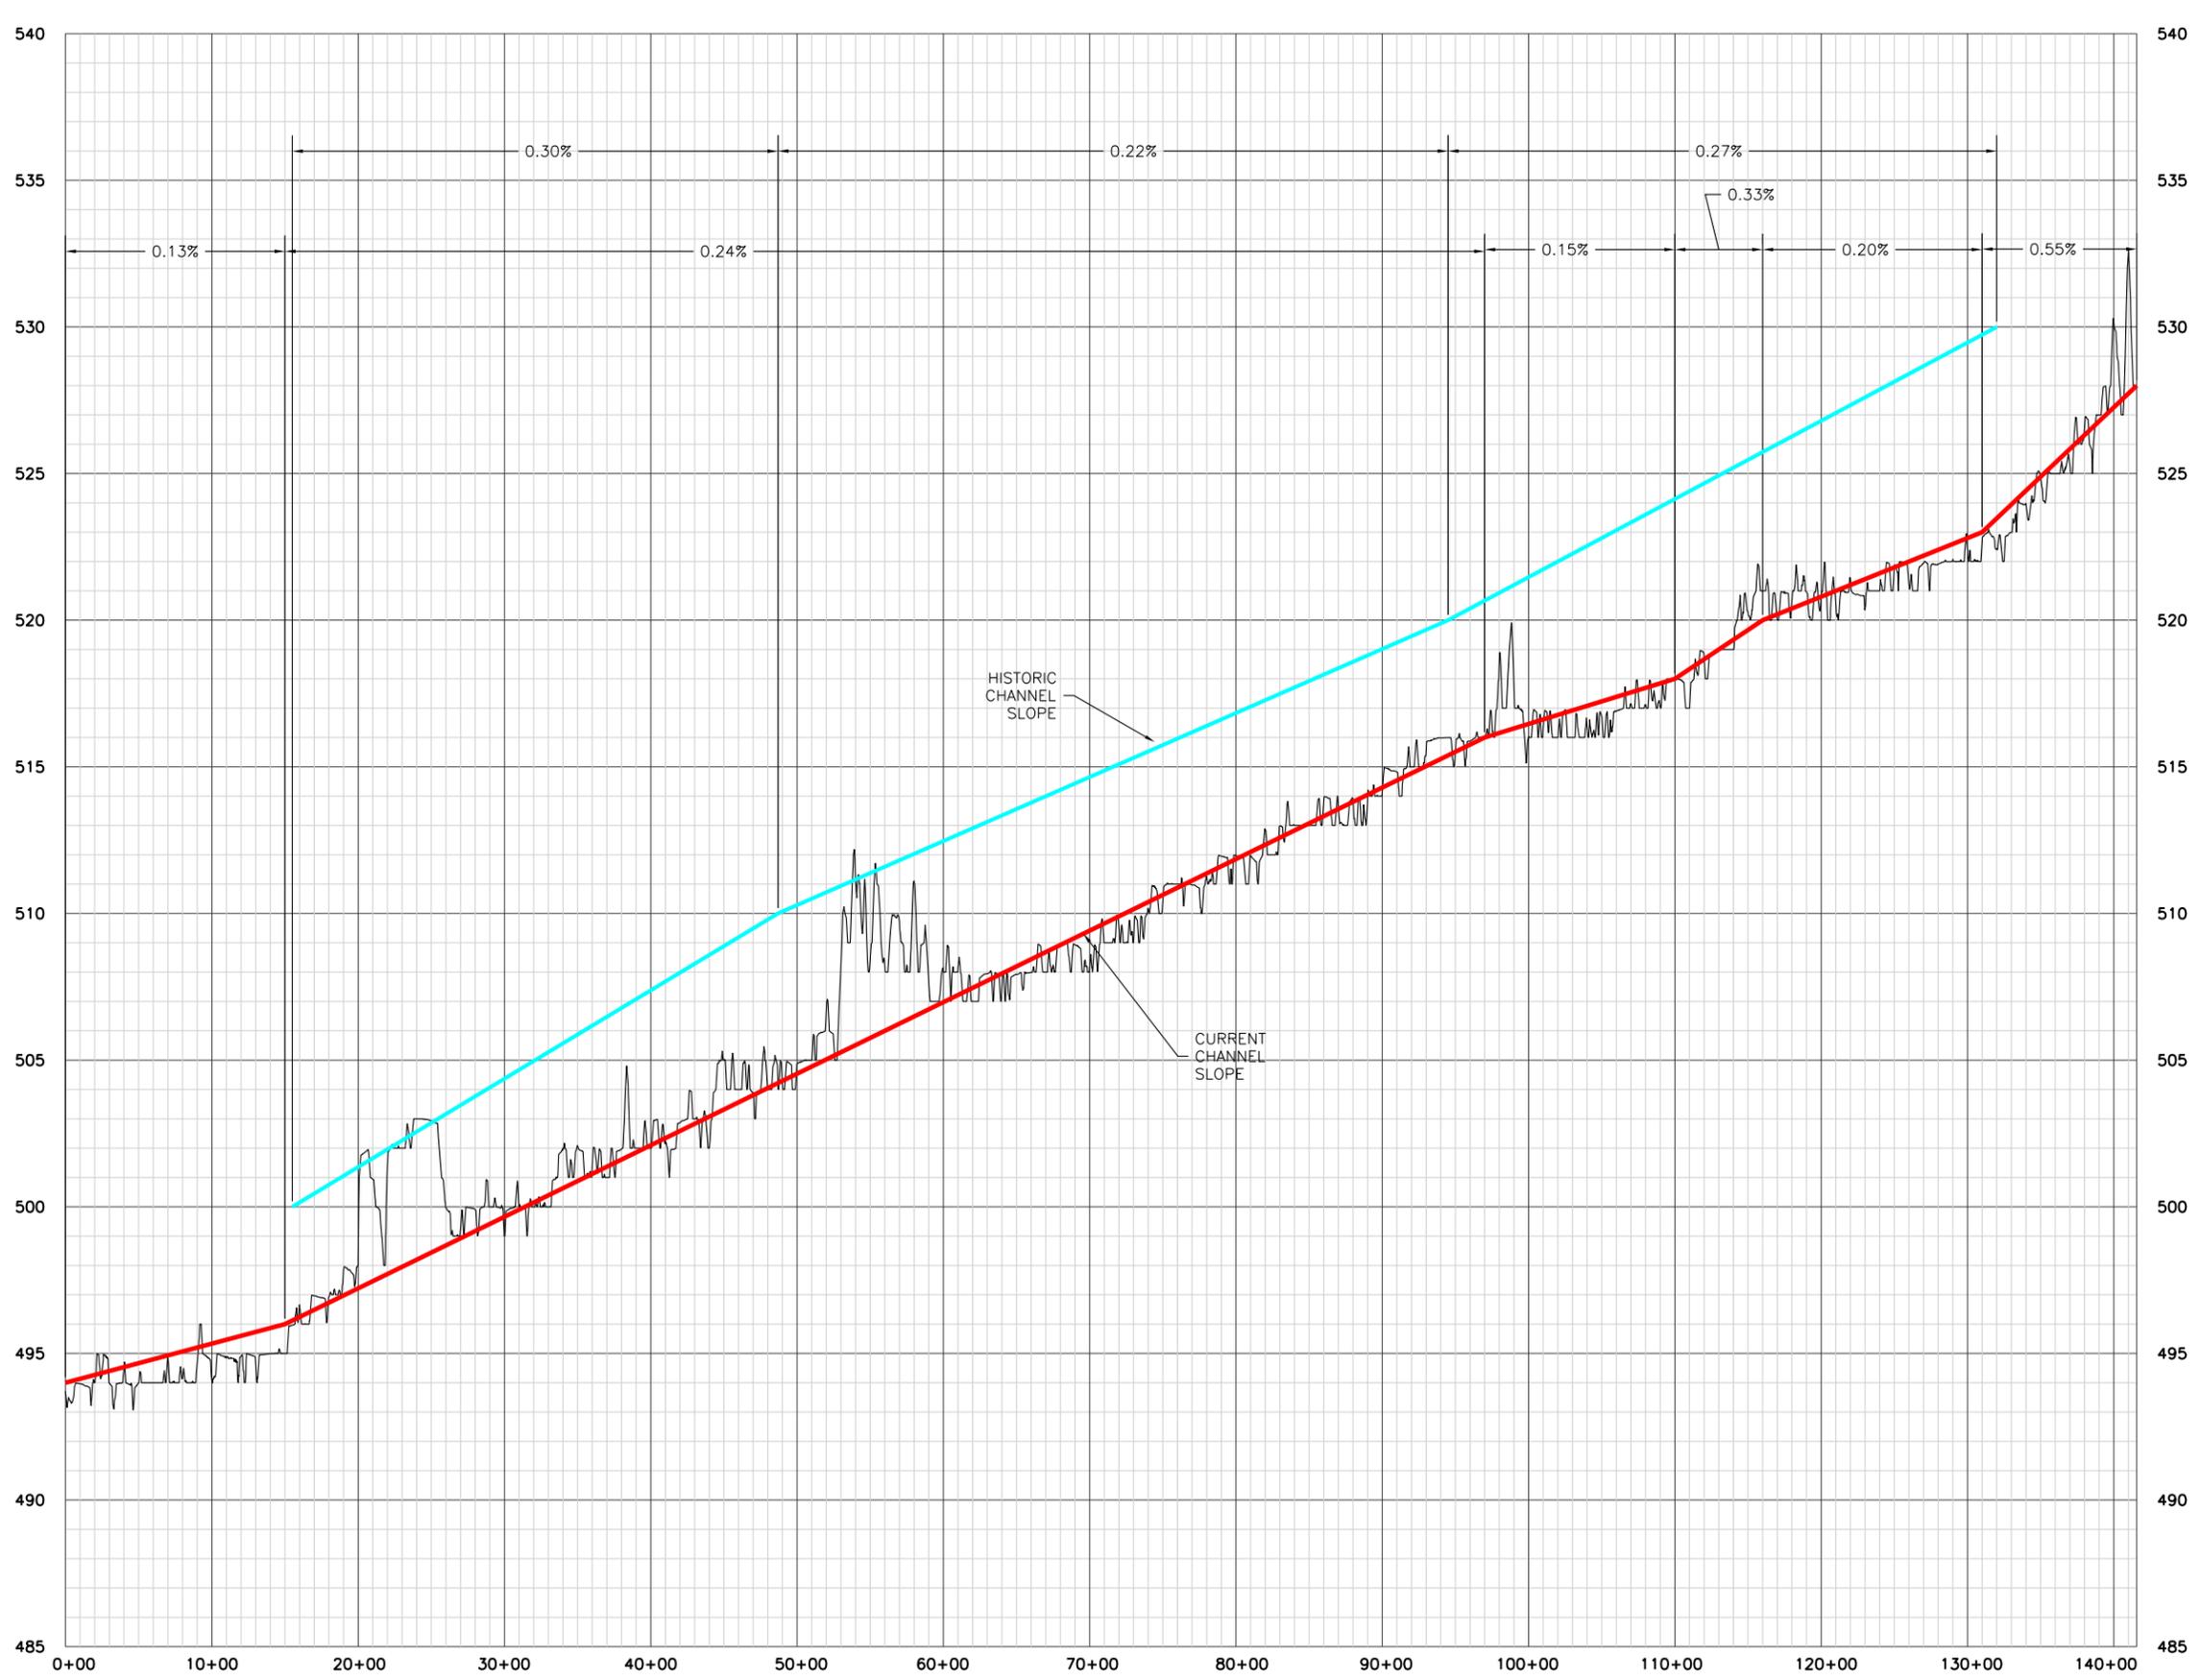
The average slope of Sandy Creek is approximately 0.26% with variations from approximately 0.15% to approximately 0.43% (Figure 5.41). The average top width of Sandy Creek is 35 feet and the average depth is 8 feet, with the exception of two short segments from Station 97+00 to 108+00 and from Station 114+00 to 127+00. The average depth in these reaches is 8 feet like the rest of Sandy Creek but the top widths average 90 feet wide. The banks of the 35 foot wide stream segments are nearly vertical (Figure 5.42) while the banks along the two short reaches are much flatter (Figure 5.43). The riparian vegetation along the majority of the reach includes heavily wooded upper banks and terraces with almost no bank vegetation. There are occasional trees growing on the banks of the stream but the lack of any other vegetation is resulting in continued bank erosion, undercutting, and occasional mass wasting. Even where trees are present on the slopes, the bank material is being mined from beneath and between the roots. Due to the high sediment load from bank erosion and incision the depositional patterns within Sandy Creek include frequent side bars, point bars, and occasional transverse or mid-channel bars. The wooded terrace provides dense shade along most of Sandy Creek but due to the sediment load and near vertical banks there is little to no habitat potential within the channel.
