# **SAN FRANCISCO WATERFRONT COASTAL FLOOD STUDY, CALIFORNIA**

## **SUB-APPENDIX B.2 – COASTAL LIFE SAFETY RISK**

# San Francisco Waterfront Storm Damage Reduction System Semi-Quantitative Risk Assessment

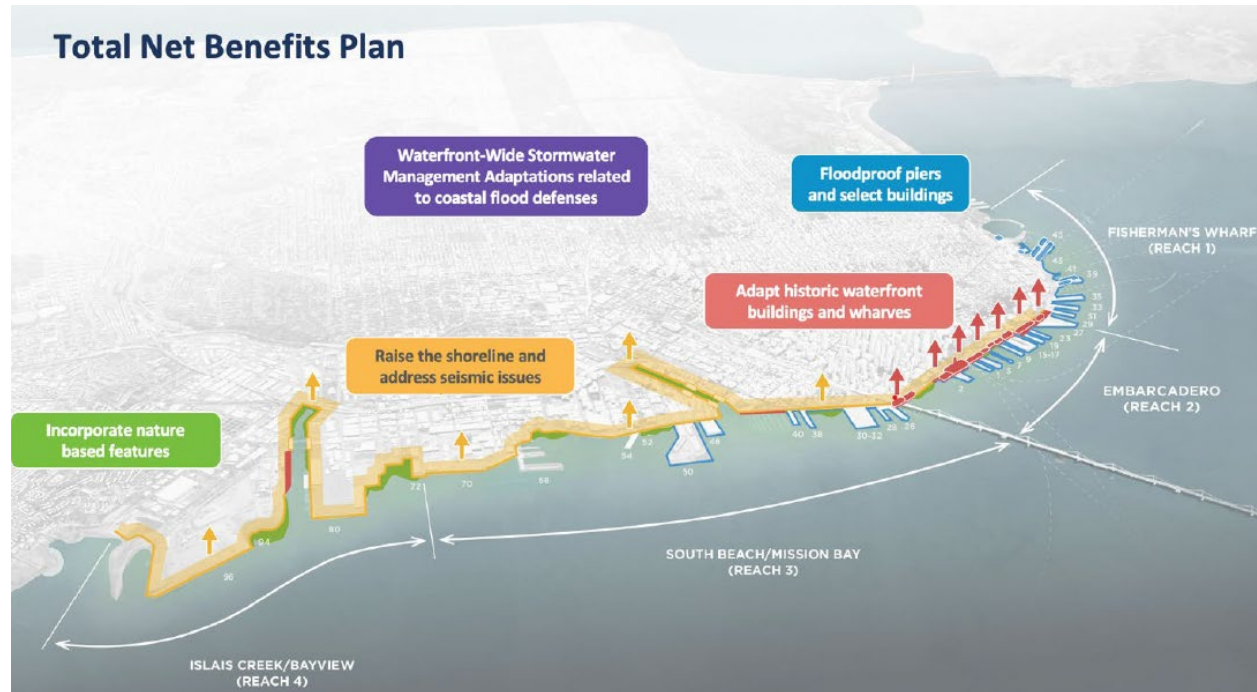
**Figure 5. Tentatively Selected Plan – Initial Actions.**

The main components of the project are shown in Figure 7 and include 4 reaches: Fisherman's Wharf, Embarcadero, South Beach/Mission Bay and Islais Creek Bayview. A broad description of the initial actions of the TSP is shown for each one of the reaches. Drawings depicting the key features of the project are included in Appendix B.

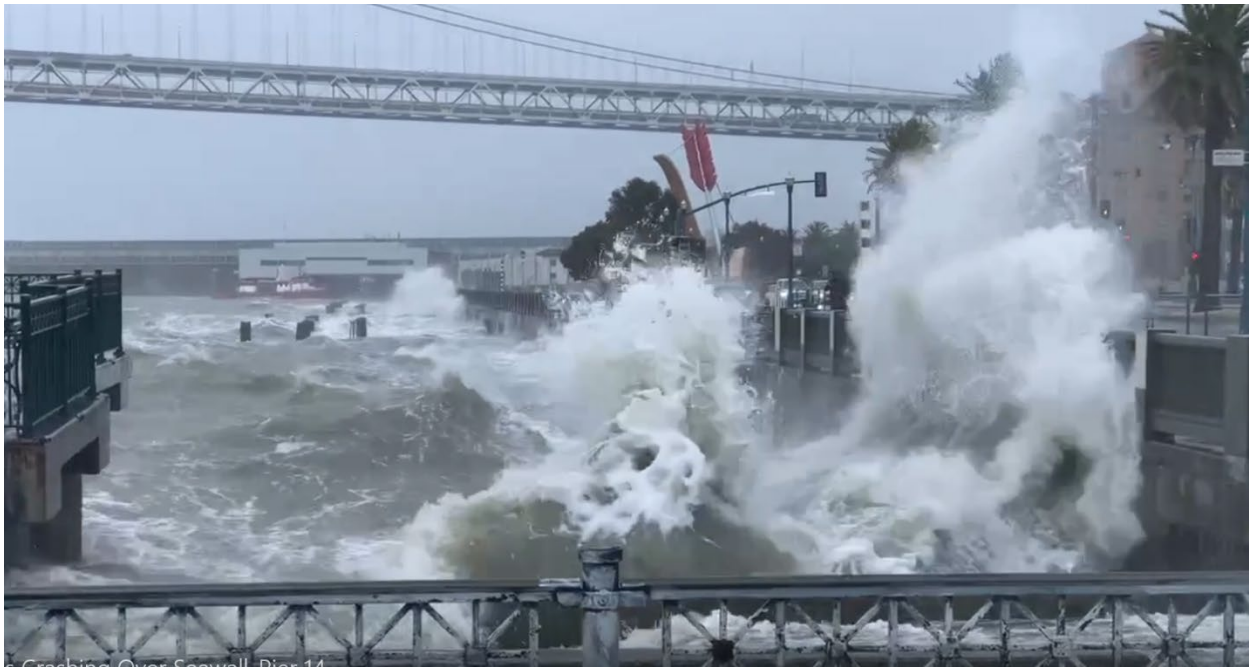
**Figure 6. Wave overtopping for existing conditions, March 2023.**

The existing risk of coastal storm damages are currently isolated to low-lying areas along the waterfront where land elevations are less than +10 feet North American Vertical Datum of 1988 (NAVD88), which is the average height of the seawall. The height of the seawall varies, as do heights along the entire waterfront. Specific low points along each reach are shown in Table 4. An example of past overtopping of the seawall occurred during an extreme tide in November 2015, resulting in Bay waters flooding the Embarcadero promenade along the waterfront near the Ferry Building. This event damaged steel plate joints, shut down at least one lane of traffic along the Embarcadero corridor, and posed a safety hazard to pedestrians. Additionally, in March 2023, a winter storm with high winds, led to extreme wave activity causing substantial shoreline overtopping at low tide (Figure 8).

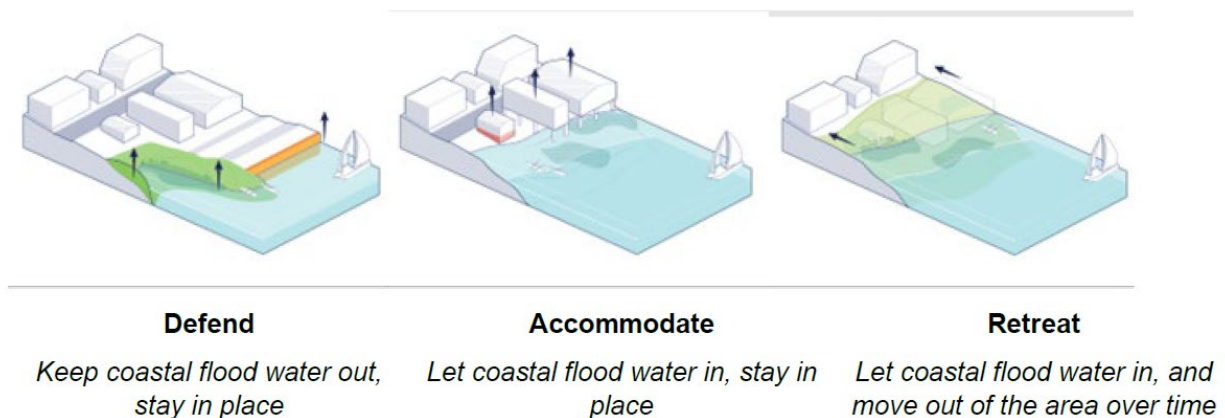
**Figure 7. Approaches to reducing risk.**

Four broad, conceptual, high-level approaches – Defend, Accommodate, Retreat, and Hybrid – were developed as a basis for formulating plans to address coastal flood risk. By law, at least one entirely nonstructural plan is required. The Defend, Accommodate, and Managed Retreat approaches are illustrated in Figure 9. Each reach has at least one of these strategies.
