# **SAN FRANCISCO WATERFRONT COASTAL FLOOD STUDY, CALIFORNIA**

## **SUB-APPENDIX B.3 – EARTHQUAKE LIFE SAFETY RISK**

JULY 2026

USACE TULSA DISTRICT | THE PORT OF SAN FRANCISCO

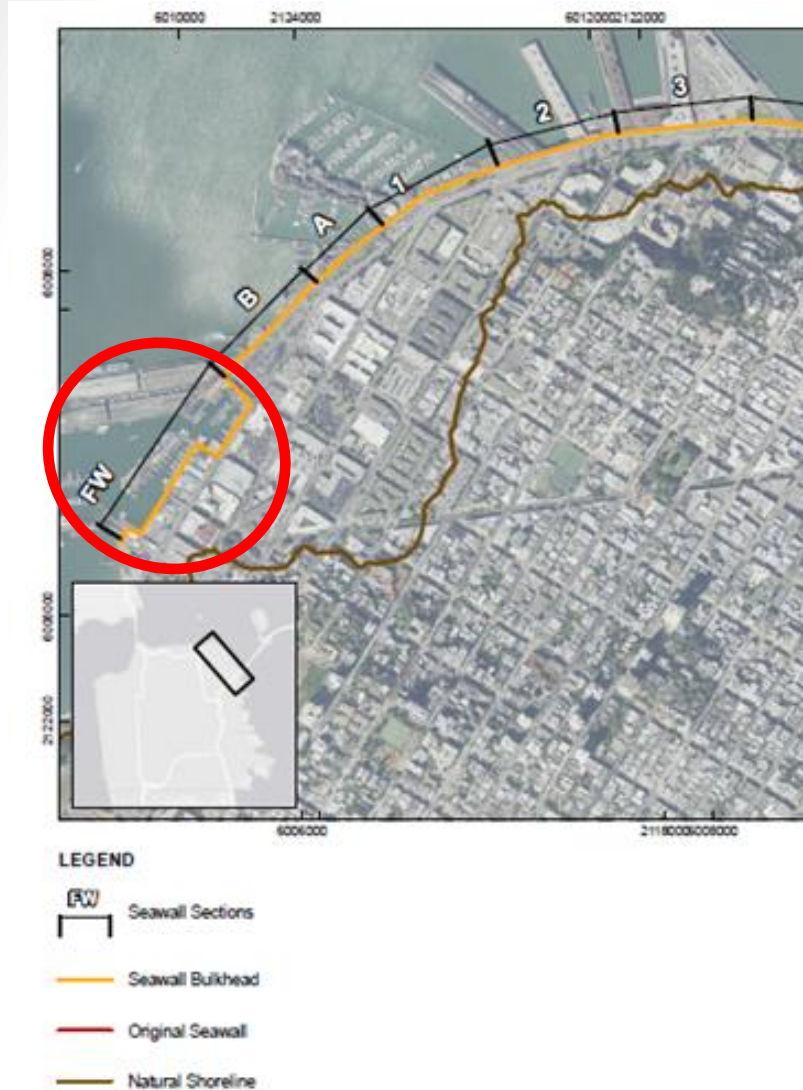
## Close Proximity of Commercial Buildings in Seawall Sub-Reach (Port ID: FW)

- Close proximity to buildings and roadway.
- Flood control system utilizing limited footprint should be contemplated.

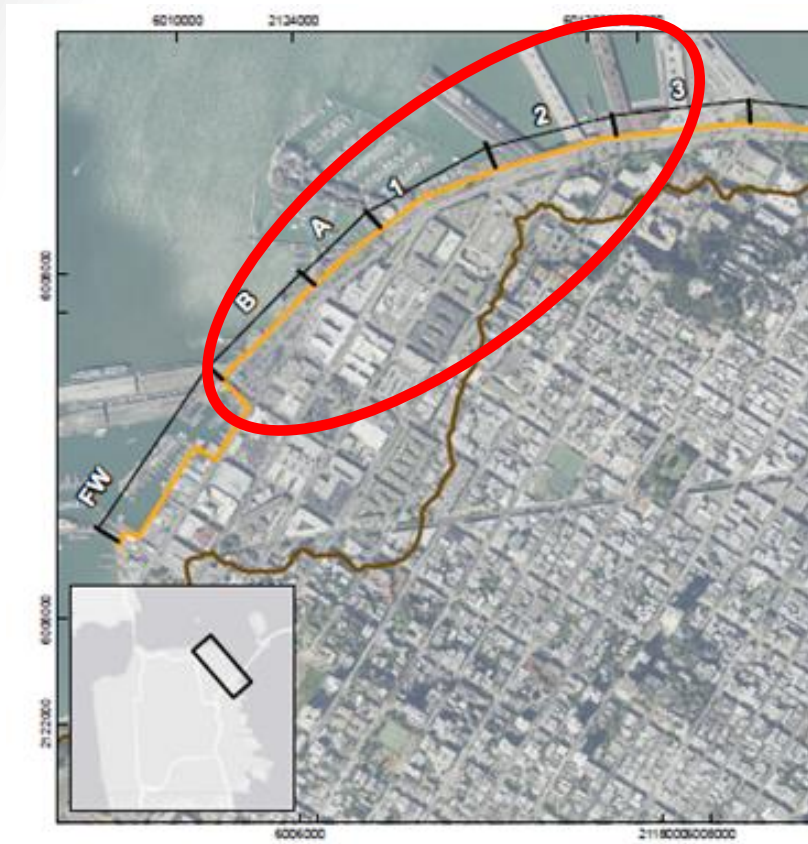
# Adequate Space for Efficient Ground Improvement Footprint without Impacting Streets and Light-rails in REACH 1: Sub-Reach: Taylor Street to North of Pier 29

- Wide promenade and park area (over rock dike) can be utilized for floodwall and ground improvement
- Flood control system utilizing limited footprint should be contemplated.

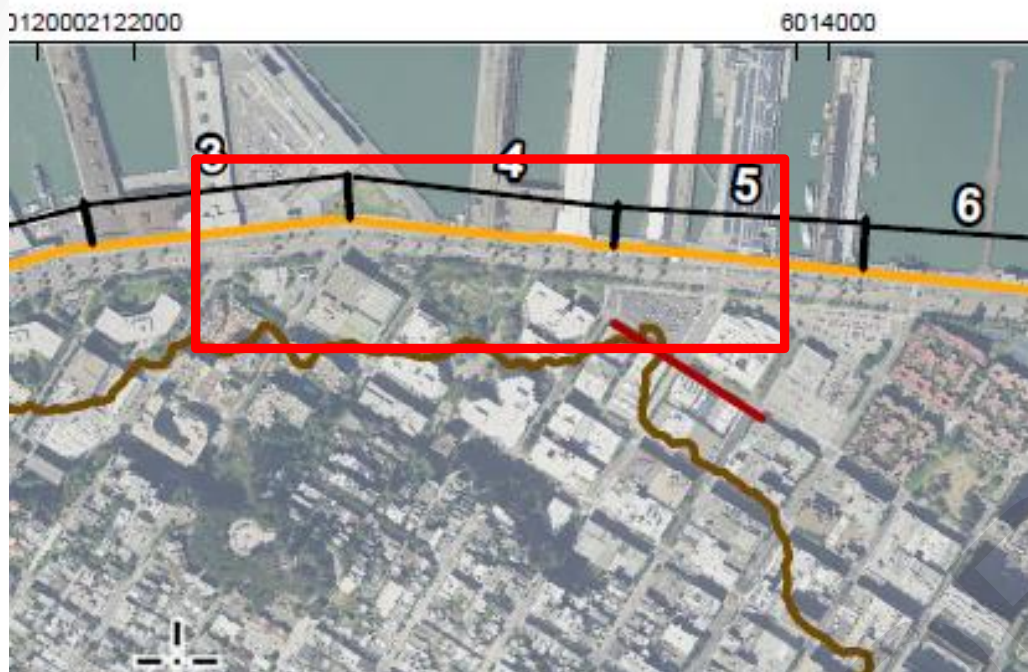
## Adequate Space for Efficient Ground Improvement Footprint without Impacting Streets and Light-rails in REACH 2: Sub-Reach: Pier 29 to Pier 15

- Wide promenade and park area (over rock dike) can be utilized for floodwall and ground improvement
- Flood control system utilizing limited footprint should be contemplated.

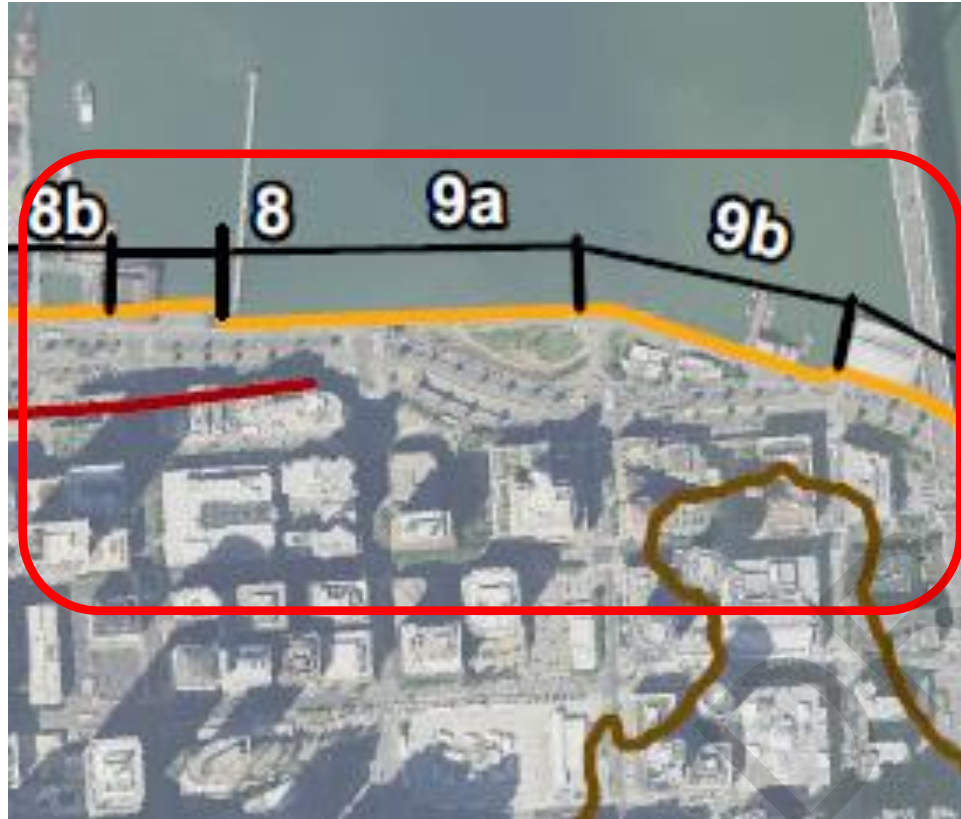
## Alignment for Flood Control System Should be Selected in REACH 2: Sub-Reach: Rincon Park to Bay Bridge

- Wide bay trail and park area. Due to shallow Fill+YBM and presence of rock dike, a flood wall system in drilled shaft may be adequate in this area.

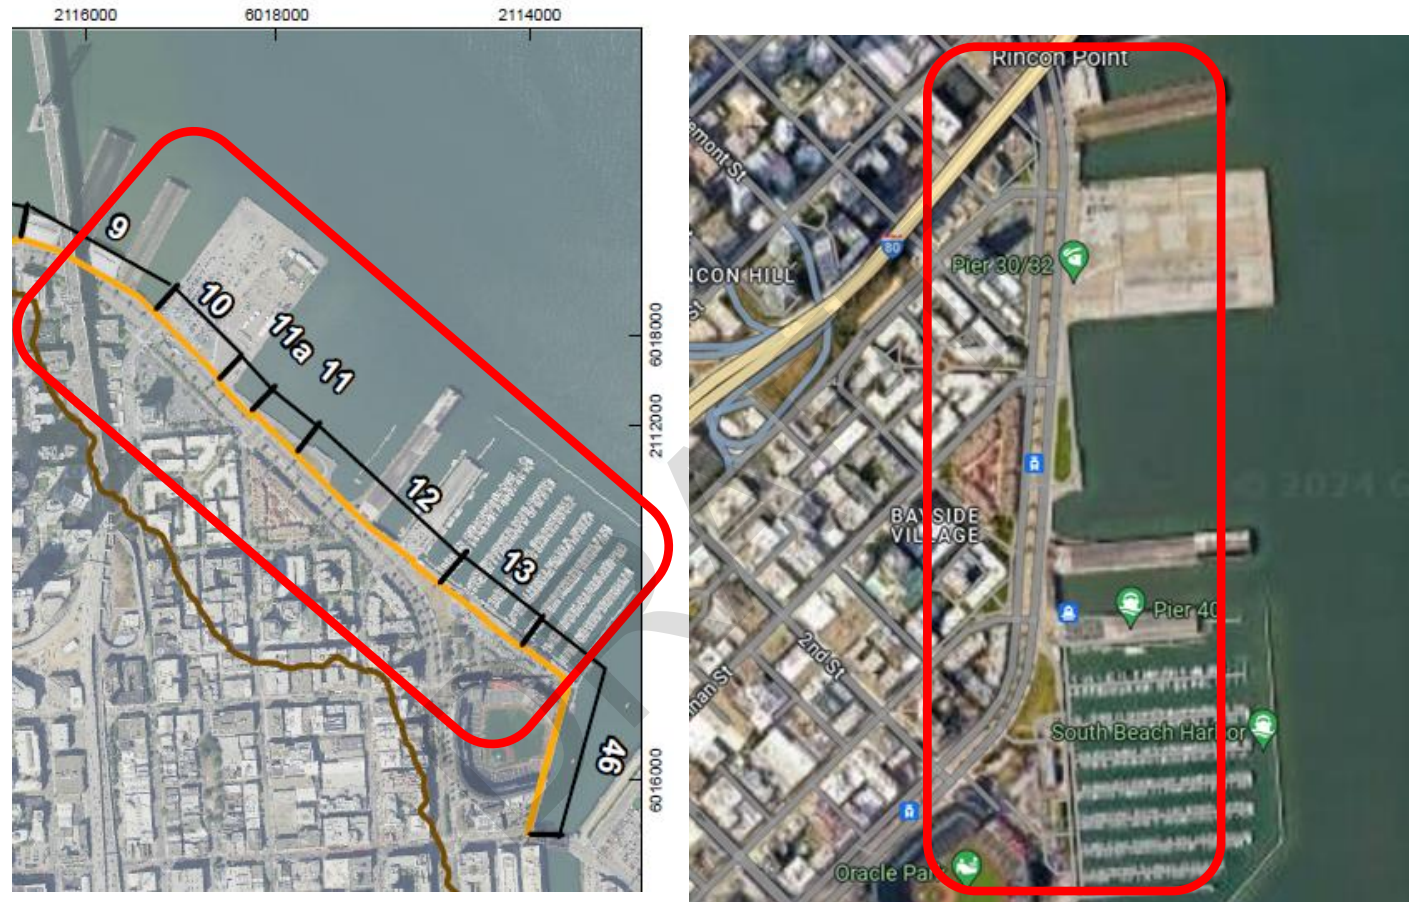
## Thickness of Rock Dike is Equal or Close to Thickness of Rock Dike + Young Bay Mud in REACH 3: Sub-Reach: Bay Bridge to Mouth of Mission Creek

- Wide bay trail, park, and parking lot area. Due to shallow Fill+YBM and presence of rock dike, a flood wall system in drilled shaft may be adequate in this area.
