Project to Remove the Neosho River Logjam at the Entrance to John Redmond Reservoir

Scope of Project

Conditions and Costs of Project

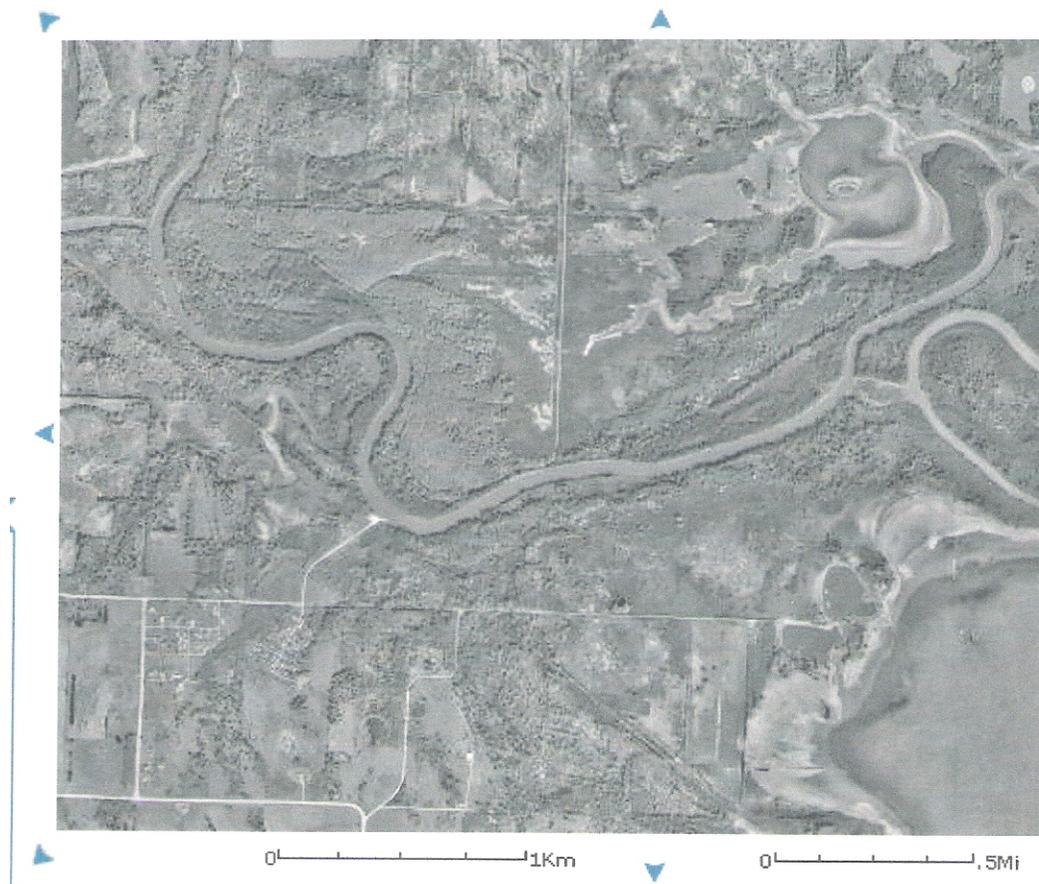
Satellite Image from 1991 shows no blockage on Neosho River

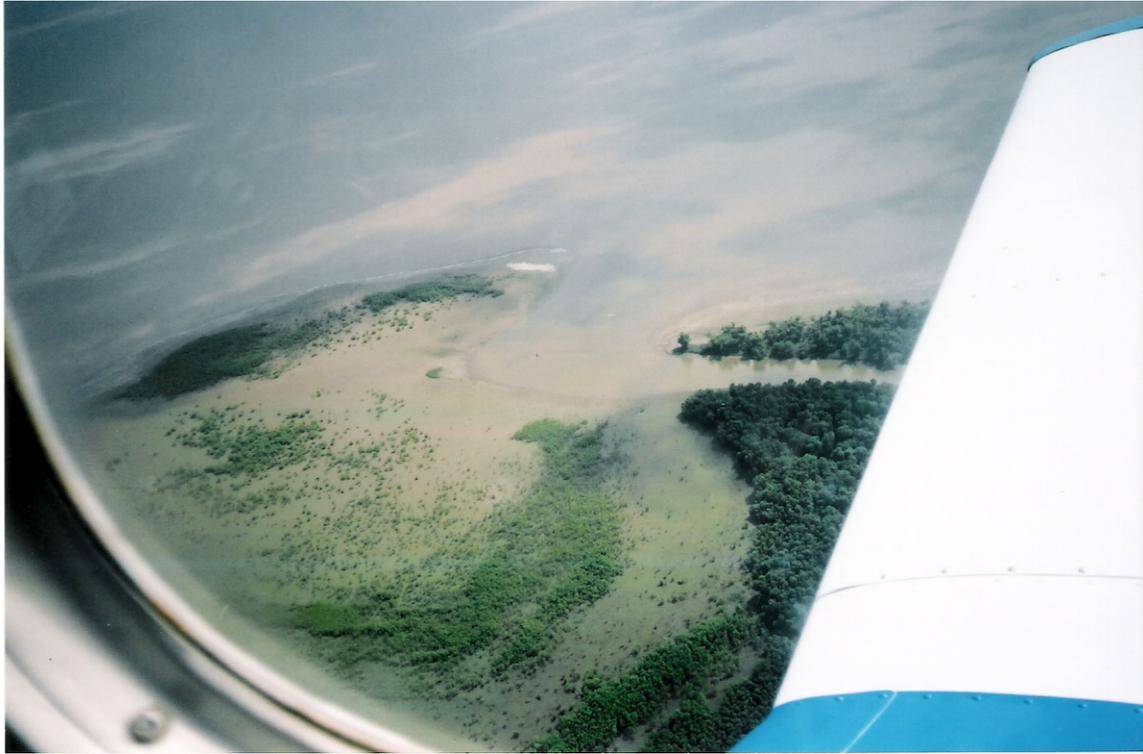
Silted mouth of Neosho River into John Redmond Reservoir with a 90 degree turn.

The first of a series of aerial photos show that entrance of the river into the reservoir is seriously silted in and the flow is forced to make a 90 degree turn to enter the lake.

- (3) In addition to doing option 2, dredging would be done at the entrance of the Neosho River into the reservoir to open up the entrance and to create a large silt basin to intercept the river silt from moving into the rest of the lake. This would probably involve removing 1 million cubic yards of silt and original material at the river entrance to create this in-lake basin. A cost estimate for this logjam removal and dredging of 1 million cubic yards would be \$ 5.5 million to \$ 8.0 million depending on the type of dredge material.

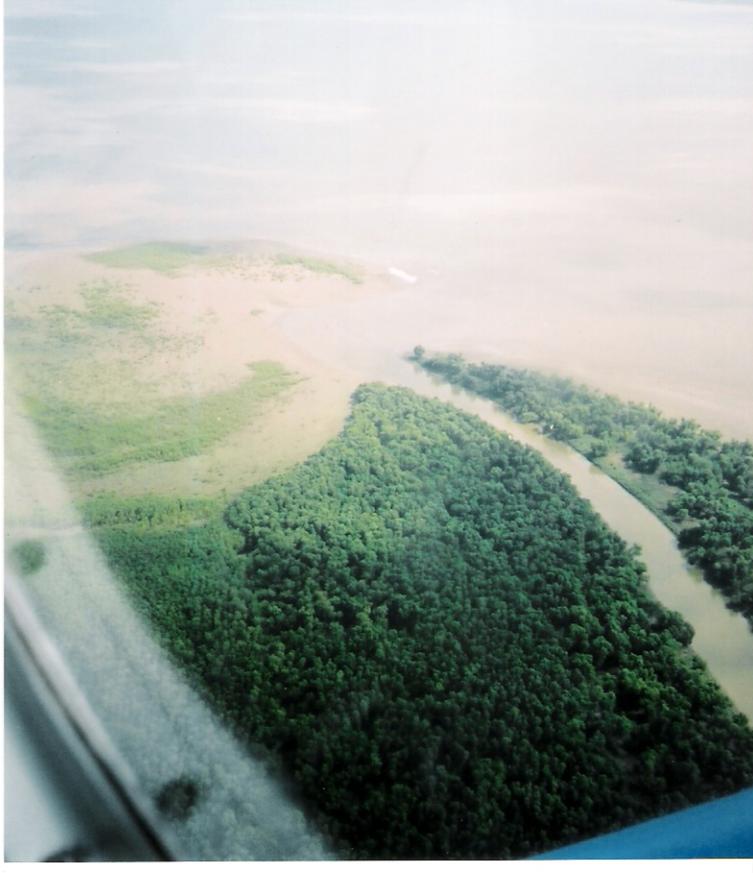
One half mile of river channel near mouth with little log debris.

From the mouth upstream, there is about a half mile stretch which is nearly clear of snags or debris. About a half mile from the mouth, there is side channel. From the side channel upstream on the main channel, debris and a partial logjam begins to appear for several hundred yards until a second side channel appears.

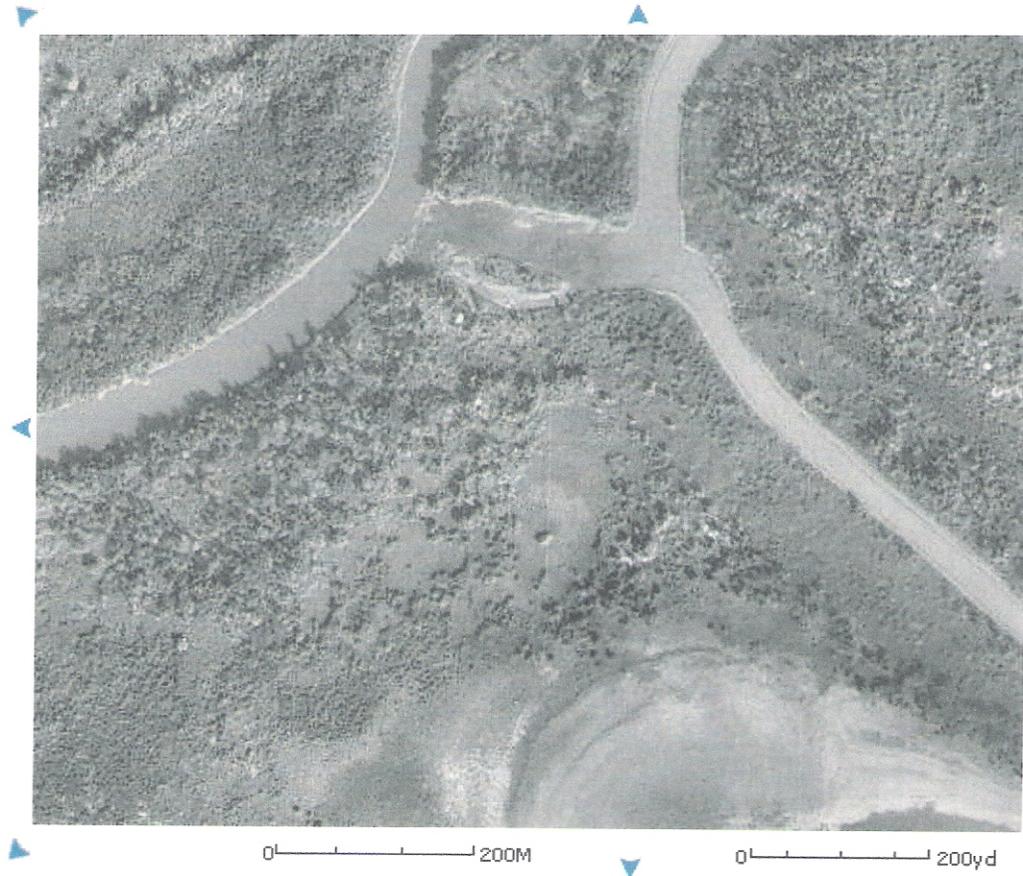
A satellite view shows both side channels off the main channel at the top of photo. These side channels appear to be an original oxbow of the Neosho River.

At their other ends, both side channels are cut off from each other and presently dead end into silt barriers which also prevents them from entering the lake at the present lake water levels.

- (1) The logjam would be dislodged and the freed logs placed and entrapped by berms or levees in the two side channels. After dislodgement, the logs would be ferried into the side channels and substantial berms would be placed at each end of the side channel to encapsulate the debris. A cost estimate for this option would be \$ 1.0 million to \$ 1.5 million.

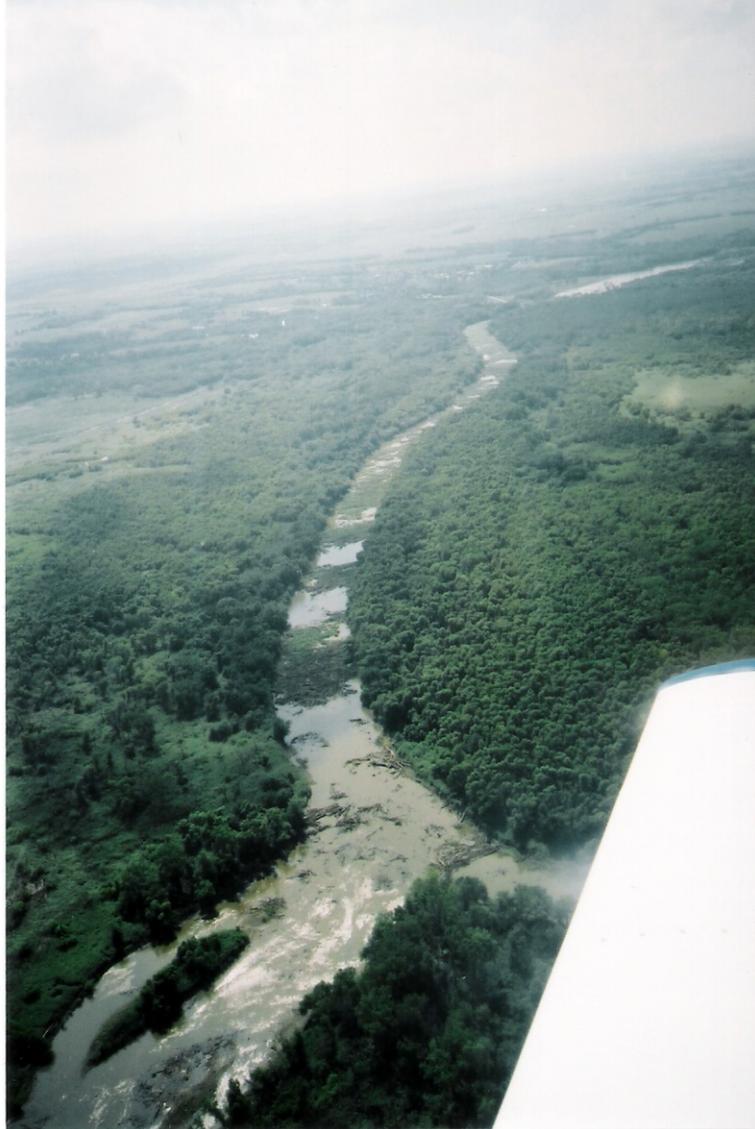
Looking upstream from the lower end of the Neosho River logjam.

Upstream from the upper side channel, the logjam becomes generally solid on the main channel across the whole width of the river. New vegetation is growing in part of the logjam. The logjam appears to be one and half miles long past the boat ramp on the river at Jacob's Creek.

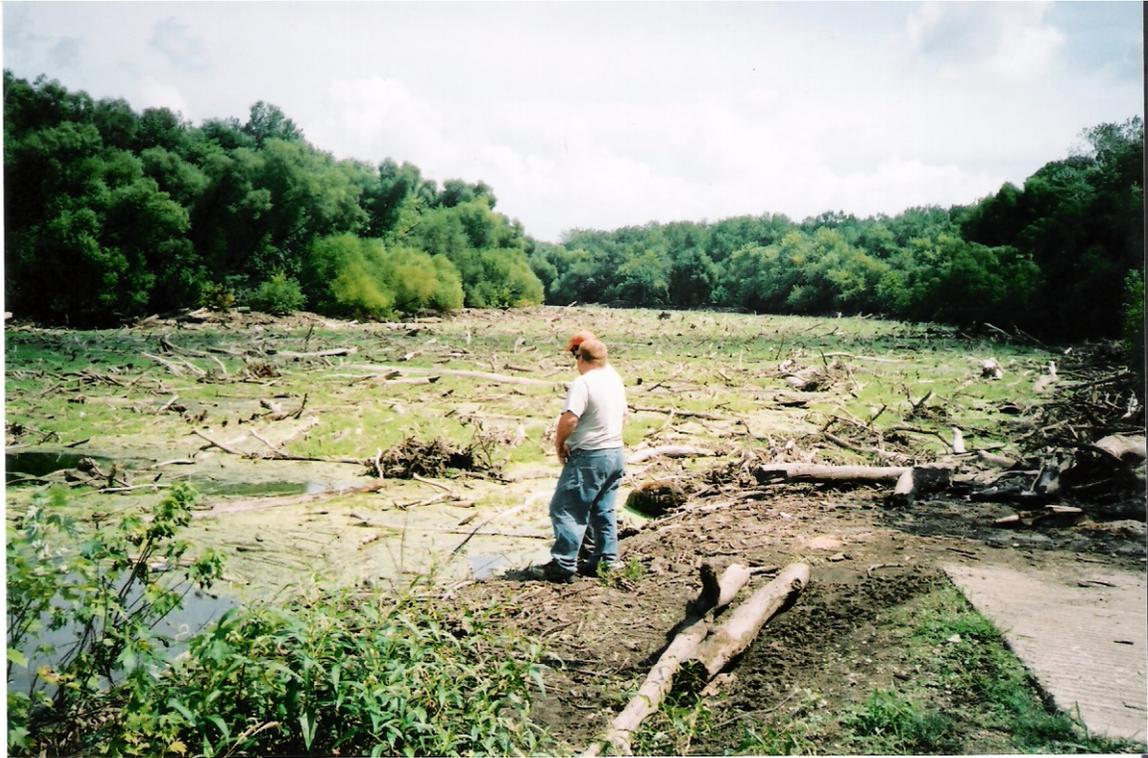
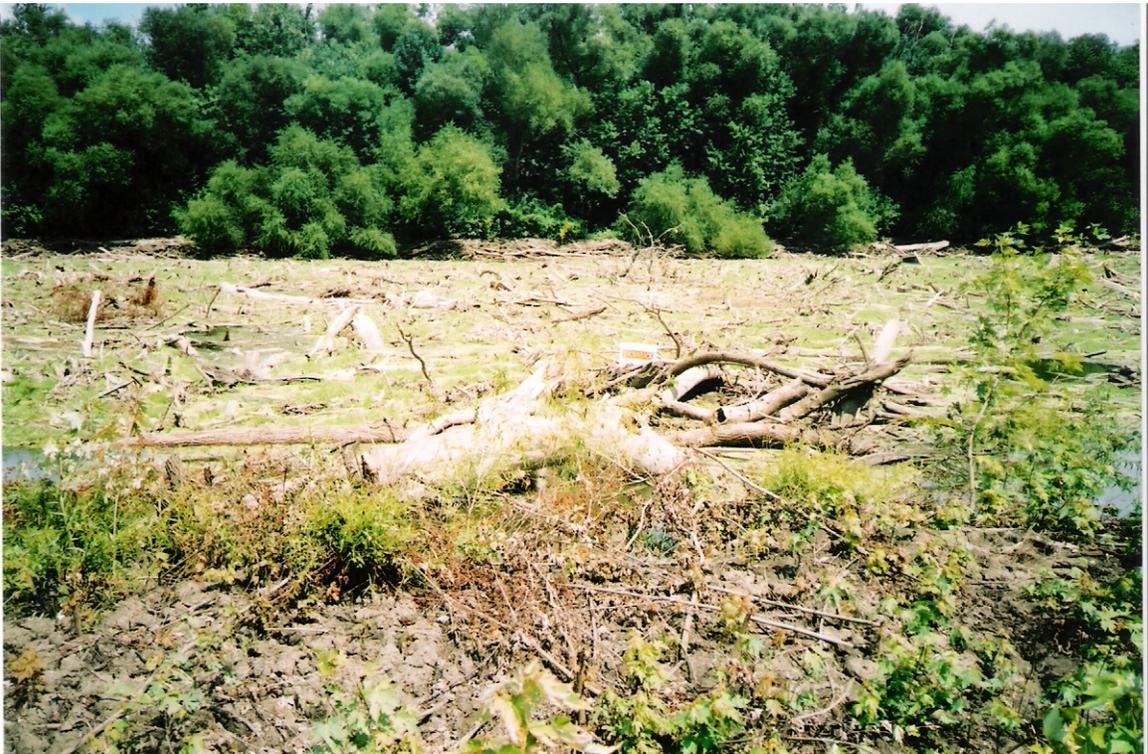
The above photos show that the upper end of the logjam covers the full width of the river and totally blocks the boat ramp from both upstream and downstream

access. The upper end of the raft appears to be several hundred yards upstream from the boat ramp.

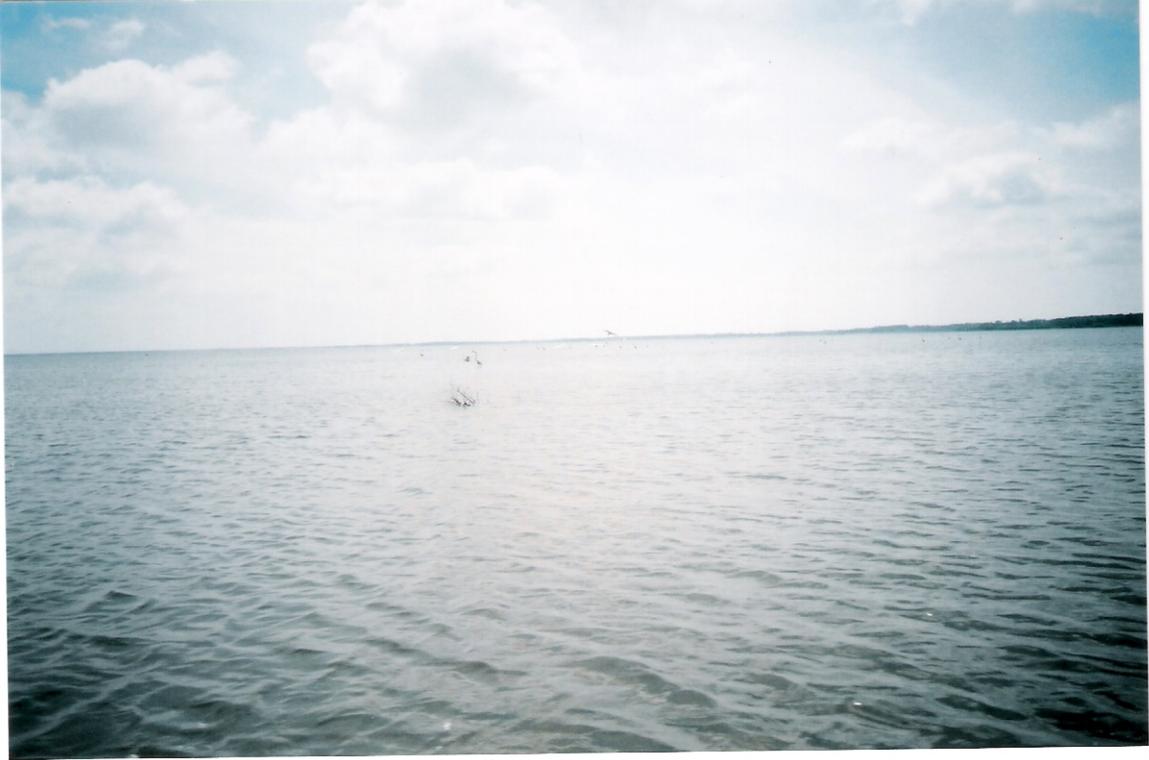
John Redmond Reservoir showing debris snags from the shallow bottom

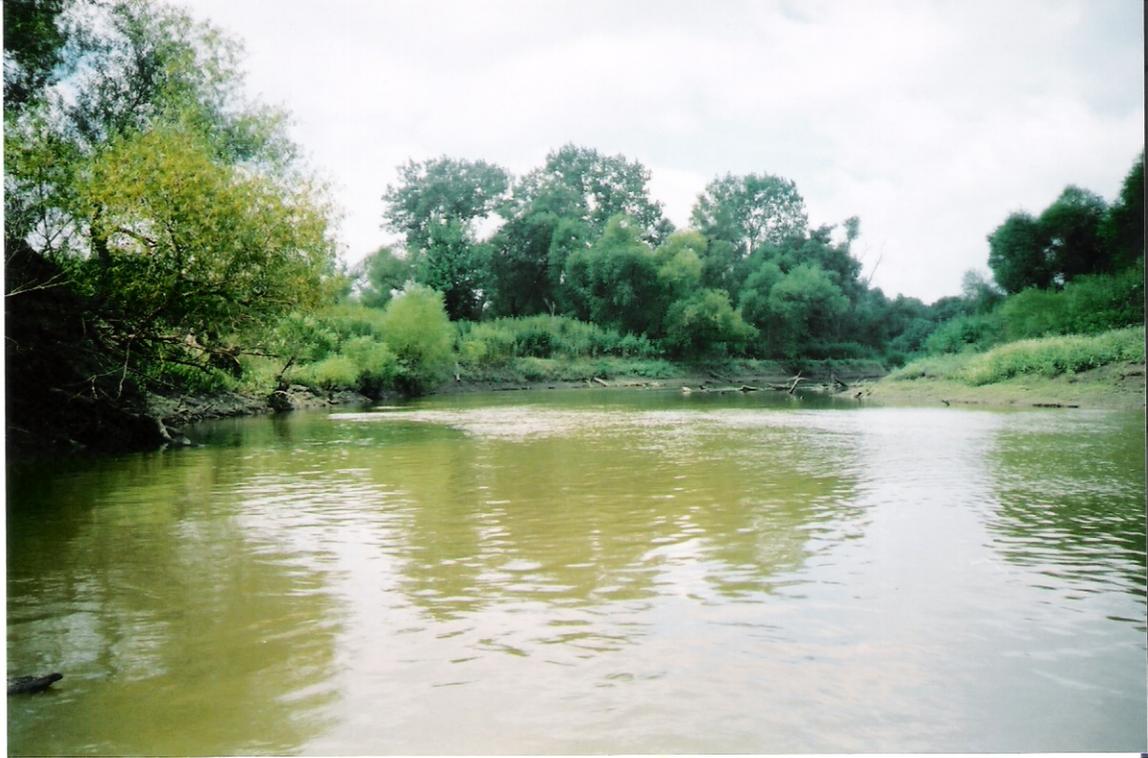
Channel without debris below the logjam near lake entrance of Neosho River

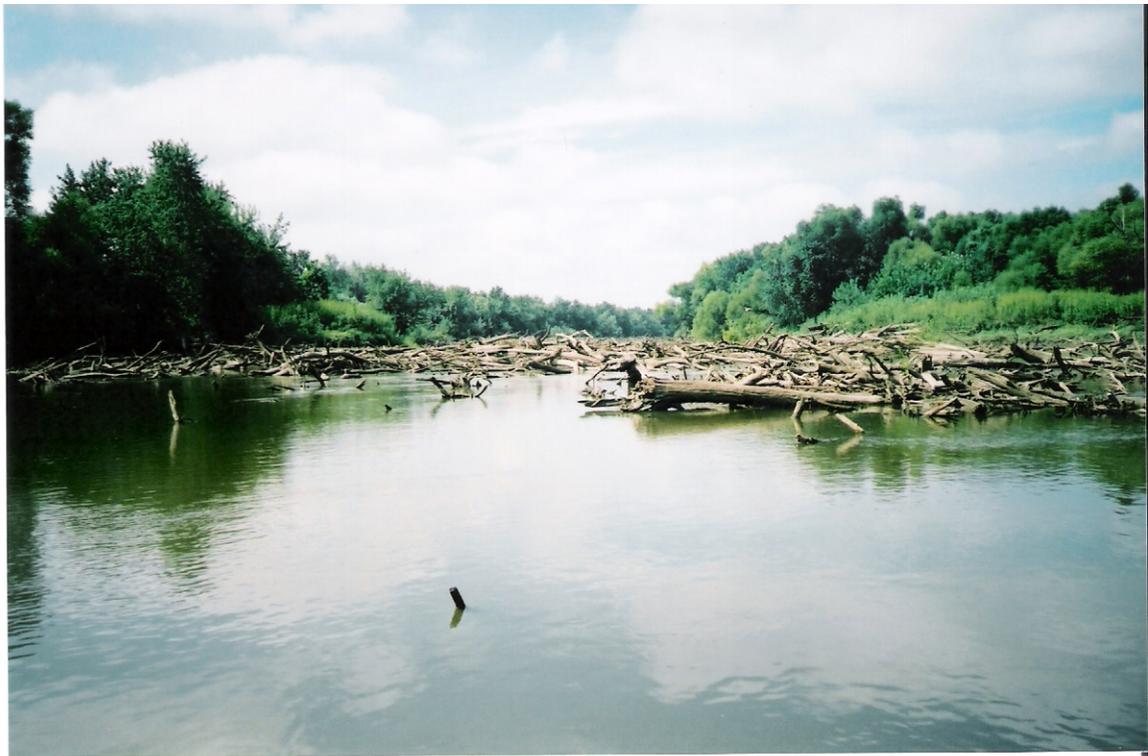
Lower end of logjam on Neosho River

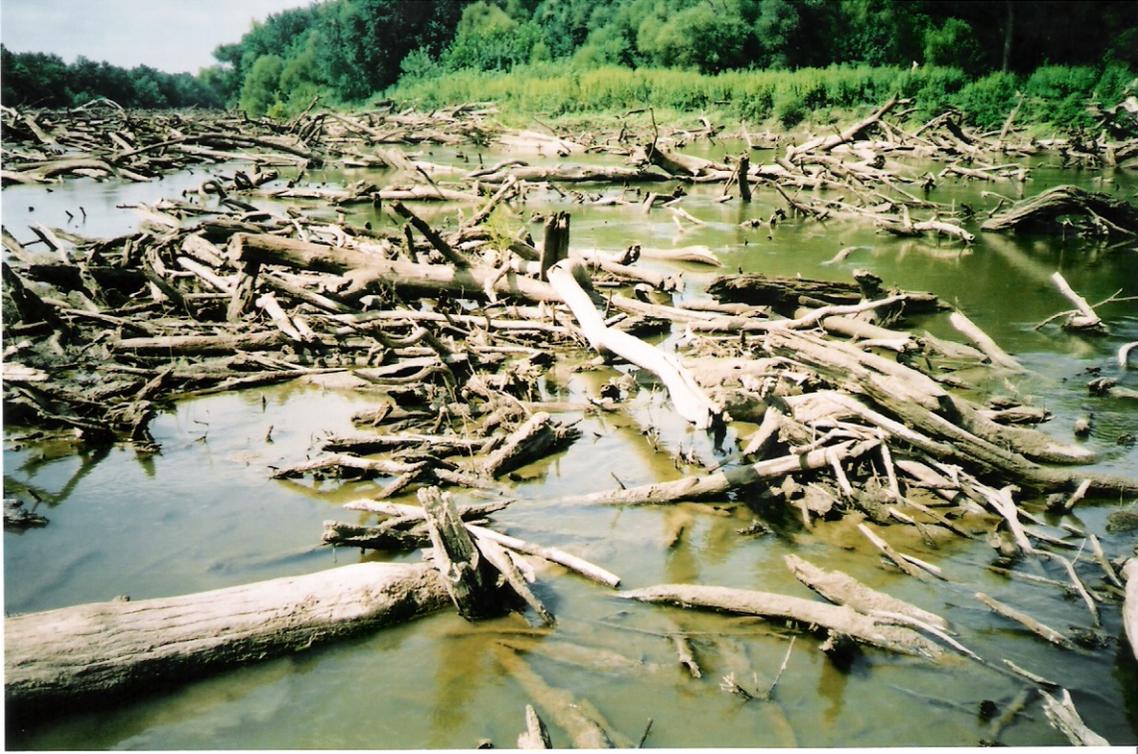
View from airboat of silt in Neosho River logjam
